CompactLogix Controller Revision 13

Catalog Numbers 1769-L31, 1769-L32C, 1769-L32E, 1769-L35CR, 1769-L35E

CompactLogix™ controller:	Firmware revision:
1769-L31, L32C, L35CR	Major revision 13, minor revision 33
1769-L32E, -L35E	Major revision 13, minor revision 34

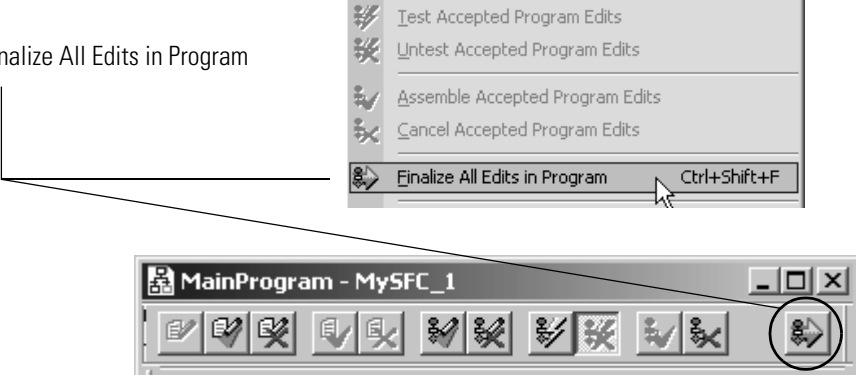
Enhancement:	Description:
Finalize All Edits in a program	<p>The <i>Finalize All Edits in Program</i> option lets you make an online change to your logic <i>without</i> testing the change.</p> <p>Finalize All Edits in Program</p>

<p>When you choose <i>Finalize All Edits in Program</i>:</p> <ul style="list-style-type: none">• All edits in the program (pending and test), immediately download to the controller and begin execution.• The original logic is permanently removed from the controller.• Outputs that were in the original logic stay in their last state unless executed by the new logic (or other logic).• If your edits include an SFC, the SFC resets to the initial step and stored actions turn off.
Motion Calculate Slave Value (MCSV) instruction	<p>Use the MCSV instruction in the following applications:</p> <ul style="list-style-type: none">• Position cam: electronic camming between two axes according to a specified cam profile• Time cam: electronic camming of an axis as a function of time, according to a specified cam profile <p>The MCSV instruction returns the slave value within a specified cam profile for a given master value. The master value can be master position or time. Use that information to re-synchronize motion after a fault or to calculate dynamic phase corrections.</p>

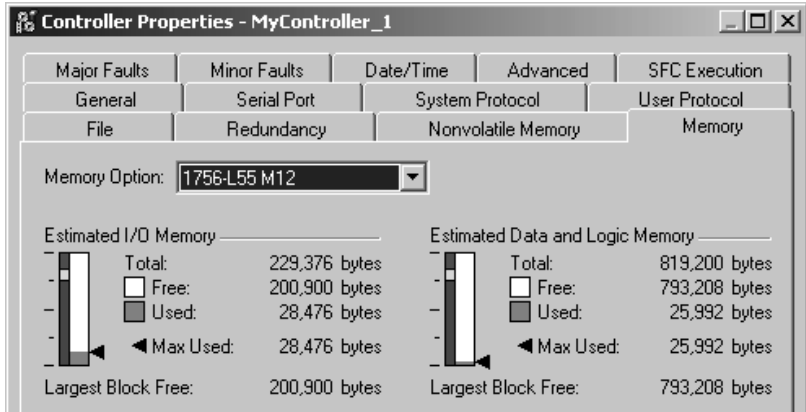
Enhancement:	Description:									
Estimate Memory Information Offline View Memory Information Online	<p>To estimate how much controller memory your project requires, use the <i>Memory</i> tab of the controller properties dialog box. For each of the memory areas of your controller, it lets you estimate number of bytes of:</p> <ul style="list-style-type: none">• free (unused) memory• used memory• largest free contiguous block of memory <div>

</div> <p>When online with a controller, the <i>Memory</i> tab shows the actual memory usage of the controller. The tab includes a <i>Max Used</i> entry for each type of memory. The <i>Max Used</i> values show the peak of memory usage as communications occur.</p>									
Improved Performance of Simple Structured Text Statements	<p>The controller now executes simple structured text (ST) assignments and comparisons faster than previous revisions.</p>

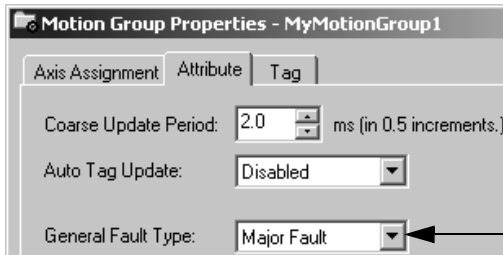
For Function Block Instructions that use periodic timing, DeltaT now includes the fractional portion of the task's period	<p>If your function block instruction uses the periodic timing mode, the controller <i>no longer</i> truncates the fractional portion of a task's period to produce the delta time (DeltaT).</p> <p>In previous revisions, the controller truncated the fractional portion of the task's period.</p>
While in Program mode, a motion group fault no longer produces a major fault	<p>As an option, you can configure a motion group to produce a <i>major fault</i> any time the group detects a motion fault.</p>

<p>With this revision, a motion group that is configured to produce a major fault produces a major fault <i>only</i> if the controller is in run/remote run mode.</p> <p>In <i>previous</i> revisions, the motion group could produce a major fault while the controller was in program/remote program mode. For example, a store to nonvolatile memory interrupts the execution of the motion planner, which produces a fault.</p>

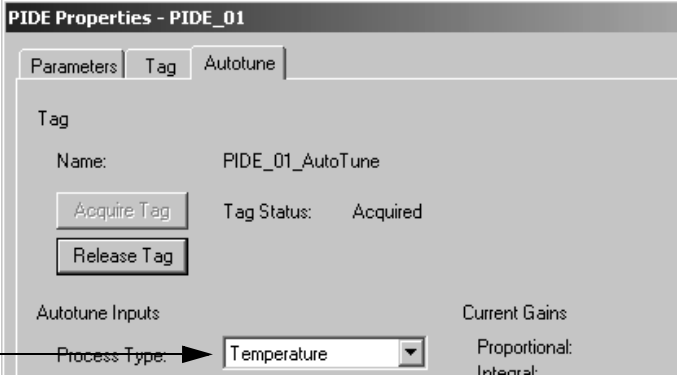
Change:	Description:
Out-of-range subscript no longer produces a fault during prescan	<p>During prescan, the controller automatically clears any faults due to an array subscript that is beyond the range of the array (out of range).</p> <p>In <i>previous</i> revisions, this produced a major fault.</p>
Autotune now uses a non-integrating process model for temperature processes	<p>When you autotune an Enhanced PID (PIDE) function block with the Process Type = Temperature, autotune now uses a non-integrating process model to estimate tuning constants. This gives better tuning constants for most application.</p>

<p>Temperature setting — Process Type: Temperature</p> <p>In previous revisions, autotune used an integrating process model.</p>
You <i>must</i> place a label (LBL) instruction at the start of a rung	<p>If your logic includes a Label (LBL) instruction, make sure the instruction is the first instruction on the rung. If it is <i>not</i>, move the LBL instruction to the beginning of the rung. Otherwise, the routine will <i>not</i> verify.</p> <p>In previous revisions, RSLogix 5000 software let you place the LBL instruction elsewhere on the rung. But the controller always executed the instruction as if it were at the beginning of the rung.</p>

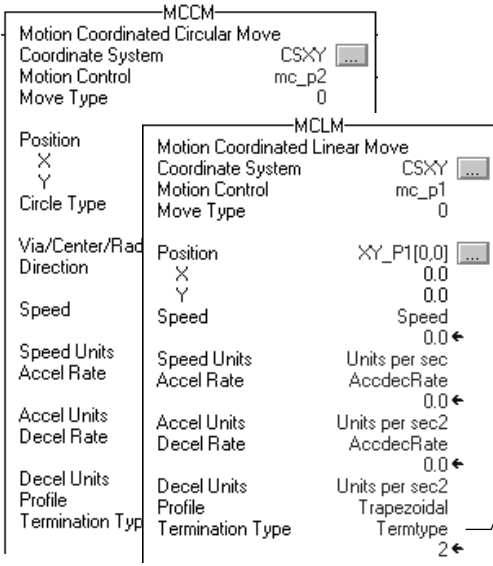
Anomaly:	Description:
blended moves produce smoother, more accurate motion	<p>This revision improves the response of the axes when you blend the execution of Motion Coordinated Linear Move (MCLM) and Motion Coordinated Circular Move (MCCM) instructions.</p> <ul style="list-style-type: none"> If the Termination Type = command tolerance (2) or no deceleration (3), axes change more smoothly and follow the intended path more closely. If the Termination Type = command tolerance (2) or no deceleration (3) and the program path direction is reversed, the instruction will exceed the specified acceleration/deceleration for the MCLM or MCCM instruction.

<p>Termination Type 0 = actual tolerance 1 = no settle 2 = command tolerance 3 = no deceleration</p>
large message (MSG) instructions might have caused a non-recoverable fault	<p>The following configuration of a Message (MSG) instruction might have produced a non-recoverable fault:</p>
