FlexLogix Controller Revision 11

Cat. No. 1794-L33, 1794-L34, and 1794-L34/B

These release notes should be used with major revision 11, minor revision 26 of the FlexLogix Controller firmware. Use this firmware with:

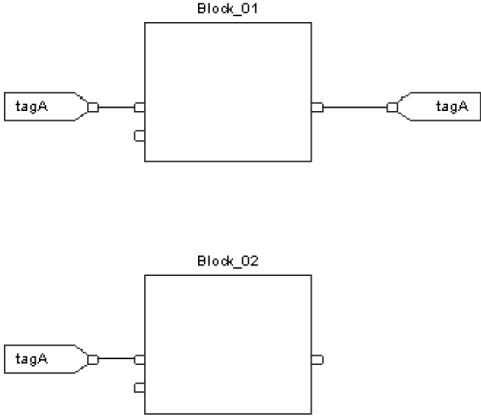
Change:	Description:
Use the Same Tag in Multiple IREFs and OREFs	<p>You can use the same tag in multiple IREFs and an OREF in the same routine. Because the values of tags in IREFs are latched every scan through the routine, all IREFs will use the same value, even if an OREF obtains a different tag value during execution of the routine. In this example, if tagA has a value of 25.4 when the routine starts executing this scan, and Block_01 changes the value of tagA to 50.9, the second IREF wired into Block_02 will still use a value of 25.4 when Block_02 executes this scan. The new tagA value of 50.9 will not be used by any IREFs in this routine until the start of the next scan.</p> <p>—</p>

<p>The diagram illustrates two function blocks, Block_01 and Block_02, arranged vertically. Block_01 is a square block with an input tagA on its left side and an output tagA on its right side. Block_02 is a square block with an input tagA on its left side and an output tagA on its right side. The tags are represented by rounded rectangles with a small square on the side indicating the connection point.</p>
