Monthly Report · October 2026 · Huawei FusionSolar fleet review

10 Huawei plants installed by Solar ESS. Data for 1–24 October 2026, the 24 October day profile, alarms for 1–25 October and live inverter readings on 25 October. Expected October yield is taken as 4.3 kWh per kWp per day, and savings are estimated at 4.5 THB/kWh. Site names are replaced with labels that stay the same in future reports.

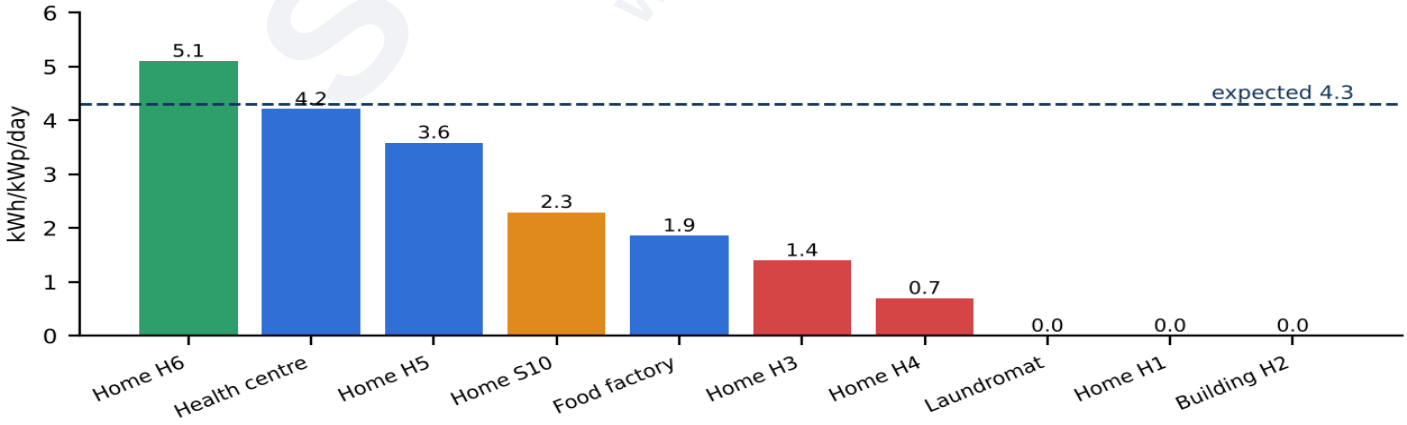
210.9 kWp
Installed PV (3 plants have no kWp set; 5 kWp assumed)

7,032 kWh
PV yield, 1–24 October

5
Plants to fix now

4
Settings or upgrade

1
Healthy

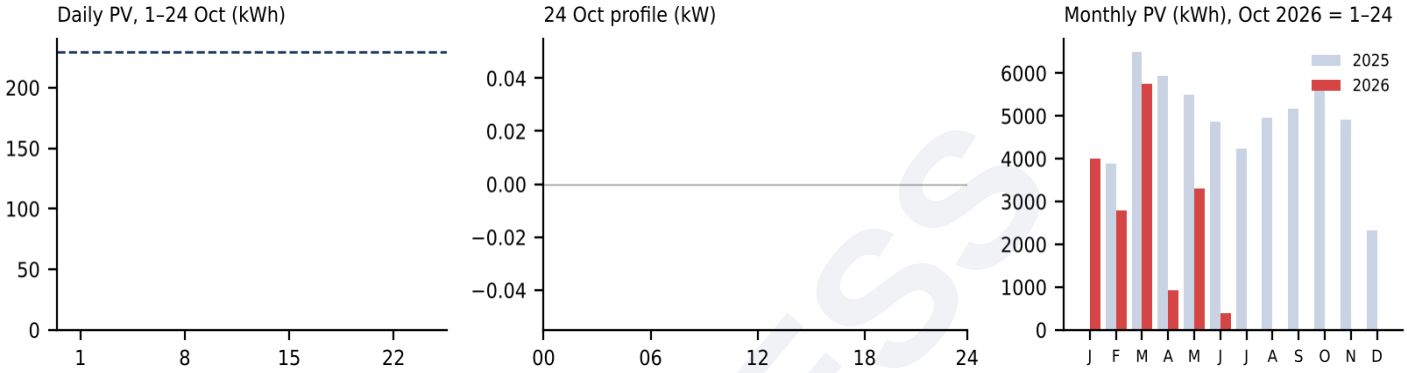
Building H2, Chiang Mai

No data since June 2026

• The SmartLogger, the 50 kW inverter and both power meters show as disconnected. The last production data is from June 2026 (385 kWh), and the active alarm is "Network Connection Error".

• In 2025 this 53 kWp system made 3,900–6,500 kWh a month. We can't tell from the cloud whether it is still producing, so up to about 5,000 kWh a month is unmonitored.

1. Call the owner to ask whether the inverter display shows it running, and whether the internet router or SIM at the logger has changed.

2. Restore the SmartLogger's internet connection (router, LAN cable or 4G SIM), then check that all devices reconnect.

3. If the inverter itself is off, send a technician. A 53 kWp system off for 4 months is worth about 90,000 THB in lost energy.

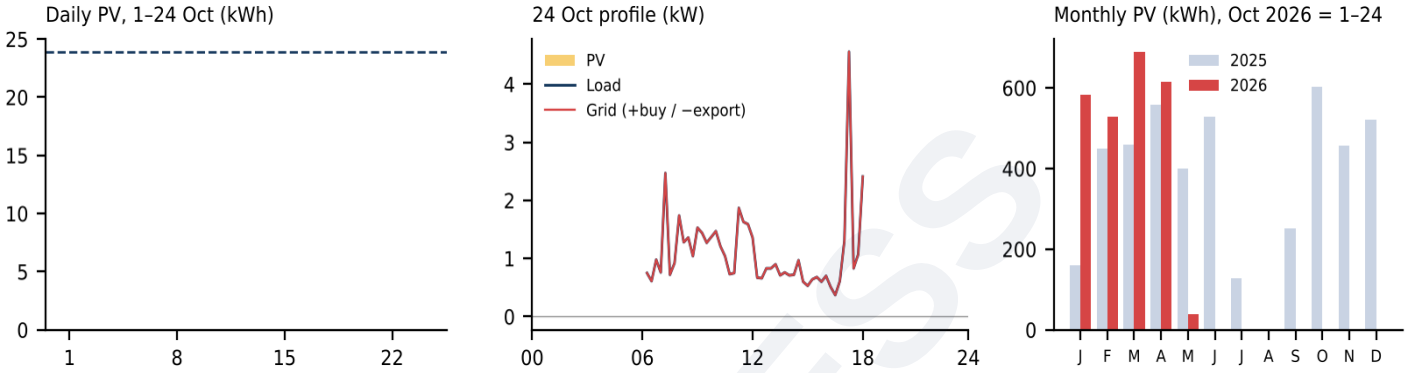
Home H1, Chiang Mai

No production since 2 May 2026

• The inverter has produced nothing since 2 May 2026 at 12:14. It still reports "Grid Failed" and reads 0 V and 0 Hz on the grid side, so it cannot see the grid at all.

• The house keeps buying all its power from the grid: 416 kWh in 1–24 October, and 360–720 kWh a month since May.

• In January–April 2026 the system made 530–690 kWh a month. About 6 months of production, roughly 3,500 kWh, has been lost so far.

1. Site visit: check the AC breaker or isolator between the inverter and the main board, then the AC cable and terminals at the inverter. A tripped or switched-off AC breaker is the most likely cause.

2. If the breaker trips again, test the cable insulation and the inverter's AC relay before switching back on.

3. Once it's running again, confirm that FusionSolar shows a grid voltage of about 230 V and normal production the next sunny day.

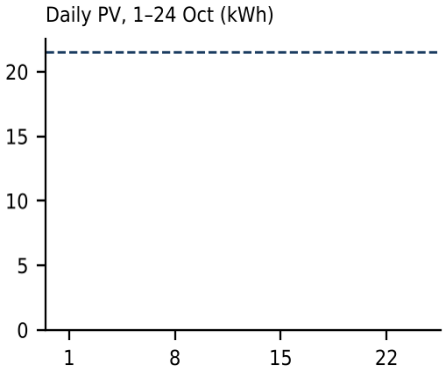
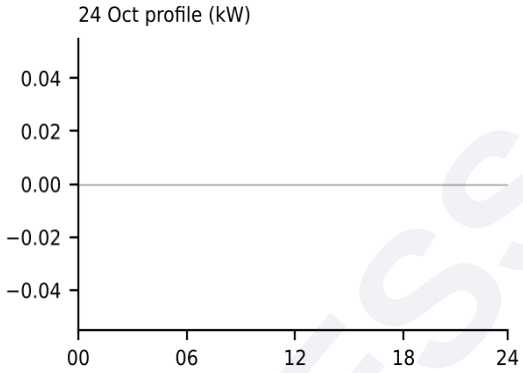
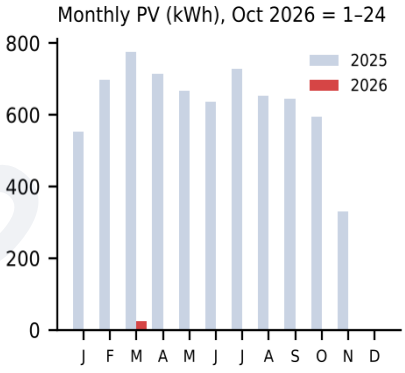
Laundromat, Songkhla

Offline since March 2026 – check if replaced

• The Huawei inverter and dongle have been disconnected since March 2026, with a "Network Connection Error" alarm since 23 March. The plant capacity is set to 0 kWp.

• It made 590–770 kWh a month in 2025. The same laundromat also appears on SolisCloud, so the Huawei inverter may have been replaced.

1. Confirm with the owner or technician whether the Huawei inverter is still installed.

2. If it was replaced, close this plant in FusionSolar so it stops showing as faulty. If it is still installed, reconnect the dongle to Wi-Fi.

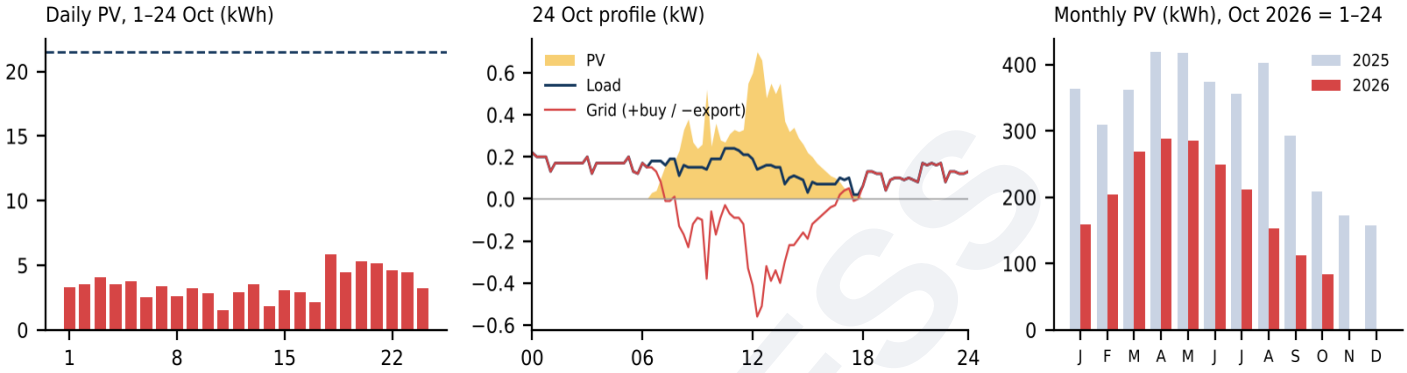
Home H4, Samut Songkhram

Very low yield – 0.7 kWh/kWp

• It made only 83.7 kWh in 24 days, or 0.70 kWh per kWp per day. A healthy system makes about 4–5 (Home H6 made 5.1).

• At 10:00 on 25 October the inverter was putting out 0.26 kW from 4.995 kWp. Home H6 was putting out 2.5 kW from 5 kWp at the same time.

• The monthly yield is falling: 288 kWh in April and 285 in May, then 249, 211, 153 and 112 kWh, and now 84 kWh in October. Even its best month in 2025 (418 kWh) was low.

• There was a grid fault on 8 October (undervoltage, Grid Failed and a power meter fault). The meter and export data look normal now.

1. Site check: look for shading from trees or new buildings, heavy dirt, and burnt or loose MC4 connectors. Measure the open-circuit voltage of each string.

2. Compare the string voltage with the design. If one string is open-circuit, the inverter will be running on only part of the array.

3. Clean the panels and trim any trees, then check the yield again after 1 week.

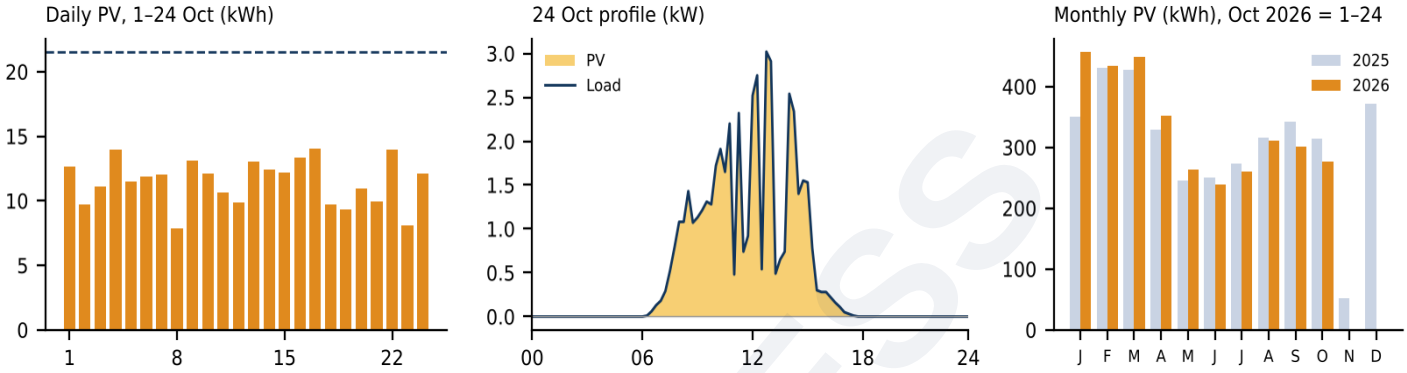
Home S10, Songkhla

Meter reads zero – consumption unknown

• The power meter reads 0 kW all day and night. FusionSolar therefore shows consumption equal to PV, and zero grid purchase since June 2025.

• It made 275.6 kWh in 24 days, or 11.5 kWh a day. The plant capacity is not set (0 kWp), and output is choppy with a peak of about 3 kW.

1. Check the power meter's CT direction and its RS485 wiring to the inverter. A meter that reads zero means any export limit isn't working properly.
2. Enter the real PV capacity (kWp) in FusionSolar so the yield per kWp can be tracked.
3. Check the active power limit setting on the inverter. If the array is about 5 kWp, a 3 kW peak with frequent dips is too low.

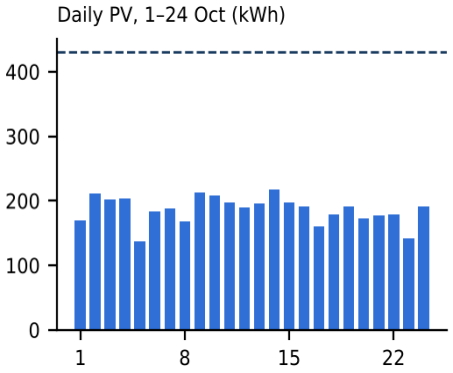
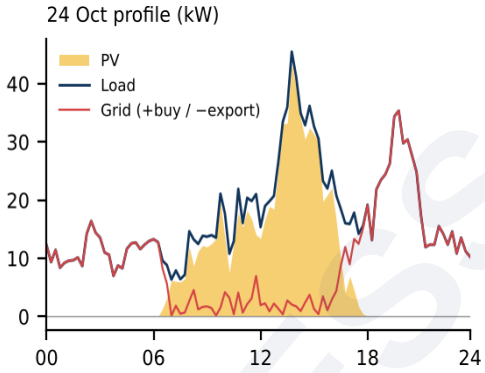
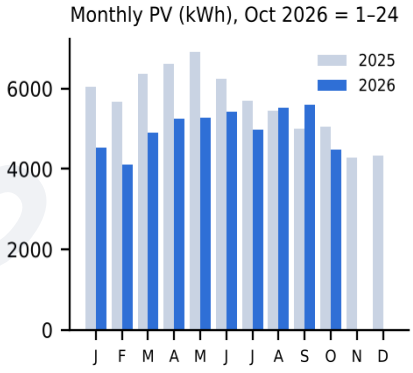
Food factory, central Thailand

Zero-export curtailment – battery opportunity

• 100 kWp on two 50 kW inverters made 186 kWh a day (1.86 kWh/kWp). Output follows the factory load: the meter shows only 0.1–7 kW drawn from the grid at midday, while PV stays well below its capacity.

• On 24 October PV peaked at 43 kW when the array could have given 70–80 kW. At 4.3 kWh/kWp, about 240 kWh a day is being held back by the zero-export limit.

• The factory bought 5,898 kWh from the grid in 1–24 October, mostly in the evening and at night (25–35 kW from 18:00 to 21:00).

1. Offer a battery of about 150–200 kWh. It would store the curtailed midday energy and use it from 17:00 to 23:00, cutting grid purchase by about 180 kWh a day, worth around 24,000 THB a month.

2. Lower-cost step: move flexible loads (boilers, pumps, cold rooms, cleaning) to 10:00–14:00.

3. Check whether the factory can apply for PEA export, so surplus can be sold instead of thrown away.

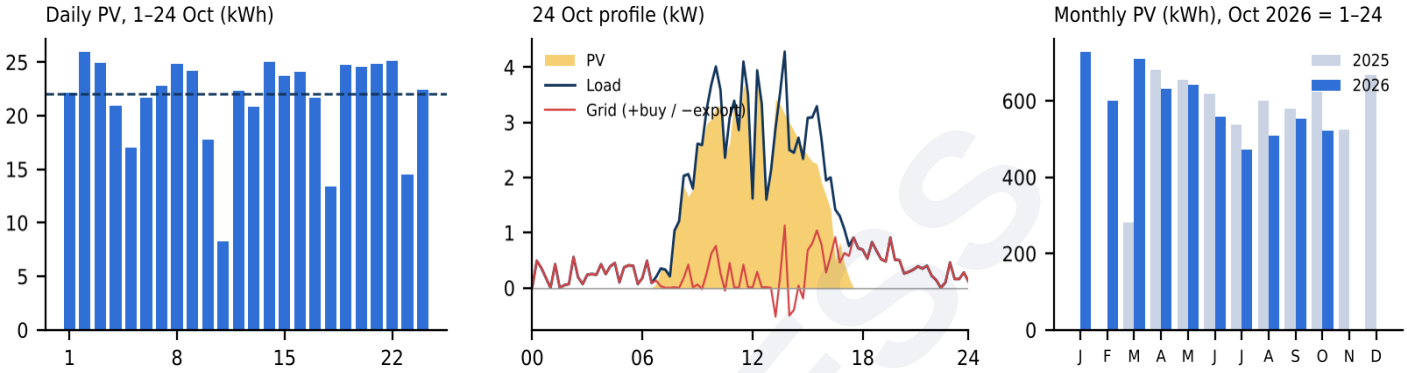
Health centre, Chiang Mai

Load is double the PV – add panels

• 5.12 kWp with optimizers made 21.6 kWh a day (4.2 kWh/kWp), close to what we expect. All 8 optimizers are working evenly.

• The health centre used 1,105 kWh in 24 days but PV covered only 47%. It bought 589 kWh and exported almost nothing (1.2 kWh).

• At midday PV follows the load, with the meter close to 0 kW, so the zero-export limit is holding output back slightly on low-load days.

1. Propose about 5 kWp more PV with a second inverter (the existing 5 kW three-phase inverter is fully used). That would cover about 600 kWh a month more and save around 2,700 THB a month.

2. Keep zero export on. If the panels are added, check the daytime load first, as weekend load is lower.

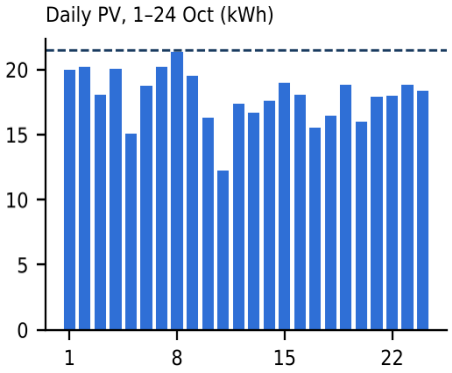
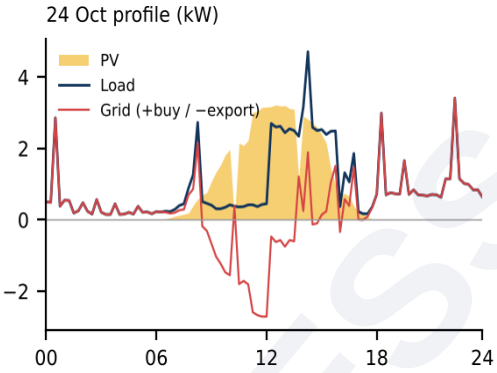
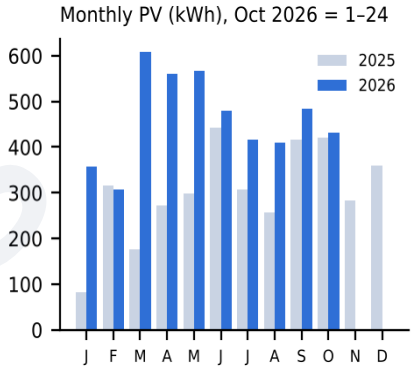
Home H5, Chiang Mai

Exports 62% – battery or load shift

- It made 430 kWh in 24 days, or 17.9 kWh a day: 3.6 kWh/kWp if the array is 5 kWp. The capacity is not set in FusionSolar.
- It exported 269 kWh (62% of PV) at midday and bought 224 kWh in the evening and at night. Only 162 kWh of PV was used directly in the home.
- There were 46 short grid overvoltage trips in October; output impact was small.

1. Enter the real PV capacity (kWp) in FusionSolar.
2. Suggest moving water heating, laundry and air-con pre-cooling to 10:00–15:00.
3. Offer a 5–10 kWh battery if export is credited at 2.20 THB/kWh or less. It would cut evening grid purchase by about 200 kWh a month.

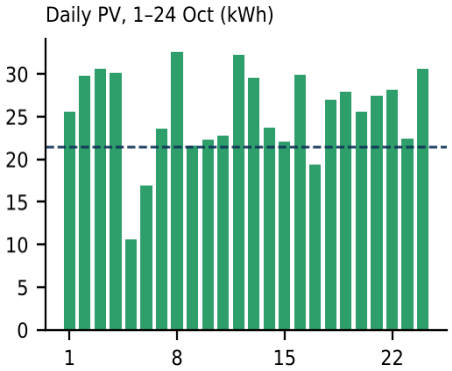
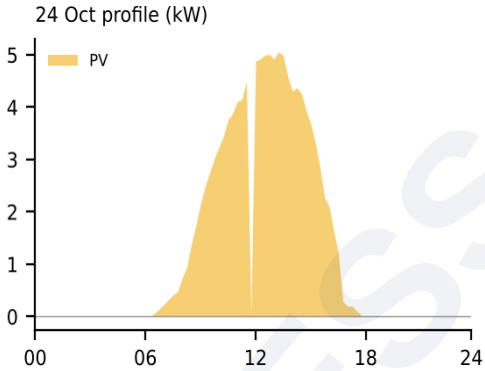
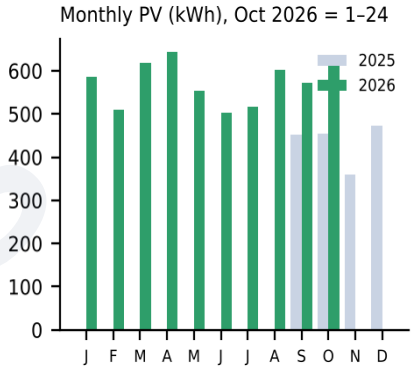
Home H6, Chiang Rai

Healthy – watch the grid voltage

• It made 612 kWh in 24 days (5.1 kWh/kWp per day), the best in the fleet. That is already more than the 455 kWh it made in the whole of October 2025.

• However, there were 1,097 grid overvoltage trips in October. Grid voltage was already 243.6 V at 10:00. Each trip is short, so the energy lost is small for now.

• There is no power meter, so consumption and export aren't recorded.

1. Measure the voltage at the meter at midday. If it often goes above 250 V, ask PEA to check the transformer tap.
2. Optional: add a Huawei smart meter to record consumption and export.
