# ControlLogix Enhanced Redundancy System, Revision 16.81

## Redundancy Module Catalog Numbers

1756-RM, 1756-RMXT

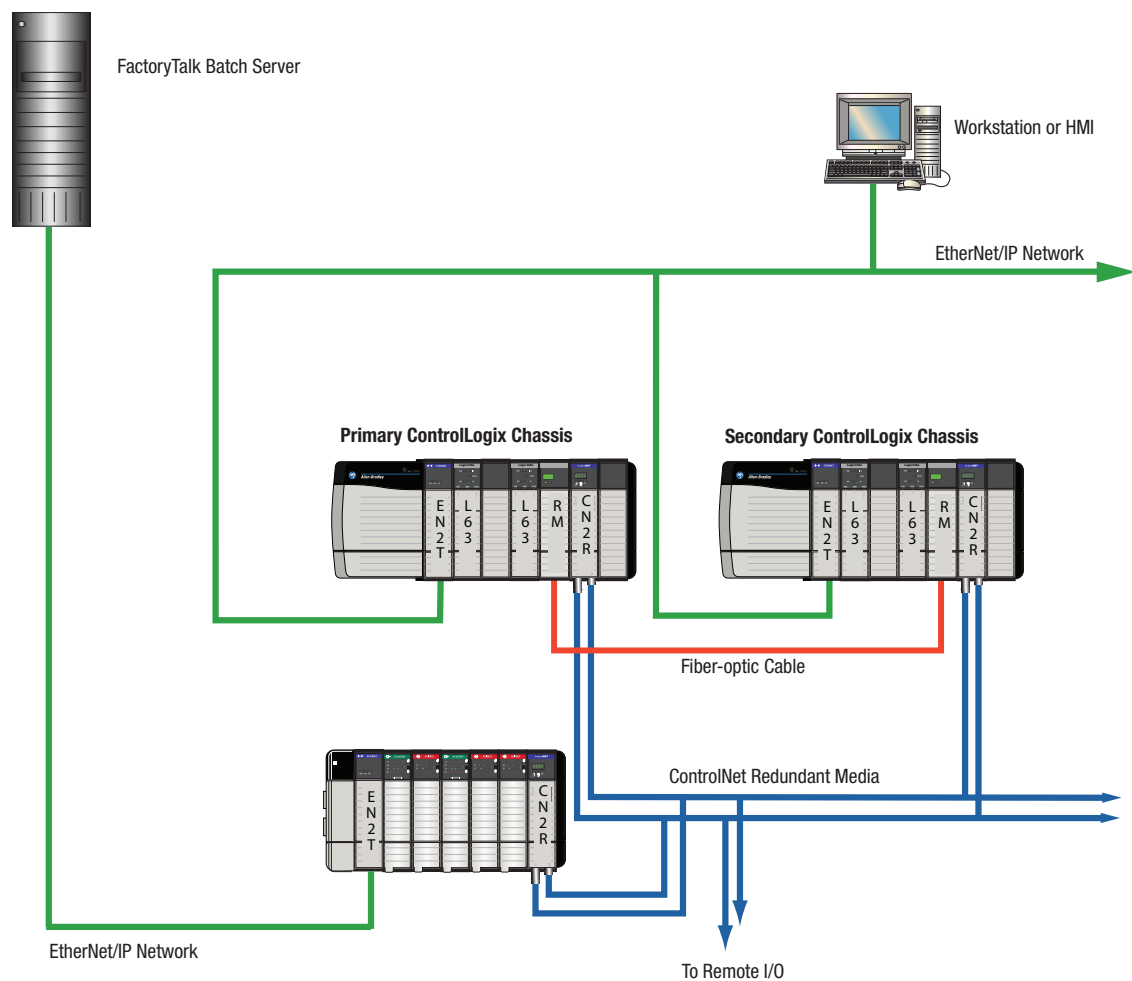
You cannot connect to the FactoryTalk Batch Server directly from an EtherNet/IP module placed in the redundant chassis.

This illustration demonstrates one method of bridging the ControlNet network of the redundant system to the EtherNet/IP network that the FactoryTalk Batch Server is running on.

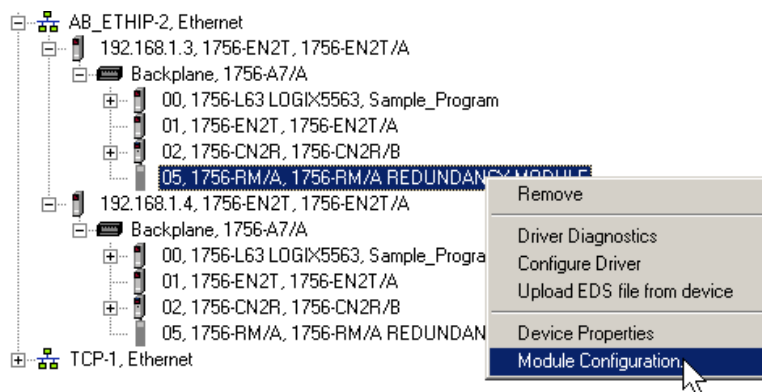
3. Right-click your redundancy module and choose Module Configuration.

The Module Configuration dialog box opens.

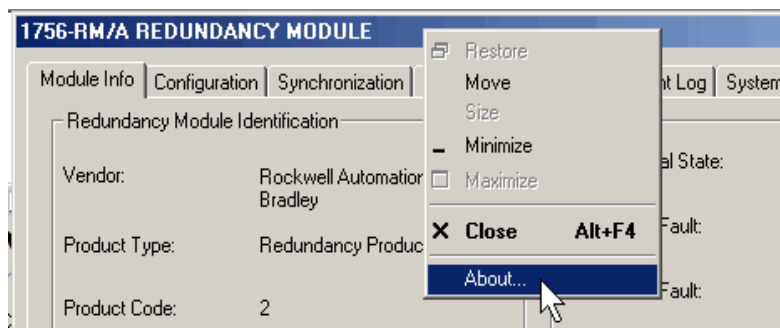
4. Right-click the title bar and select About.

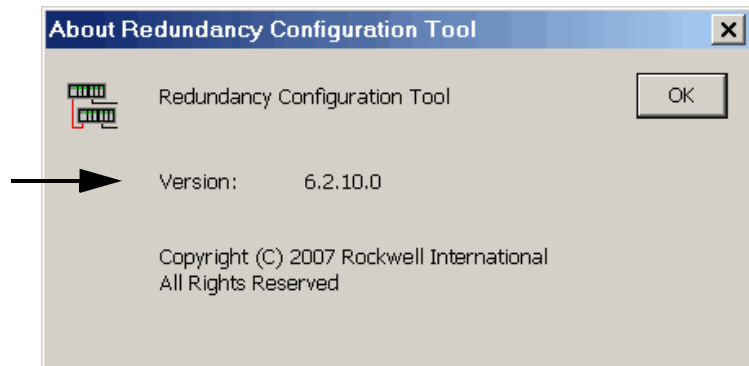
The About dialog box opens and indicates the RMCT version.

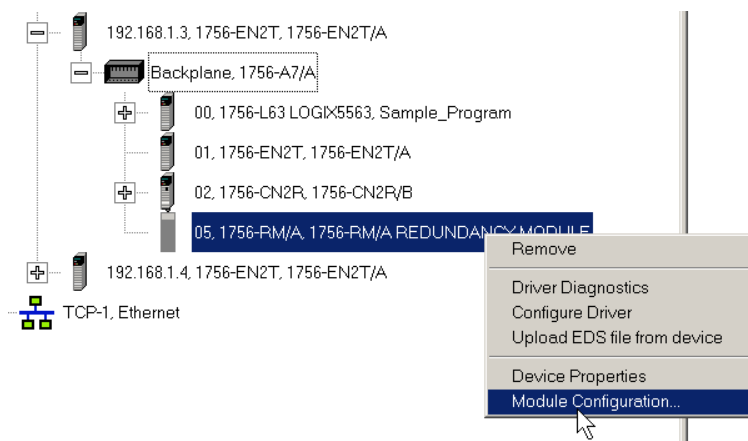
2. Open RSLinx Classic software and browse to the redundancy module.
3. Right-click the redundancy module and select Module Configuration.

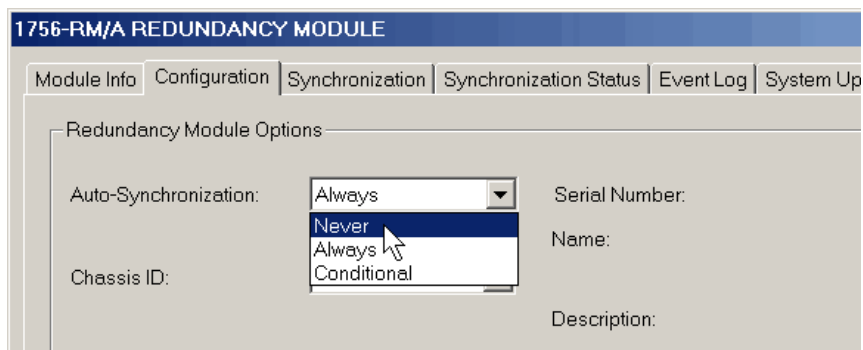
4. Click the Configuration tab.
5. From the Auto-Synchronization pull-down menu, choose Never.

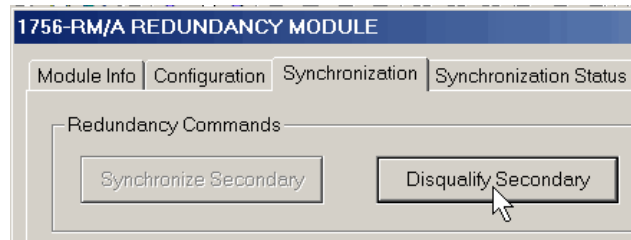
7. Click the Synchronization tab.

8. Click Disqualify Secondary, then click Yes.

The secondary chassis is disqualified as indicated by the RMCT at the bottom-left of the RMCT and on the redundancy module's status display.

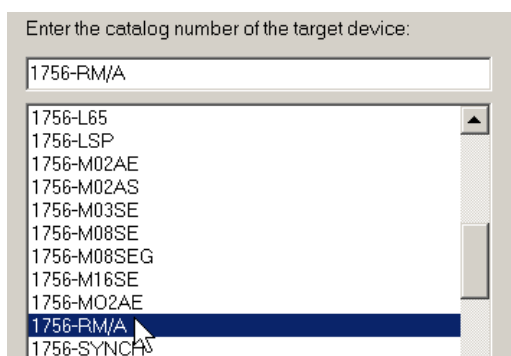
1. Launch ControlFlash software and click Next.
2. Select the redundancy module catalog number and click Next.

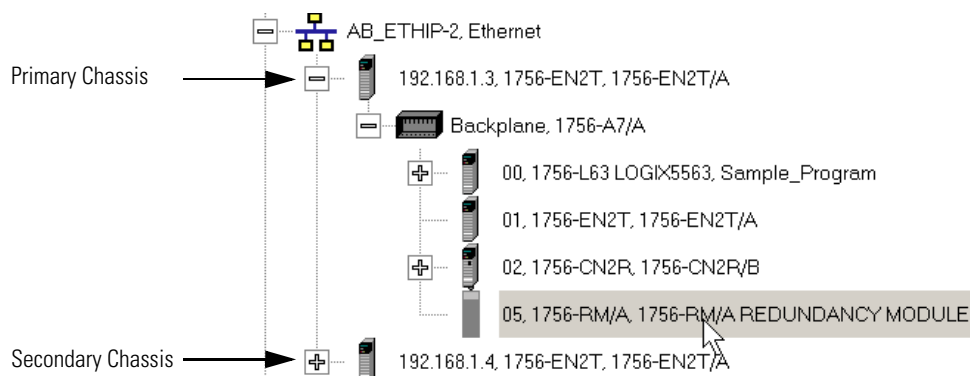
3. Browse to the redundancy module and select it.

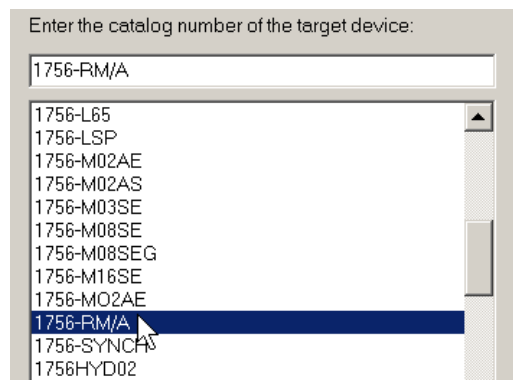
1. Launch ControlFlash software and click Next.
2. Select the redundancy module catalog number and click Next.

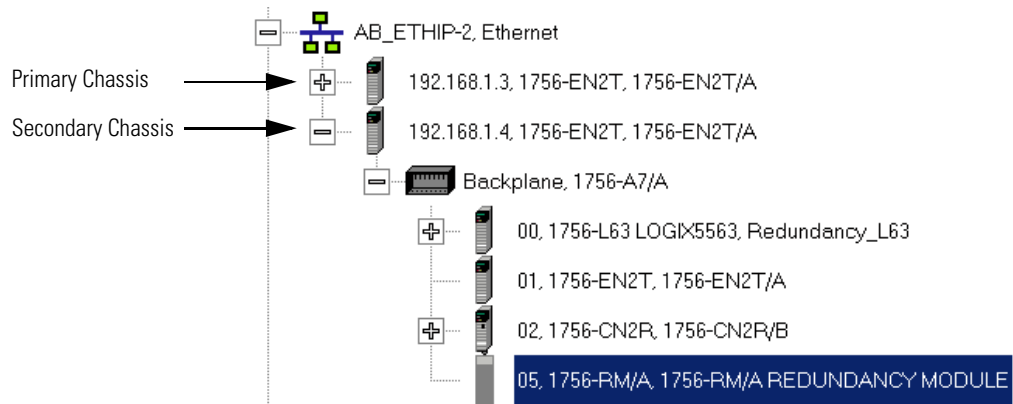
3. Browse to the redundancy module and select it.

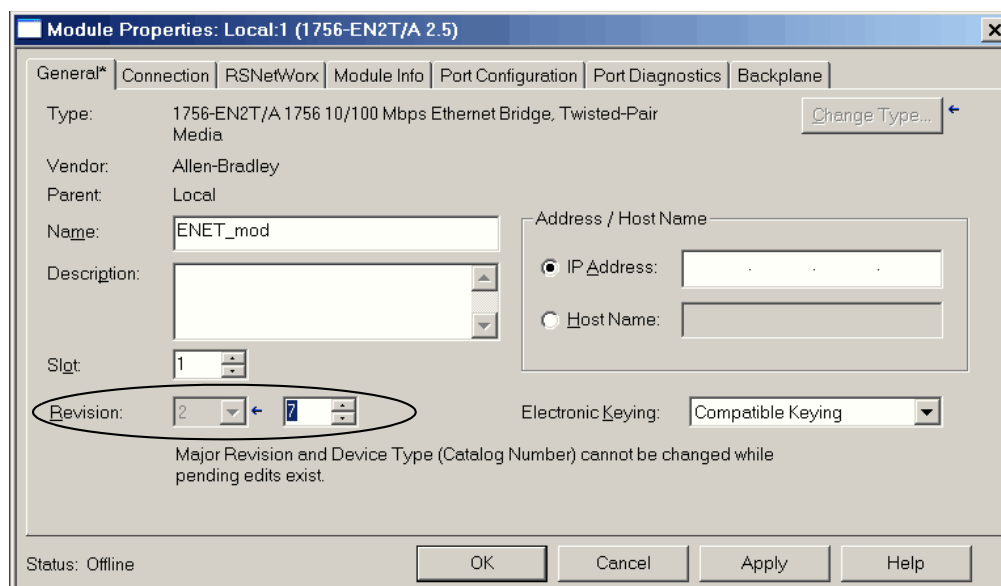
11. If you installed a new controller while upgrading the primary chassis firmware, specify the new controller catalog number.
12. Click OK.
13. Access the Module Properties for each communication module in the chassis and specify the module firmware revision you are upgrading to.

If you are unable to specify the new revision, you may need to change the Electronic Keying parameter to Compatible Keying.

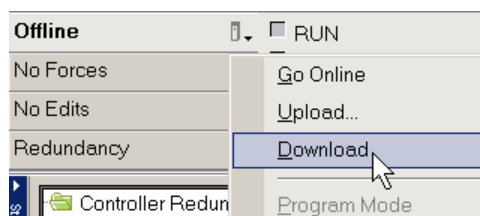
14. Save the project.
15. Download the project to the secondary controller.

The secondary controller is at the higher network address of the the two available for the redundant chassis.

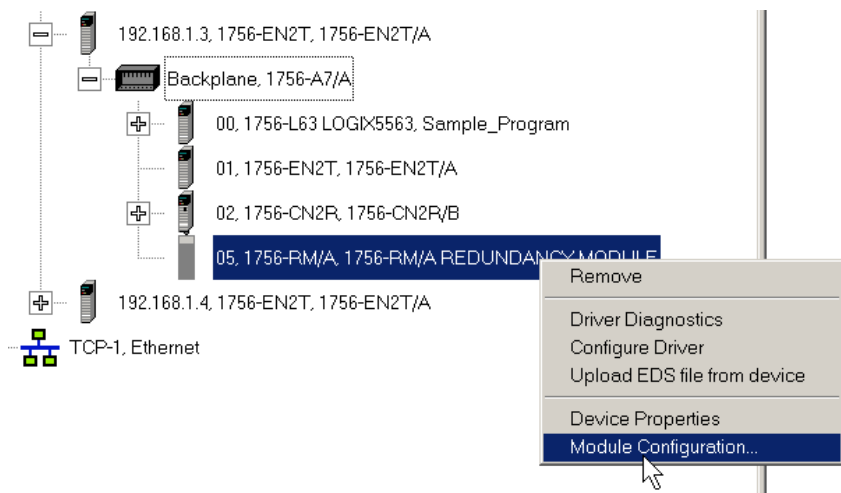
1. Open the RMCT for the 1756-RM module in the primary chassis.

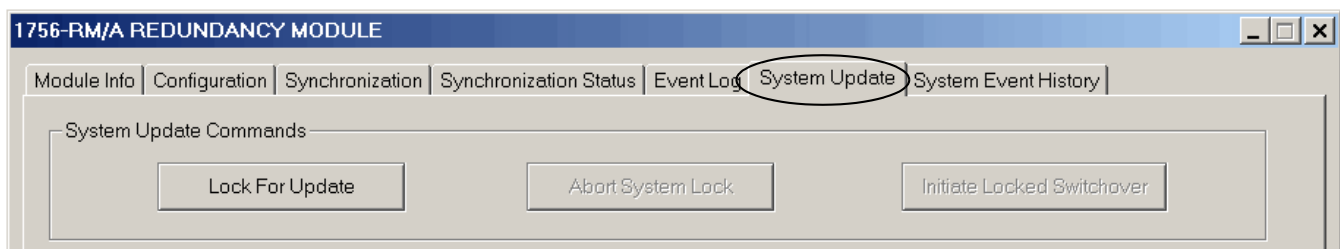
2. Click the System Update tab.

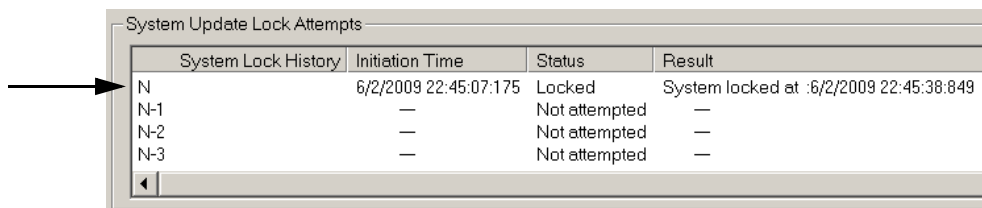
The System Update Lock Attempts log indicates when the system lock is complete.

| System Lock History | Initiation Time | Status | Result |
| N | 6/2/2009 22:45:07:175 | Locked | System locked at :6/2/2009 22:45:38:849 |

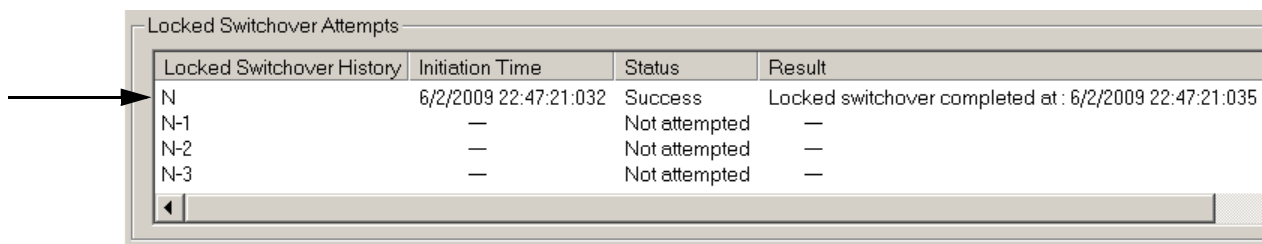
This step results in your secondary chassis assuming control and becoming the primary chassis. When the switchover is complete, the Locked Switchover Attempts log indicates success.

| Locked Switchover History | Initiation Time | Status | Result |
| N | 6/2/2009 22:47:21:032 | Success | Locked switchover completed at : 6/2/2009 22:47:21:035 |

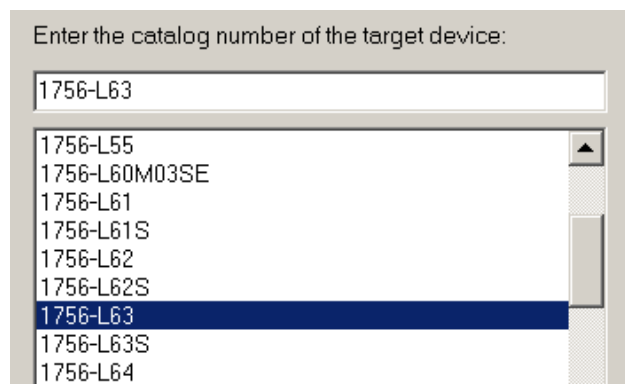
1. Launch ControlFlash software and click Next.
2. Select the module catalog number and click Next.

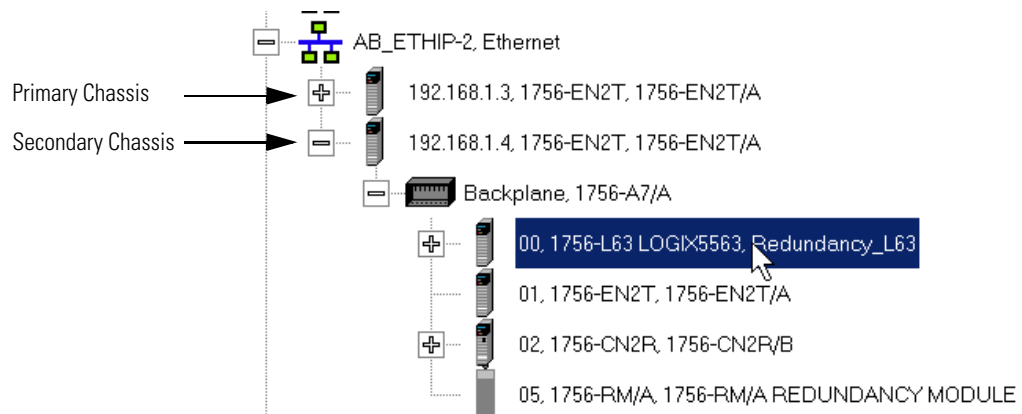
3. Browse to the module and select it.

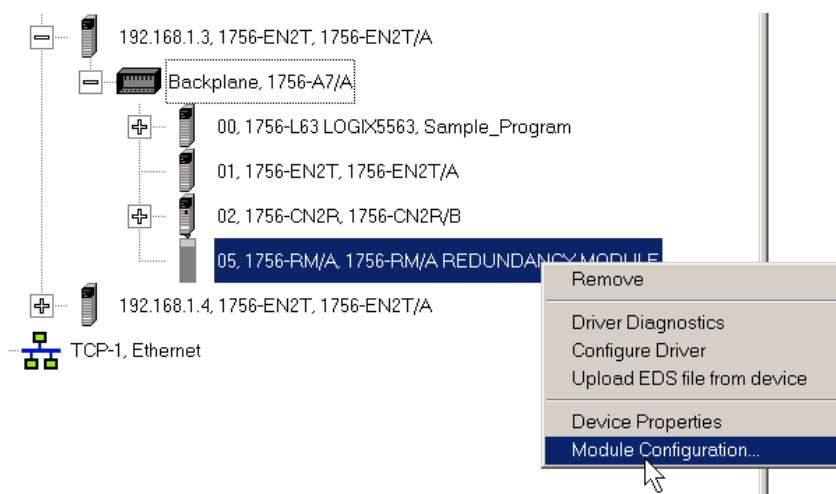
1. Launch the RMCT for the 1756-RM module in the primary chassis.

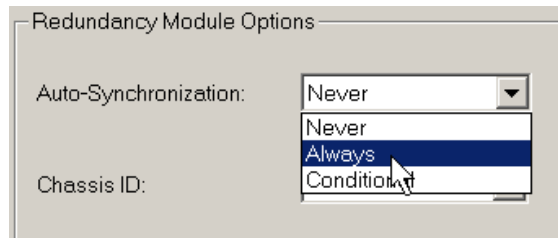
3. From the Auto-Synchronization pull-down menu, choose the frequency that suits your application.

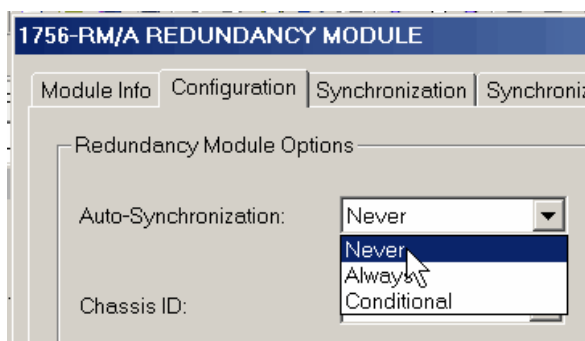
2. In the RMCT, click the Configuration tab and choose Never from the Auto-Qualification pull-down.

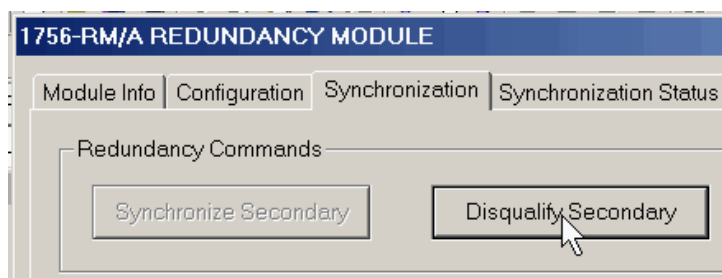
3. In the Synchronization tab, click Disqualify Secondary.

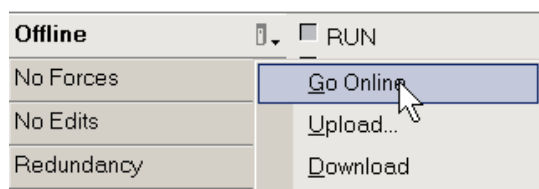
4. In RSLogix 5000 programming software, go online with the secondary controller.

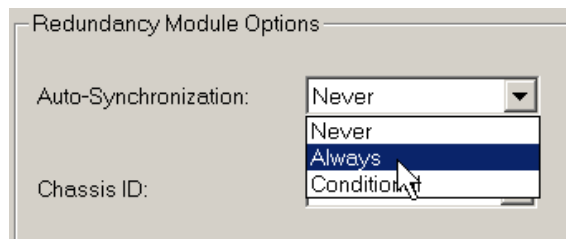
6. In the RMCT, set the Auto-Qualification parameter according to your preference.
