Results after the settings change

October 2026 Monthly Report · part 3 of 3 · 28 October 2026

3 · Results
28 Oct 2026
This report: three days before and three days after the change

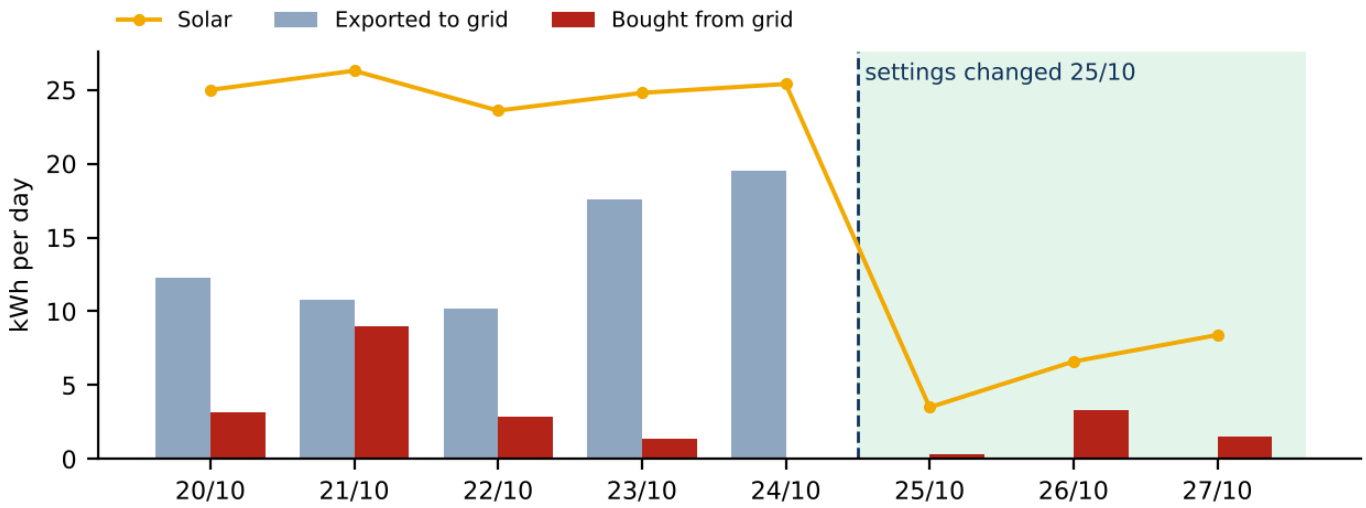
Plant	What we changed	Before (22–24 Oct)	After (25–27 Oct)	Result
Office (5 kWp)	Solar Sell off	15.8 kWh/day exported	0 kWh/day exported	**Worked**
Villa A, Koh Samui	Battery floors 50 → 20 %, 150 A, load first	Battery stopped at 50 % in the evening; 17.6 kWh bought on 24 Oct	28 kWh from the battery and 4.7 kWh bought on 25 Oct (similar use); villa nearly empty 26–27 Oct	**Worked – battery stops at 35 %**
Residence, Chiang Mai	Evening/night Time-of-Use slots 40/100 → 20 %	Battery idle after 22:00; grid ≈0.7 kW	Battery covers 22:00–24:00; 1.4 kWh bought on 25 Oct; cloudy 26 Oct	**Partly clear – check battery**

- Office: working as intended. A small battery would let the solar that is now held back cover evening use; we will offer a sizing.
- Villa A: the battery stops at about 35 % instead of 20 %. We will read the inverter's battery settings again (read only) and check the battery management system.
- Residence: the battery charge level dropped suddenly from 35 % to 7 % during the night of 25–26 October. We will check the battery management system and its charge-level calibration.
- The November fleet review will repeat this comparison over a full month.
