Troubleshooting wiring harness and connector hidden concerns

The following illustrations are known examples of wiring harness, splices and connectors that will create intermittent electrical concerns. The concerns are hidden and can only be discovered by a physical evaluation as shown in each illustration.

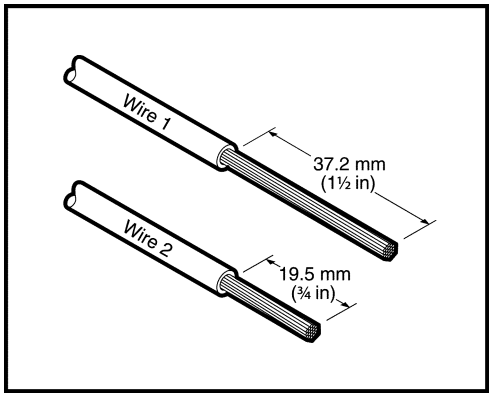
Broken wire strands in harness

1 = Wiring harness tape
2 = Wiring strand
3 = Broken strands intermittent signal
4 = Circuit insulation

Remove the tape and flex/feel each circuit for a reduction in diameter at break.
