STM32F20x and STM32F21x Errata sheet

STM32F205/207xx and STM32F215/217xx device limitations

This errata sheet applies to the revision Y and X of STMicroelectronics STM32F205xx/STM32F207xx and STM32F215xx/STM32F217xx microcontroller families. In this document they will be referred to as STM32F20x and STM32F21x, respectively, unless otherwise specified.

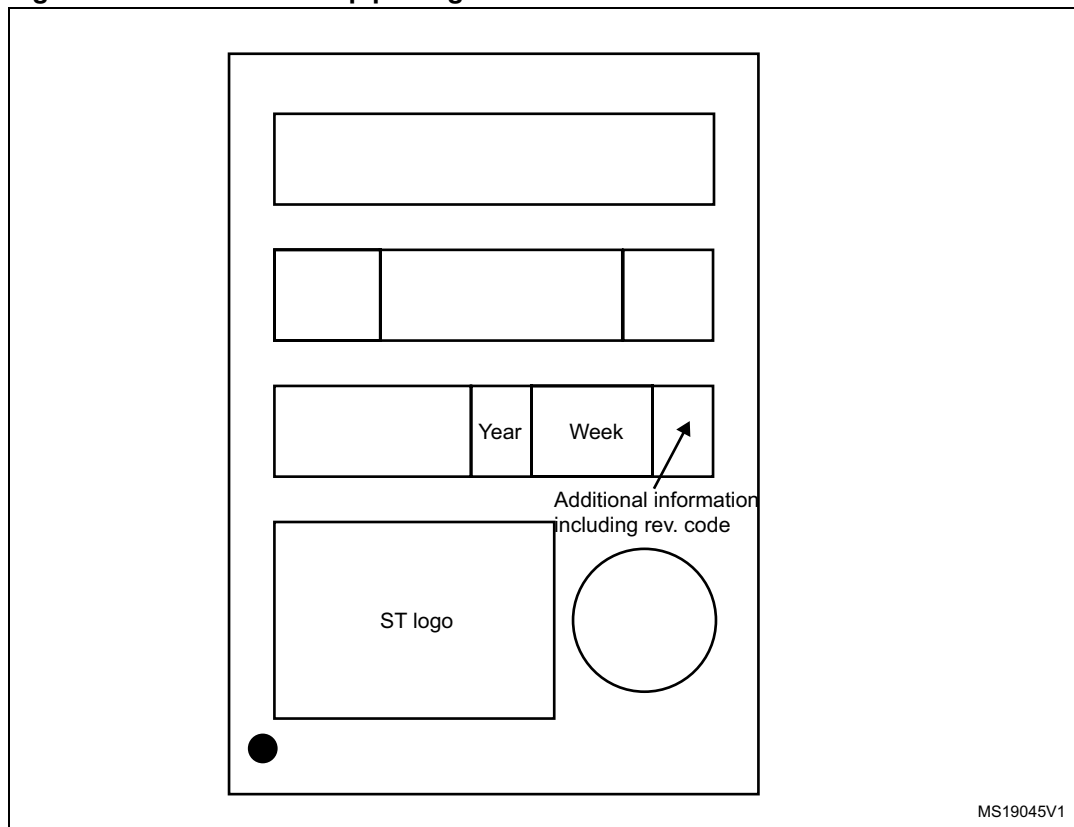
Figure 1. WLCSP64+2 top package view

Figure 1, Figure 2, Figure 3, Figure 4, Figure 5 and Figure 6 show the marking compositions for the WLCSP64+2, UFBGA176, LQFP176, LQFP144, LQFP100 and LQFP64 packages, respectively. The only fields shown are the Additional field containing the revision code and the Year and Week fields making up the date code.

1. The REV_ID bits in the DBGMCU_IDCODE register show the revision code of the device (see the STM32F20x and STM32F21x reference manual for details on how to find the revision code).
2. Refer to [Appendix A: Revision code on device marking](#) for details on how to identify the revision code and the date code on the different packages.
