Troubleshooting wiring harness and connector hidden concerns

The following illustrations are known examples of wiring harness, splices and connectors that will create intermittent electrical concerns. The concerns are hidden and can only be discovered by a physical evaluation as shown in each illustration.

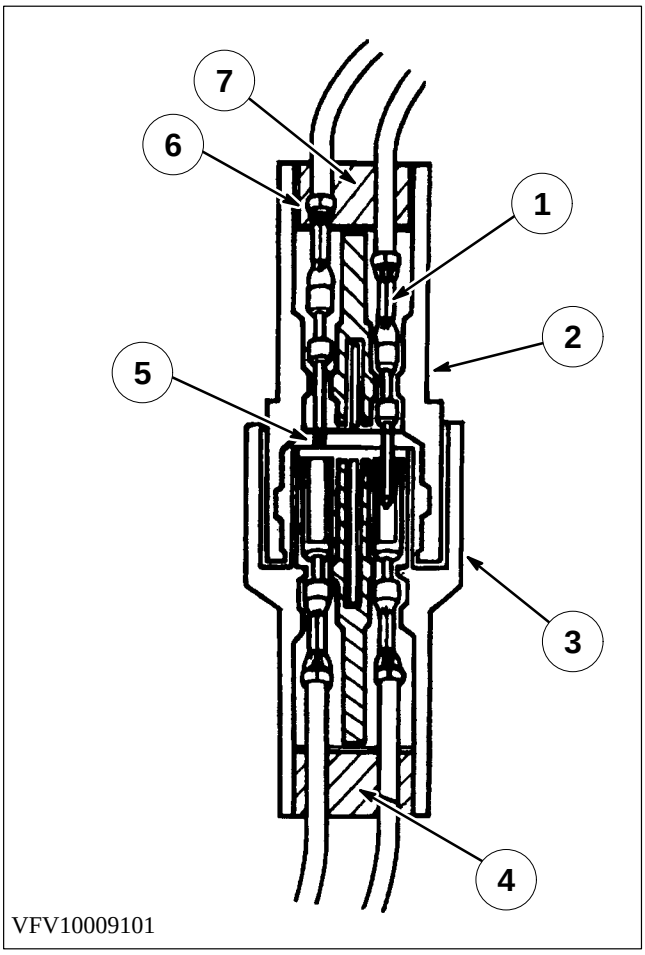
VFV10009101

Terminal not properly seated

1 = Locked terminal
2 = Male half
3 = Female half
4 = Seal
5 = Intermittent contact
6 = Unlocked terminal (Hidden by wire seal)
7 = Seal

Check for unlocked terminals by pulling each wire at the end of the connector.
