# **Wireless Universal Serial Bus Specification Errata on Revision 1.0 as of July, 2005**

**July, 2005**

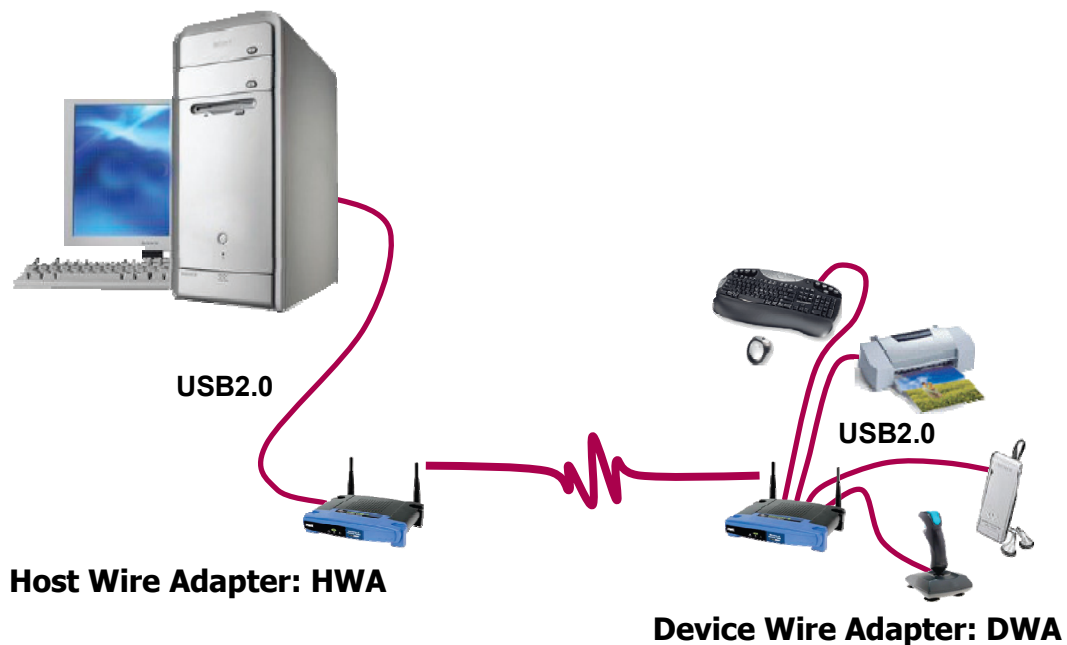
**Errata Title:** The Host Wire Adapter in figure 3-3 should be tagged as a HWA, not a DWA.

**Change:** p16, Figure 3-3 so it reads as follows:

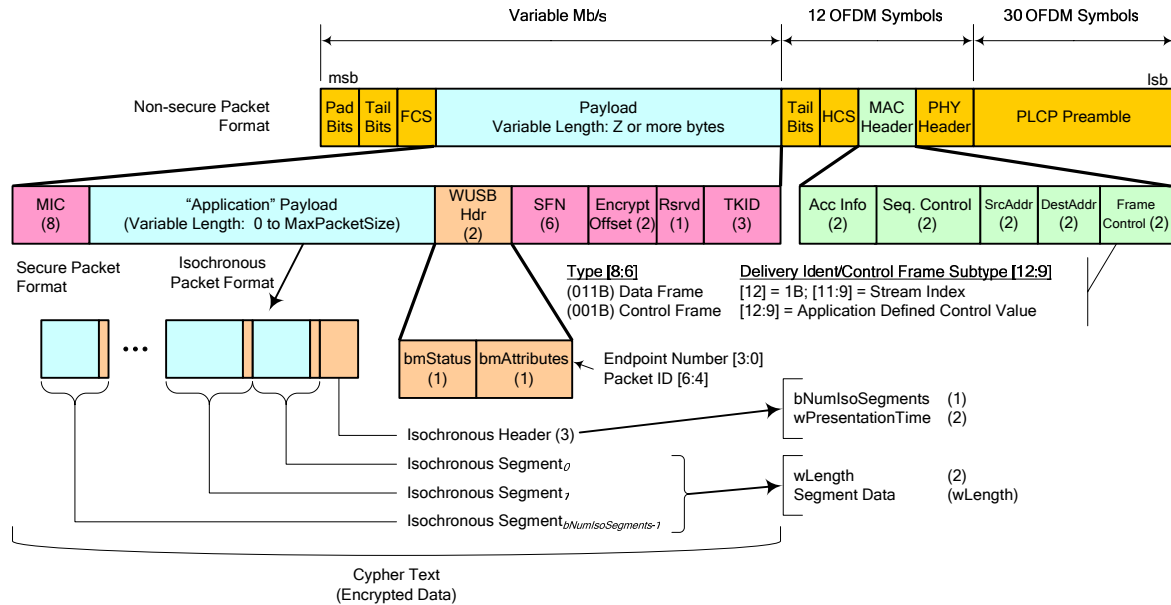
**Errata Title:** Figure 5-1 needs field names updated to match the WiMedia MAC specification.

**Background:** The SrcID and DestID fields in the MAC header portion of figure 5-1 need to be changed to match the WiMedia MAC specification.

**Change:** p87, Section 5.1, Figure 5-1 must look like:
