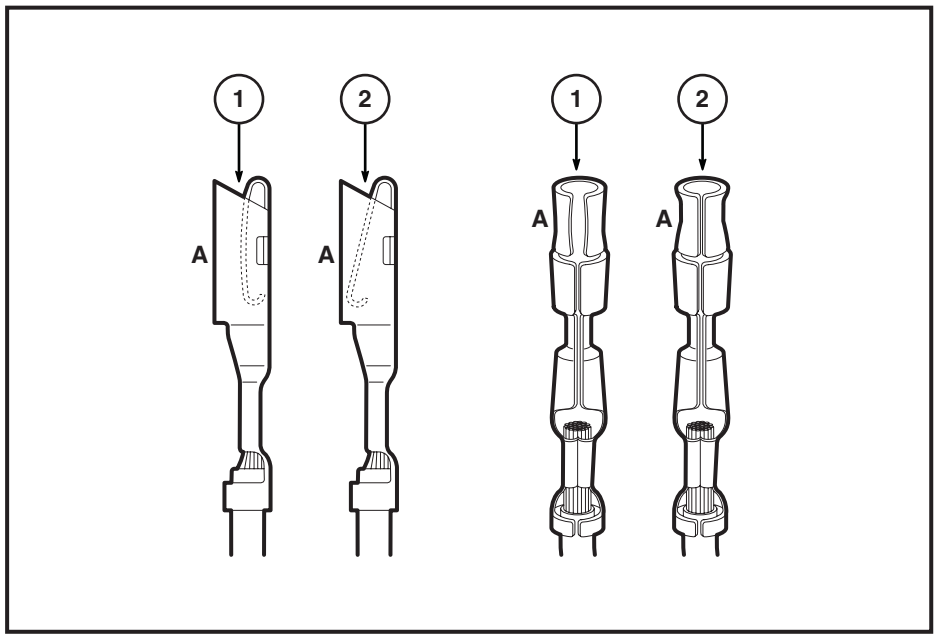
Deformed (enlarged) female terminals

1 = Enlarged
2 = Normal

Any probe entering the terminal may enlarge the contact spring opening creating an intermittent signal. Insert the correct mating terminal (Location A) from the service kit and feel for a loose fit.

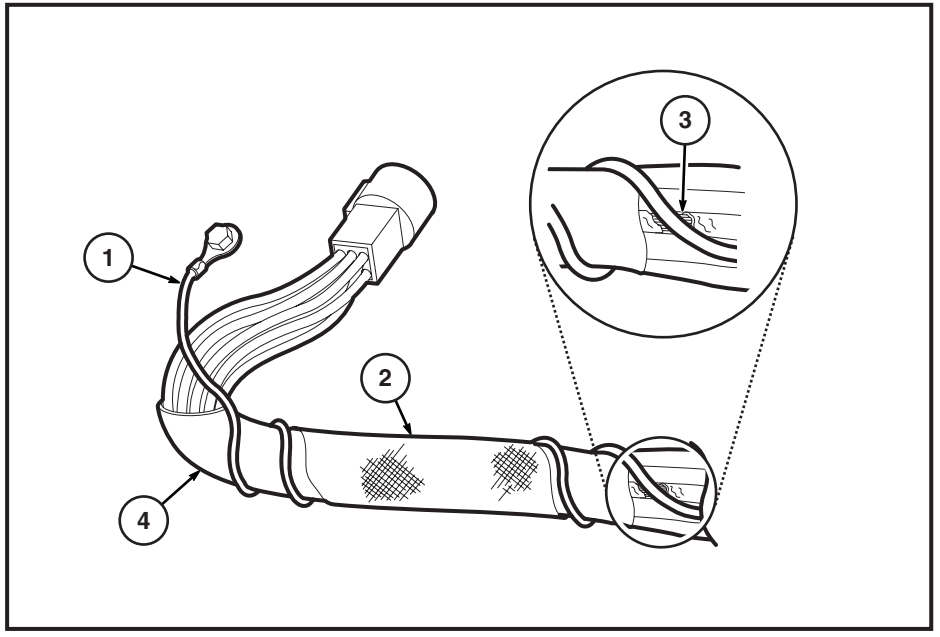
Electrical short inside the harness

1 = Solder coated wire to ground
2 = Harness protective tape
3 = Intermittent short (solder coated wire pierced through the insulation of another circuit)
4 = Grounding foil
