Wireless Universal Serial Bus Specification Errata on Revision 1.0 as of December 2006

December 2006

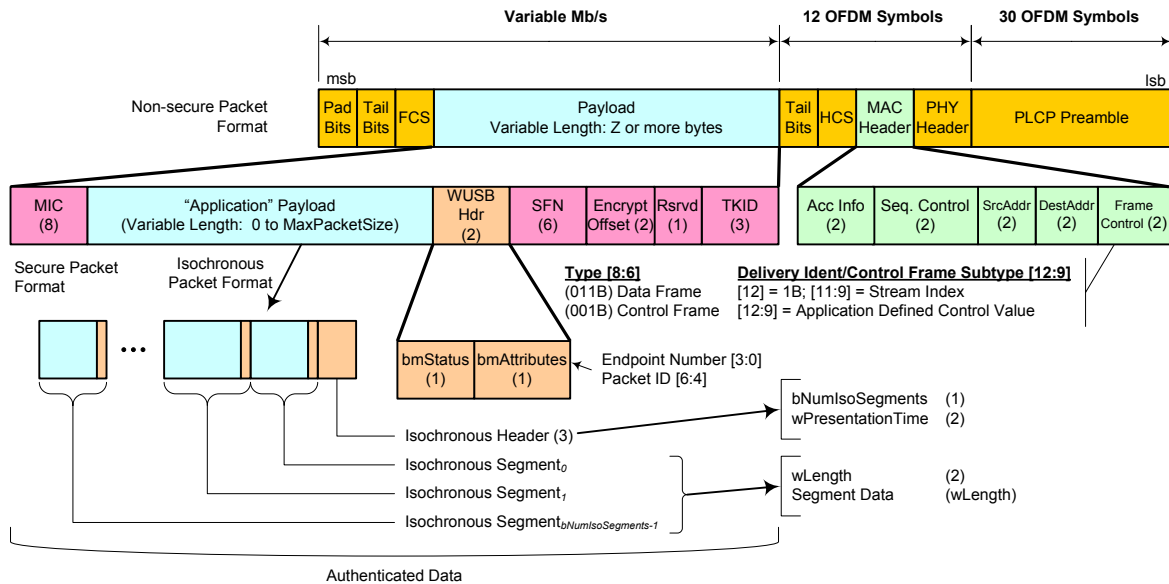
Change: p87, Section 5.1, Figure 5-1 must look like:

Erratum Title: Figure 5-1 incorrectly marks Authenticated data as “encrypted” data

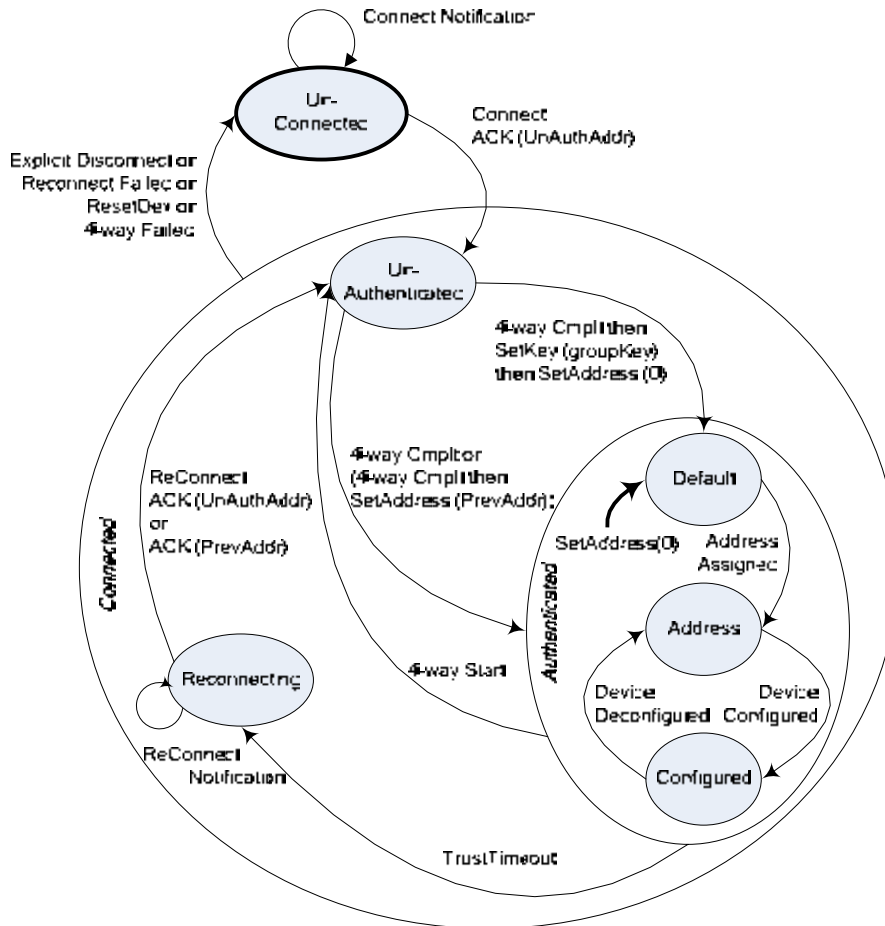
Change: p137, Section 7.1, Figure 7-1 must look like:

Background: 4-Way handshakes are always performed in clear text (i.e. they are unencrypted) and a host may choose to re-authenticate a previously authenticated device at any time. However there is currently no state transition from the **Authenticated** state the **Un-Authenticated** state when a 4-way handshake is initiated.

Note that the host may initiate a 4-way handshake at any time with the device, including while it is in any substate of the **Authenticated** device state. The control transfers used to conduct the 4-way handshake do not use secure data encapsulation during the data and handshake phases of the control transfers. A device must transition to the **UnAuthenticated** state when the host starts a 4-way handshake and all the keys the device has must be discarded.
