GT2005-68264

Visualization of Rotor Endwall, Tip Gap, and Outer Casing Surface Flows In a Rotating Axial Turbine Rig

Nikhil M. Rao¹, Cengiz Camci²

Turbomachinery Heat Transfer Laboratory
Department of Aerospace Engineering
The Pennsylvania State University

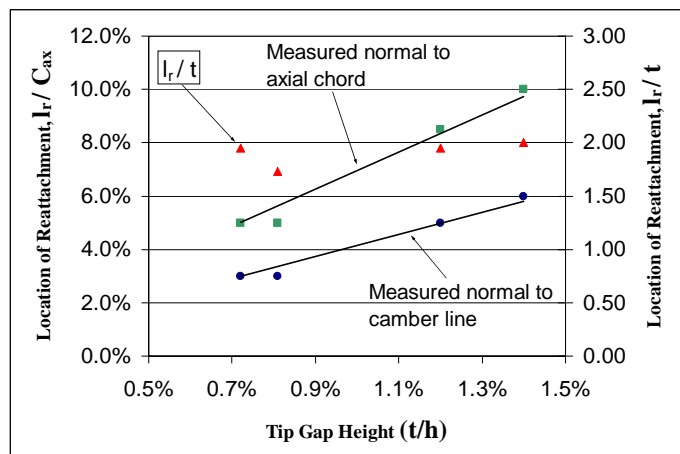
Figure 13 Location of Reattachment on Tip Surface as a Function of Tip Gap Height.

measured. When the gap height is almost doubled from $t/h = 0.72\%$ to $t/h = 1.40\%$, the reattachment line moves from 5% C_{ax} to 10% C_{ax} as measured normal to the axial chord. It is generally accepted in the literature that over tip leakage behavior varies linearly with gap size. Reattachment distance measured normal to axial chord and normalized by gap height (solid triangles) is fairly invariant with gap height. The value lies between $1.95t$ and $2t$. The outlier is at gap height $t/h = 0.81\%$ and again this is believed to be due to resolution of measurement.
