Troubleshooting wiring harness and connector hidden concerns

The following illustrations are known examples of wiring harness, splices and connectors that will create intermittent electrical concerns. The concerns are hidden and can only be discovered by a physical evaluation as shown in each illustration.

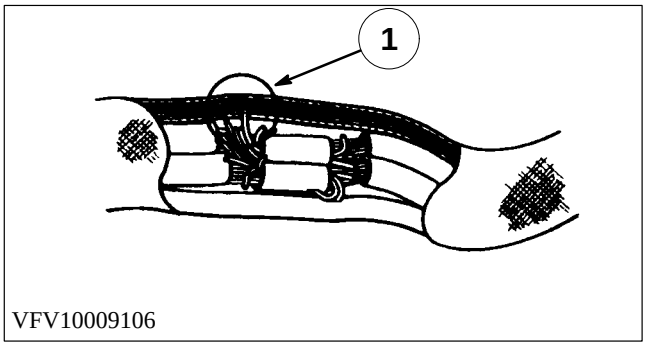
VFV10009105

Electrical short inside the harness

1 = Solder coated wire to ground
2 = Harness protective tape
3 = Intermittent short
Solder coated wire pierced through the insulation of another circuit
4 = Grounding foil
