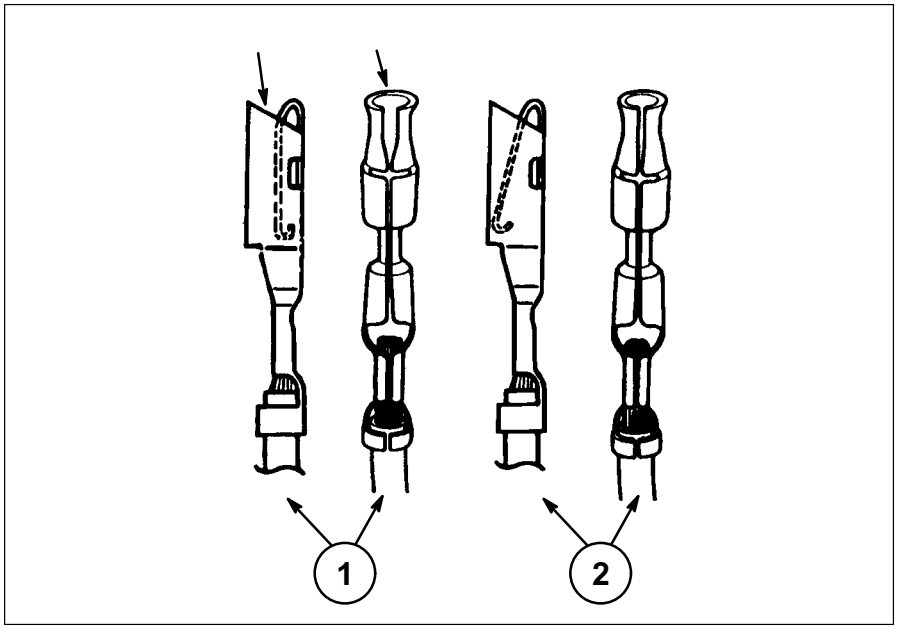
Deformed (enlarged) female terminals

1 = Enlarged
2 = Normal

Any probe entering the terminal may enlarge the contact spring opening creating an intermittent signal. Insert the correct mating terminal (Location A) from the service kit and feel for a loose fit.

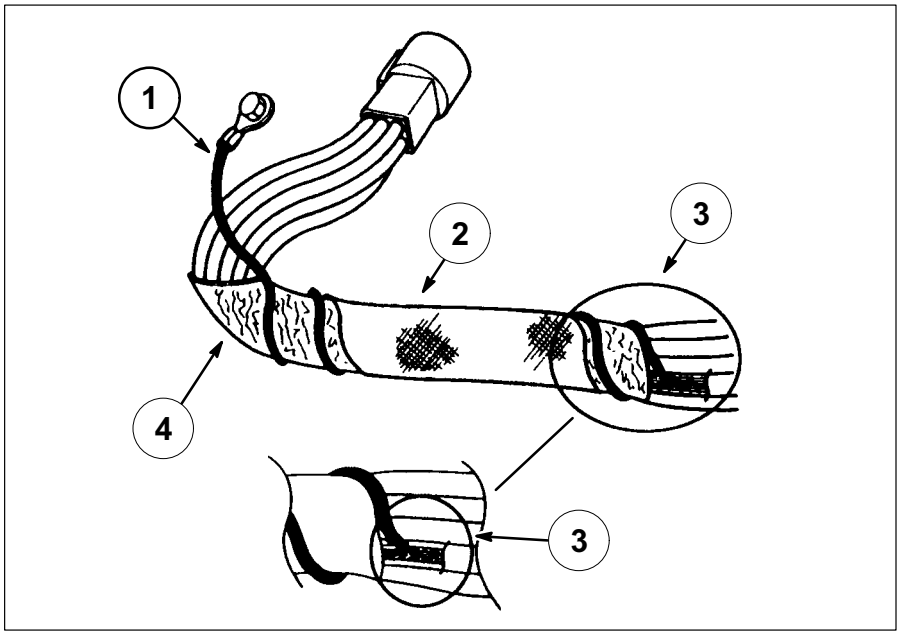
Electrical short inside the harness

1 = Solder coated wire to ground
2 = Harness protective tape
3 = Intermittent short
Solder coated wire pierced through the insulation of another circuit
4 = Grounding foil
