POWERTRAIN CONTROL MODULE REPROGRAMMING

AFFECTED VEHICLES: ALL 1999 AND 2000 MODEL YEAR WINDSTAR VEHICLES

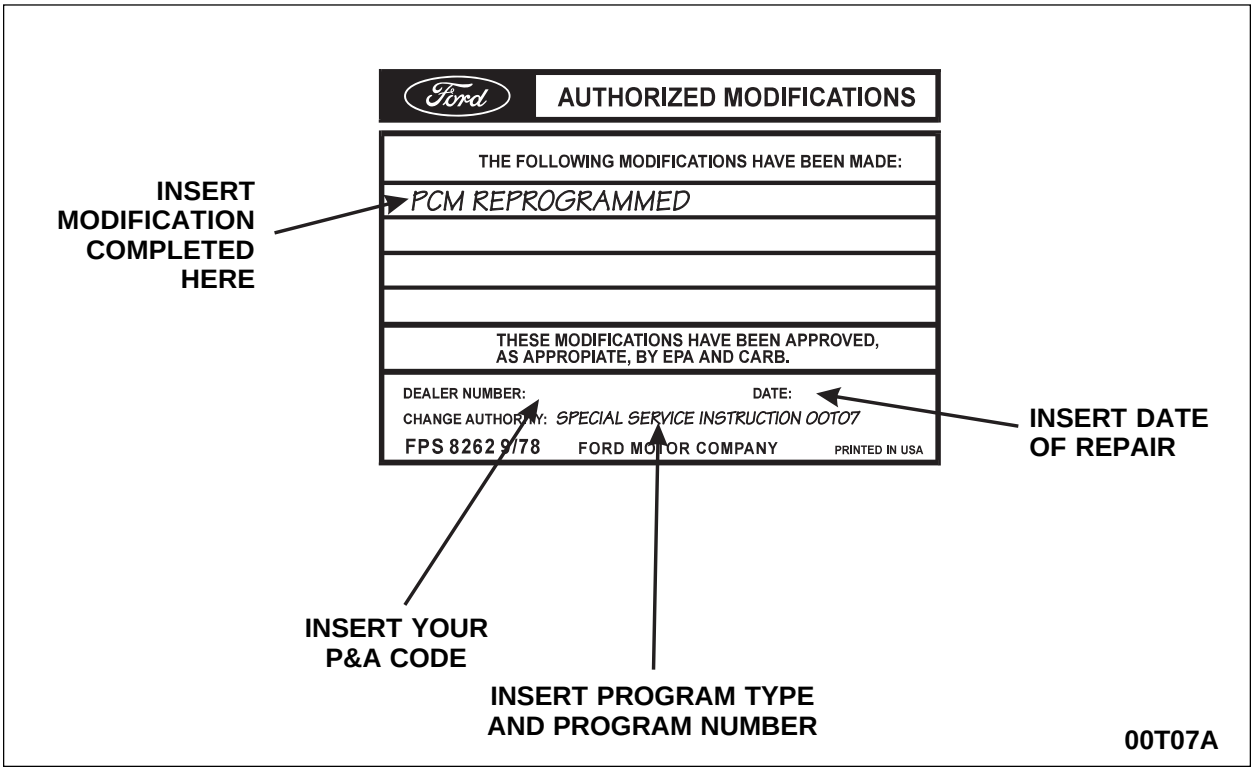
FIGURE 1

2. Obtain and prepare the Authorized Modifications Label. Write the modification completed, your P & A Code, date of repair and the program type and program number as shown below.

3. Apply label to clear area of the upper radiator support.
