# Attacking the PIC16F1936 code protection

PIC microcontrollers are widely used in embedded systems. They support a basic code protection mechanism that can be used to prevent unauthorized access to the program memory. This report describes my (unsuccessful) attempt to bypass this protection on a PIC16F1936 microcontroller via voltage glitching.

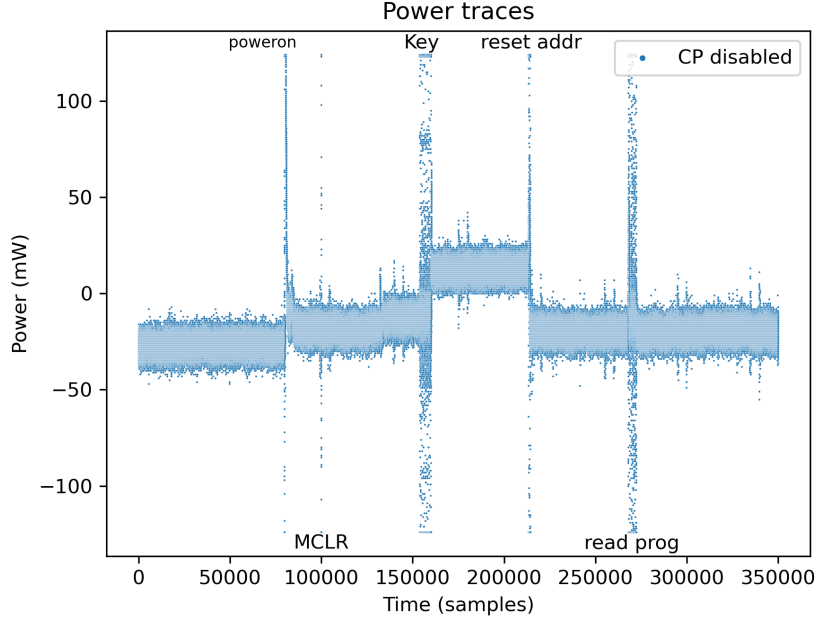
The boot sequence in programming mode, whose power trace is shown in Figure 1, is as follows:

1. Power on the [Device Under Test \(DUT\)](#)
2. Pull and hold the  $\overline{\text{MCLR}}$  pin to  $V_{\text{IL}}$
3. Send the 4-bytes key "MCHP" to the device
4. Execute the programming commands

Figure 1: Power trace of a programming session

The two matrices are correlated by column with Equation 1, and the results are plotted in Figure 3 along with a single powertrace to easily identify the boot stages. When the correlation value is close to 1, power consumption in that instant is directly related to the state of the code protection bit. Comparing this picture with Figure 1, we notice that there is high correlation in 3 key moments:
