MT7681 Uart Firmware Upgrade SOP

V0.06

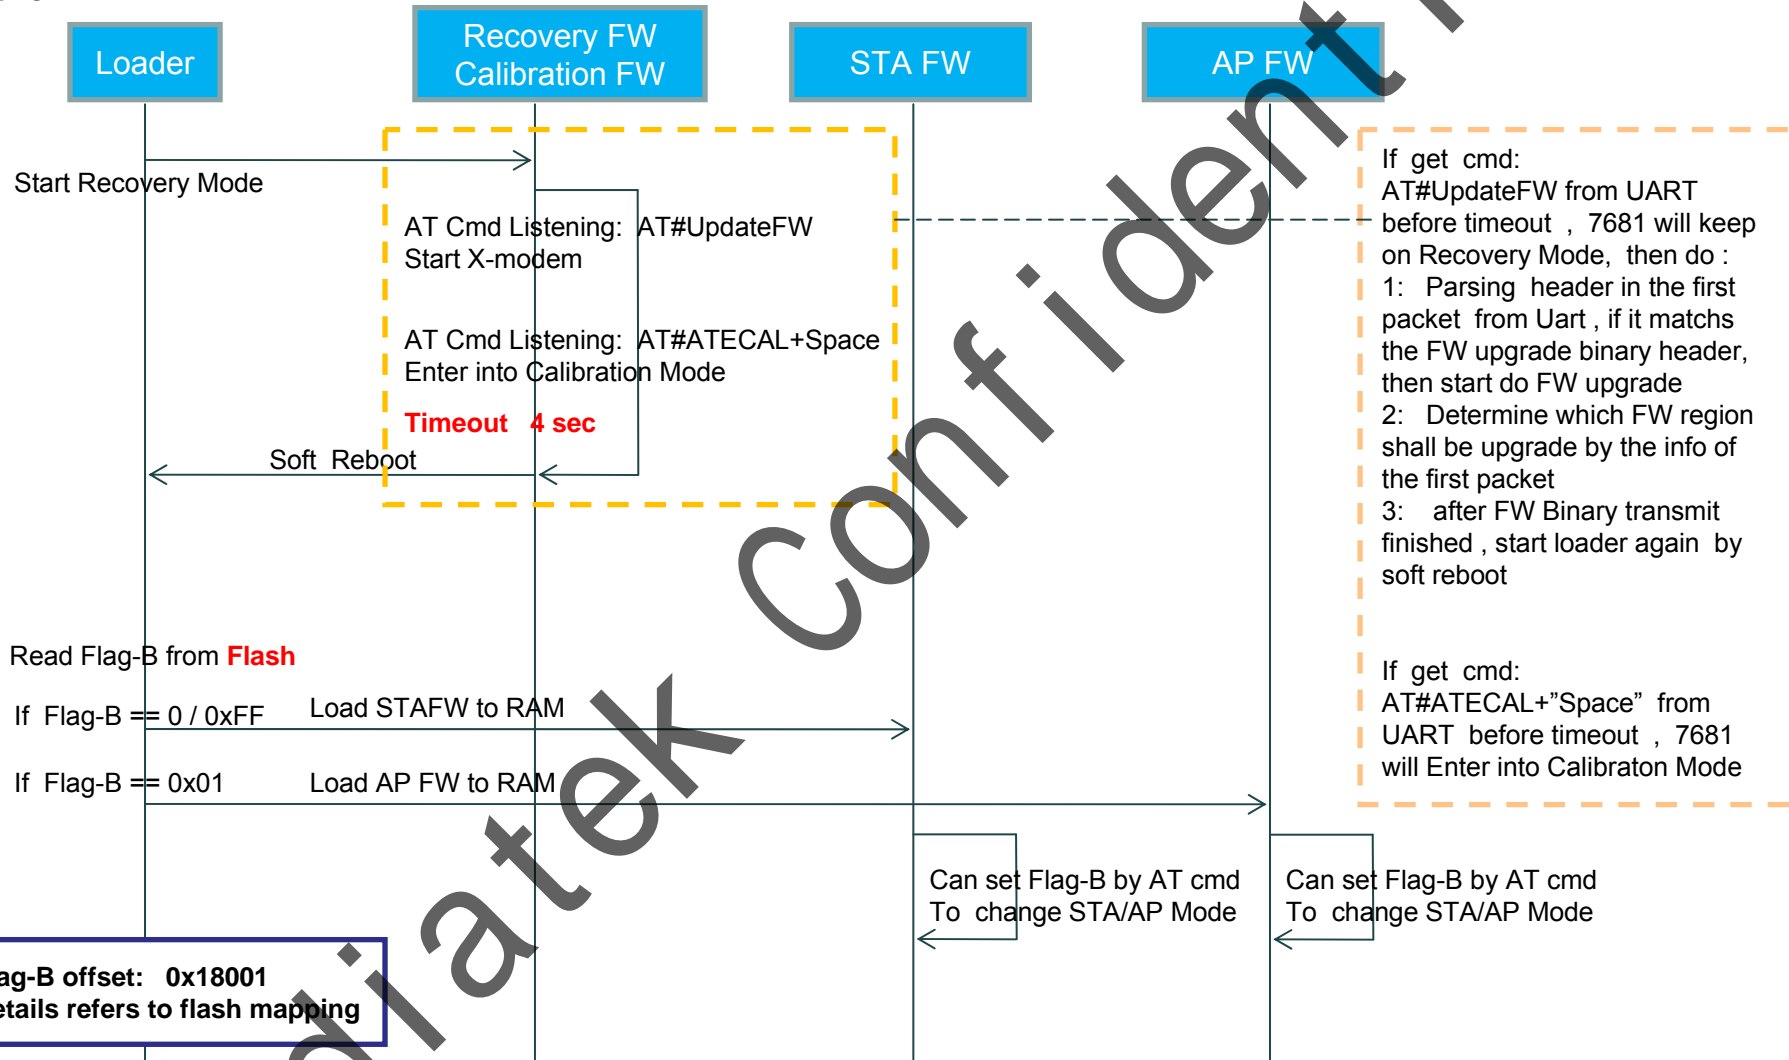
Uart FW Upgrade Flow

Power On

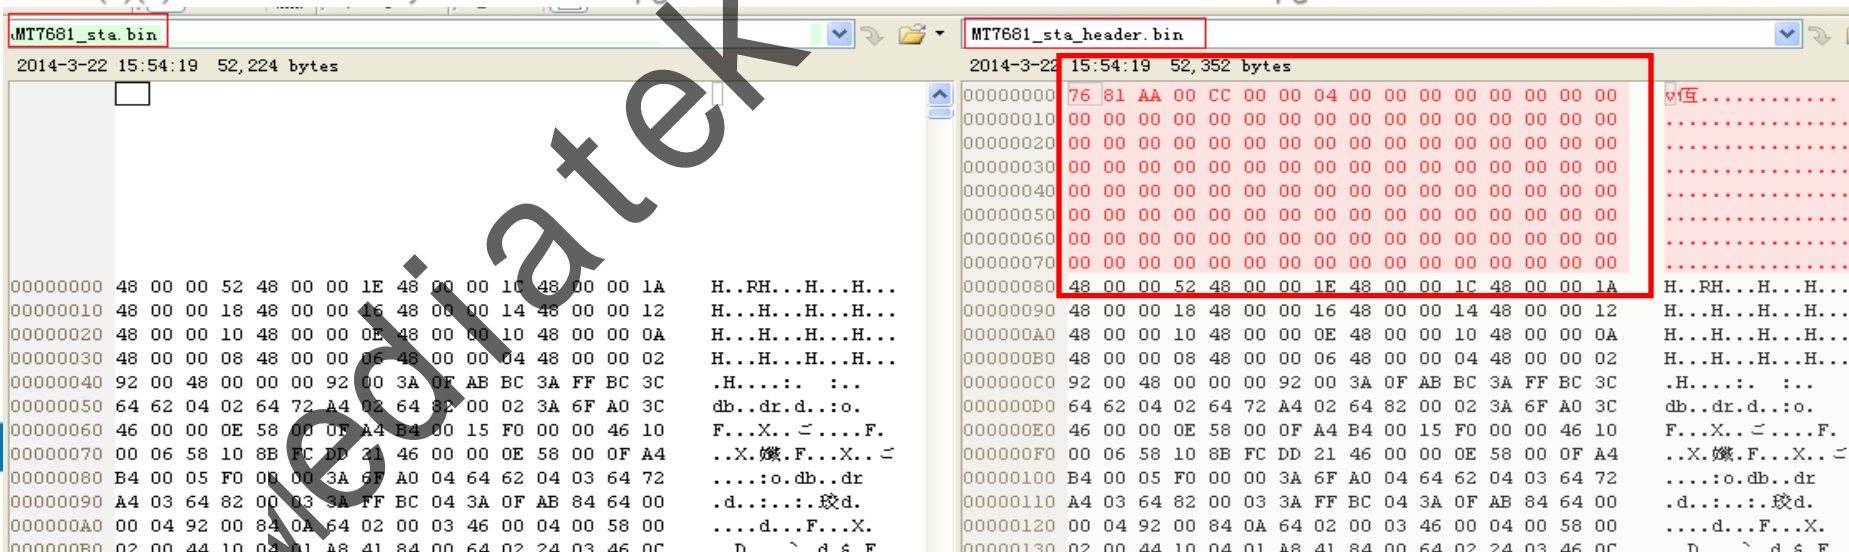
- After source code compiled, Two **types** of binary files shall be generated, one is include upgrade header, the other is not include upgrade header.

etc: MT7681_sta.bin MT7681_sta_header.bin

MT7681_sta.bin : is clean binary whose all content shall be written to STA Region of the flash
if we use flash writer to update Flash , please use this file to merge target Binary with loader.bin , EEPROM.bin
and Recovery.bin

MT7681_sta_header.bin : contains all content of the MT7681_sta.bin, and include upgrade header
if we use Uart to update Flash , please use this file

- If the XIP feature is enabled, four binary files shall be generated
- (1) MT7681_sta_ram.bin, (2) MT7681_sta_ram_header.bin,
 - (3) MT7681_sta_xip.bin, (4) MT7681_sta_xip_header.bin
- (1)(3) : are clean binary files used for flash writer FW upgrade
- (2)(4) : are the binary files include upgrade header which are used for Uart FW upgrade

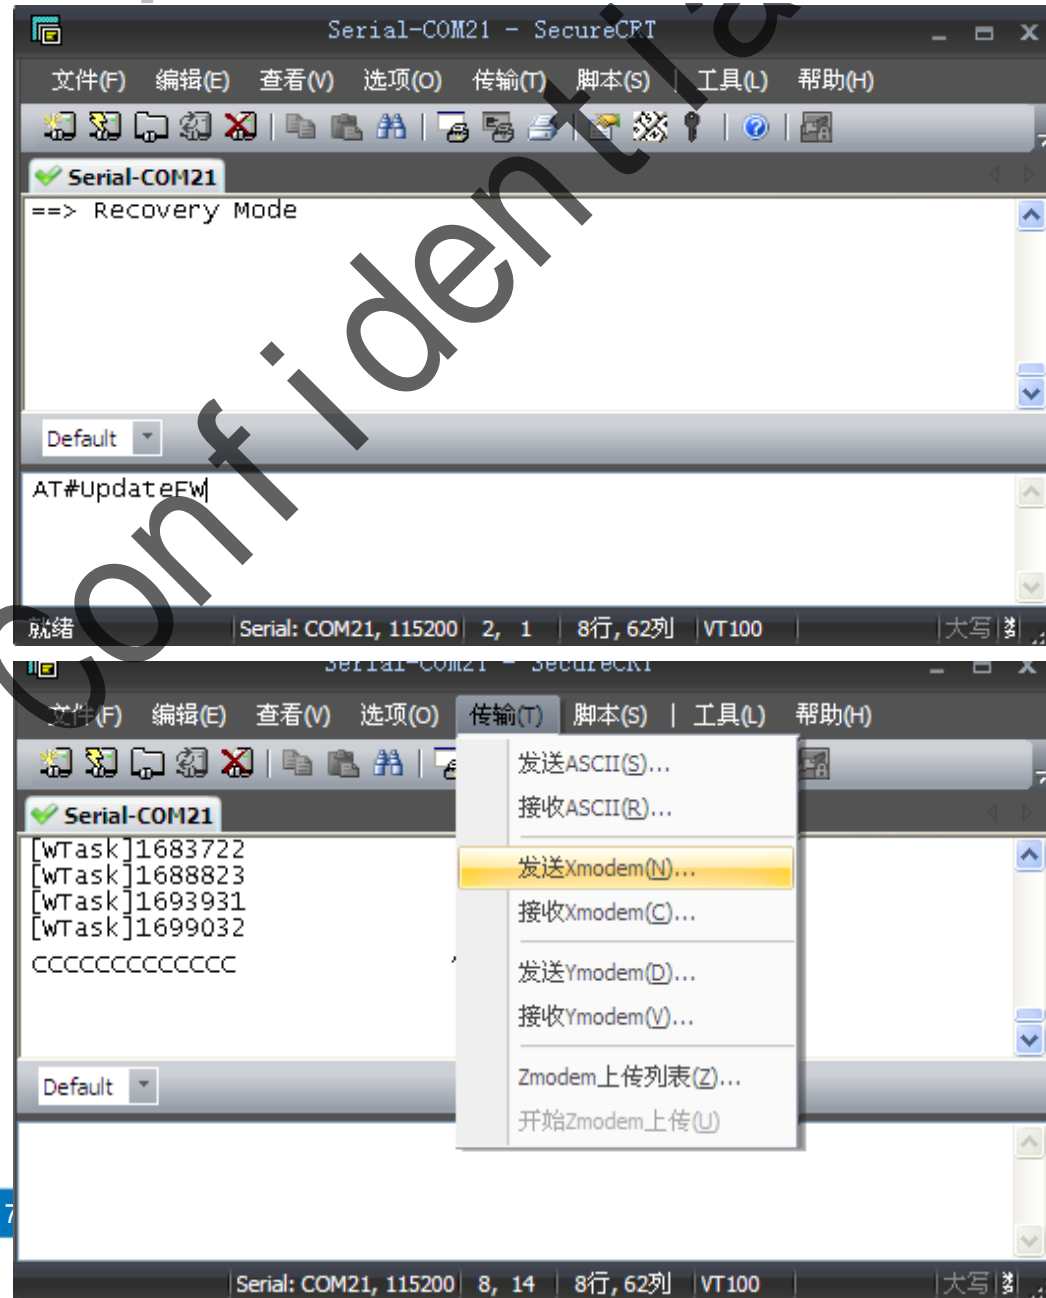
- **Step2: Start X-modem on PC**

see picture as right

Notice: MT7681 only support X-modem
128Byte Mode
