LEAK—TRANSMISSION FLUID LEAKS AT RADIATOR—VEHICLES EQUIPPED WITH AUTOMATIC TRANSMISSION AND TRANSMISSION OIL COOLER IN RADIATOR END TANK

Article No. 00-9-1

FORD: 1997-2000 MUSTANG, EXPEDITION, EXPLORER, F-150, F-250 LD
1998-2000 RANGER
1999-2000 SUPER DUTY F SERIES

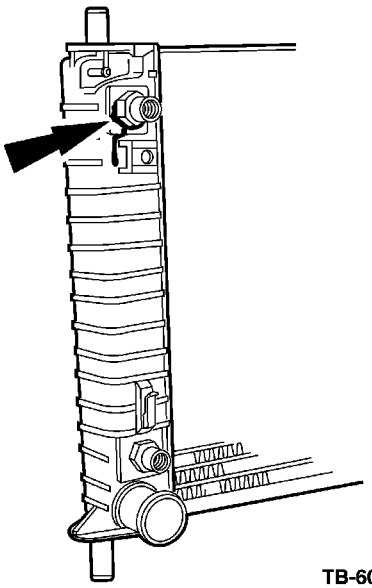
Figure 1 - Article 00-9-1

Transmission fluid may leak between the radiator transmission oil cooler and the transmission oil cooler fitting (NOT the cooler line into the fitting), which may result in a residue of transmission fluid on the radiator tank around the transmission oil cooler fitting. This may be caused by insufficient thread sealer on the transmission oil cooler fitting.

1. Verify that transmission fluid is leaking between the transmission oil cooler and the transmission oil cooler fitting (NOT the transmission cooler line fitting into the transmission oil cooler fitting). Refer to Figure 1.
2. Remove the radiator from the vehicle following Workshop Manual procedure. Place the radiator on a flat surface so that the transmission oil cooler fittings are facing upward. Refer to Figure 2.
3. Clean the area around the transmission oil cooler fitting. This will insure that contaminants do not enter the transmission oil cooler when the transmission oil cooler fittings are removed.
