DRAG LINK AND TIE ROD END INSPECTION AND REPLACEMENT

AFFECTED VEHICLES: CERTAIN 2000 MODEL YEAR F-650/F-750 AND F-7000/F-8000

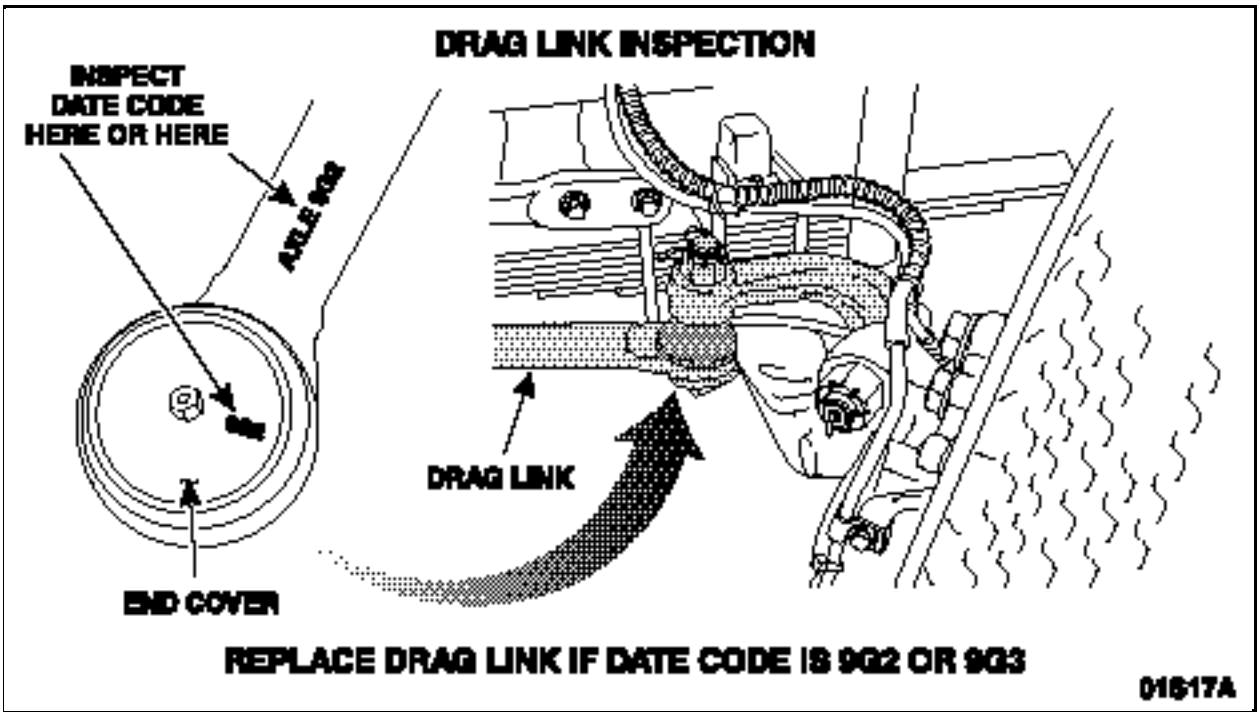
FIGURE 1

Locate the date code stamped on the end cover of the drag link or on the shaft of the drag link (next to the word “AXLE”). See Figure 1.

- If the date code is 9G2 or 9G3, replace the drag link.
   - If the date code is not 9G2 or 9G3, no drag link replacement is required.

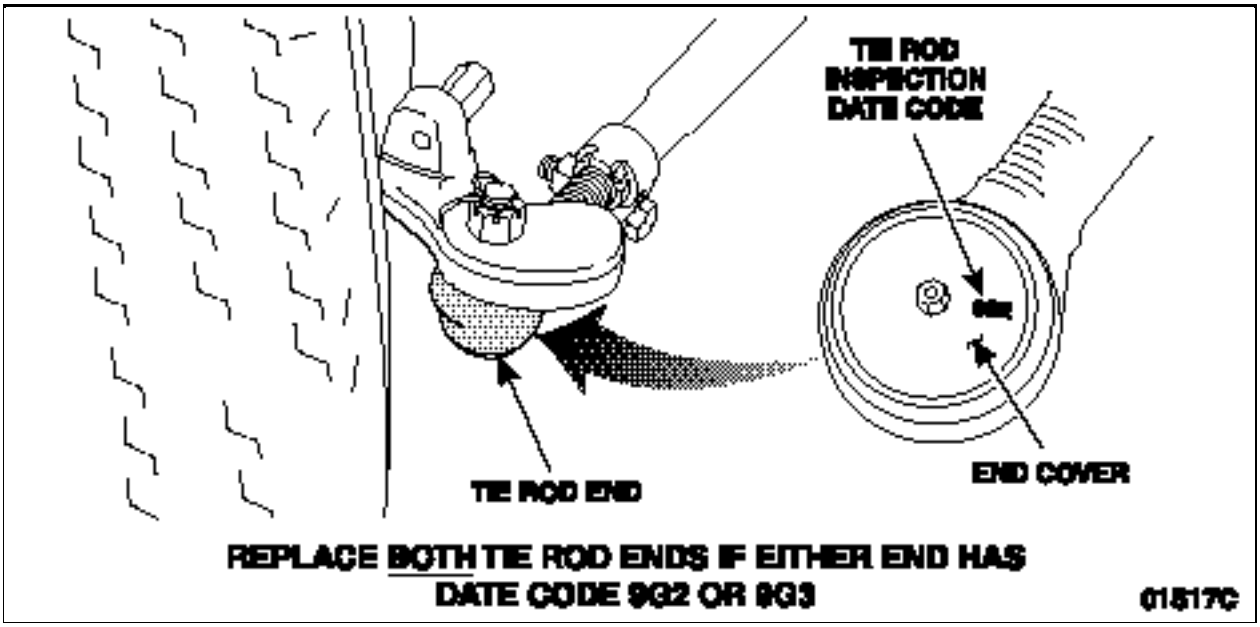
FIGURE 3

Locate the date codes stamped on the end covers of the tie rod ends. See Figure 3.

- If either tie rod end date code is 9G2 or 9G3, replace both tie rod ends.
   - If neither tie rod end date code is 9G2 or 9G3, tie rod end replacement is not required.
