Drive Test Analysis

Objectives

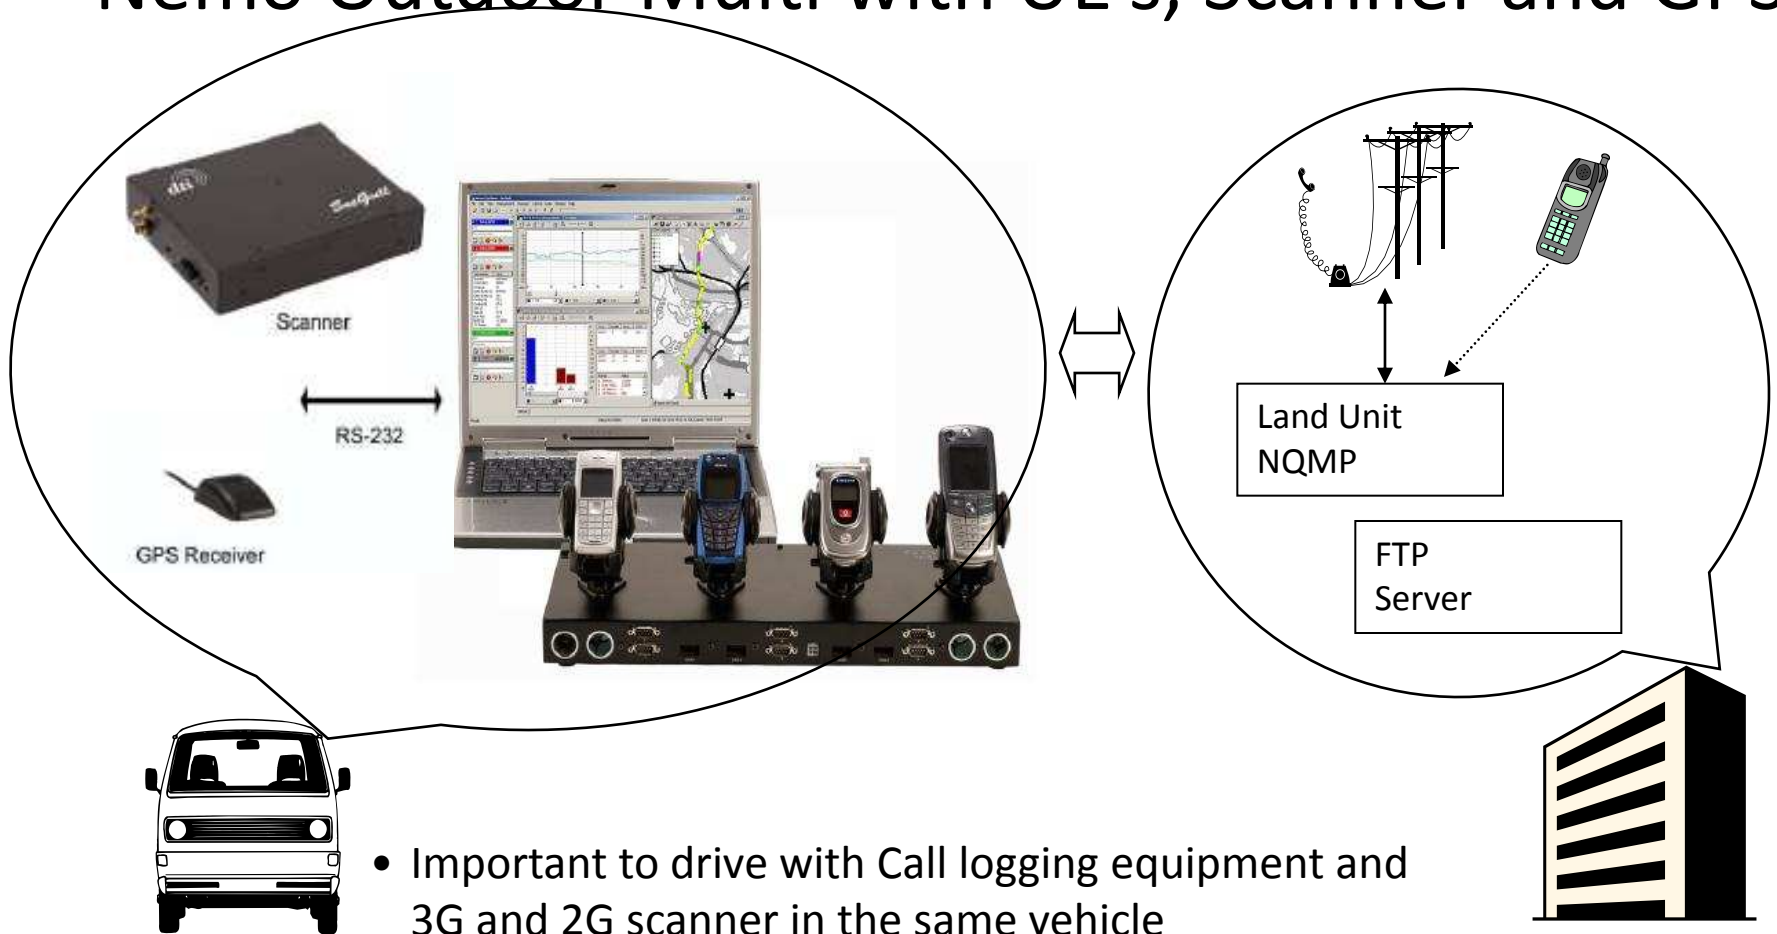
- Nemo Outdoor Multi with UE's, Scanner and GPS

- Important to drive with Call logging equipment and 3G and 2G scanner in the same vehicle

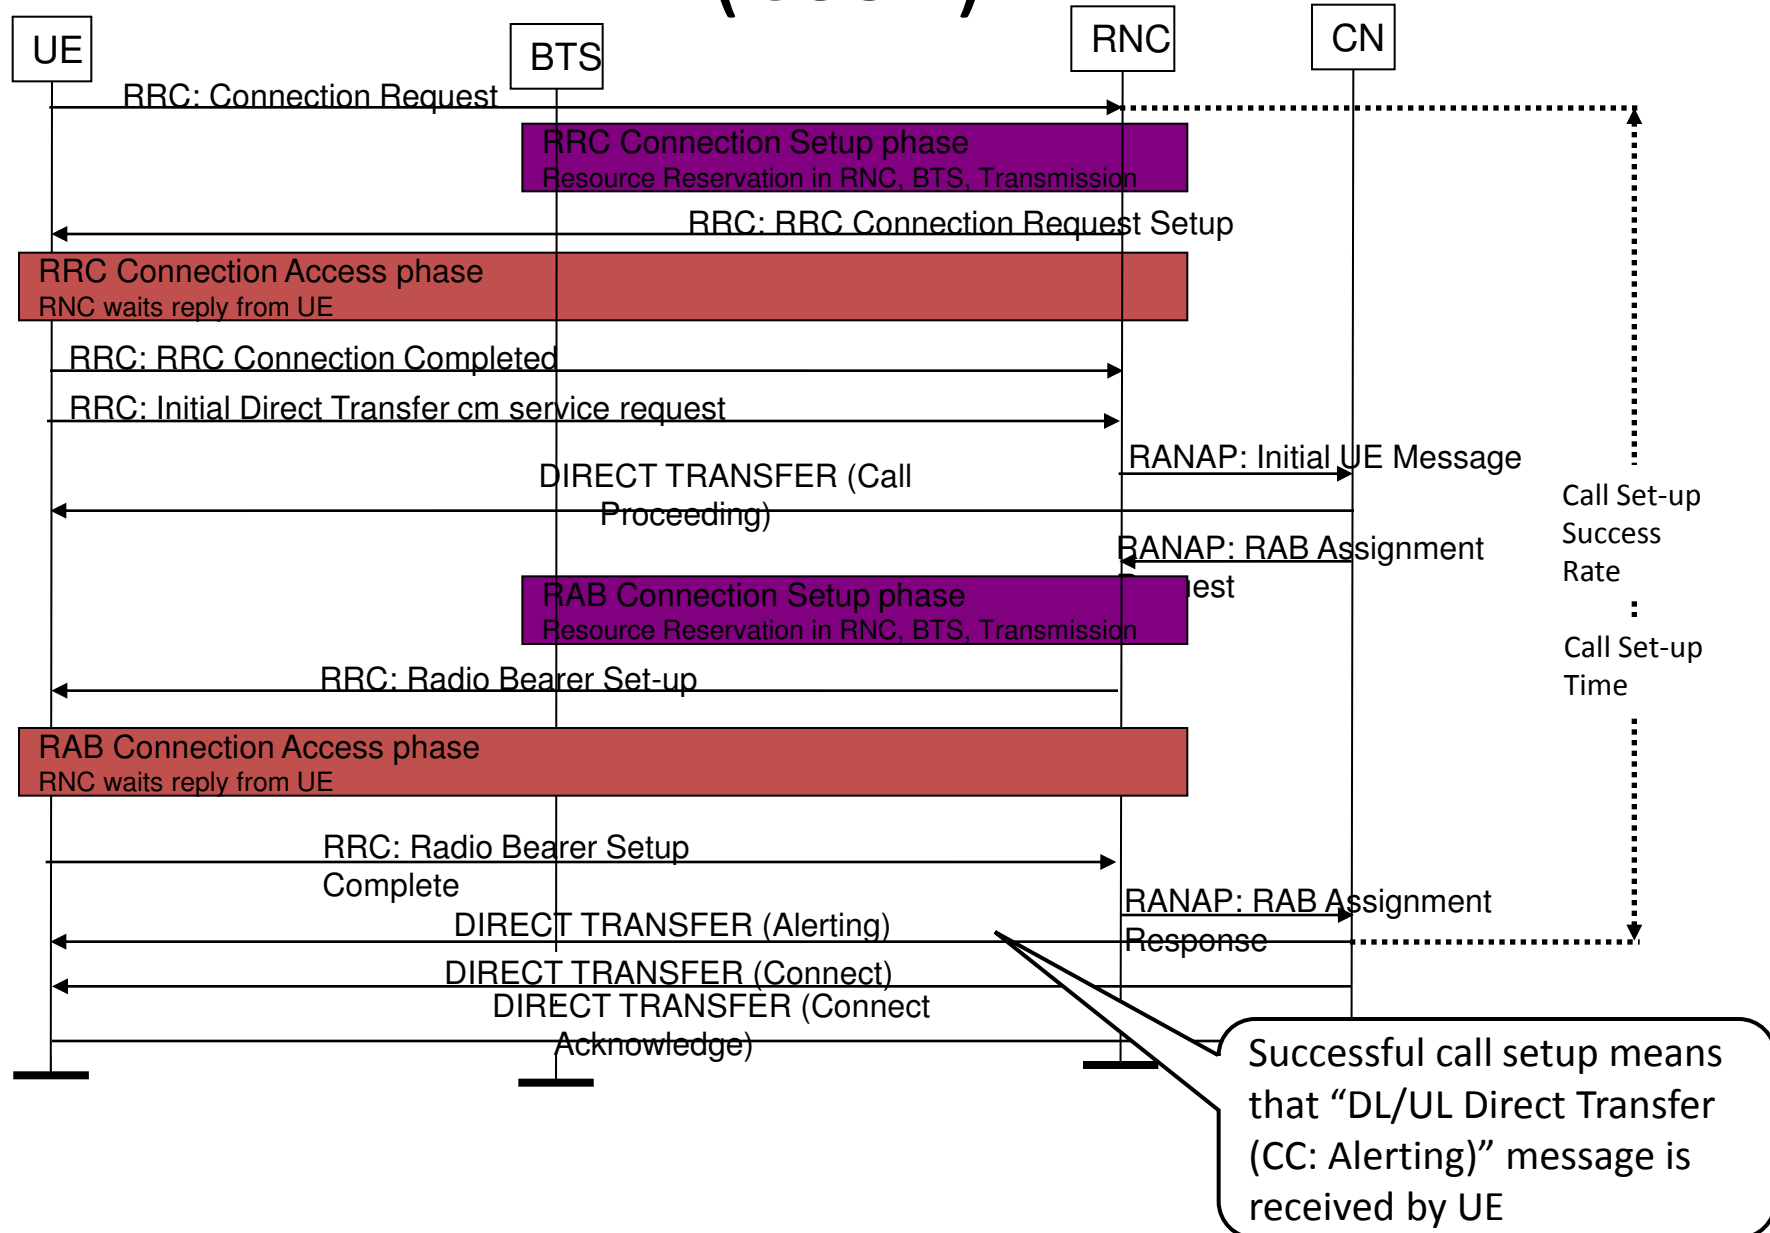
Definition of Call Set-Up Success Rate (CSSR)

- **Call Setup Success - CSSR (voice, circuit switched data)**
 - Successful call setup means that “DL/UL Direct Transfer (CC: Alerting)” message is received by UE.

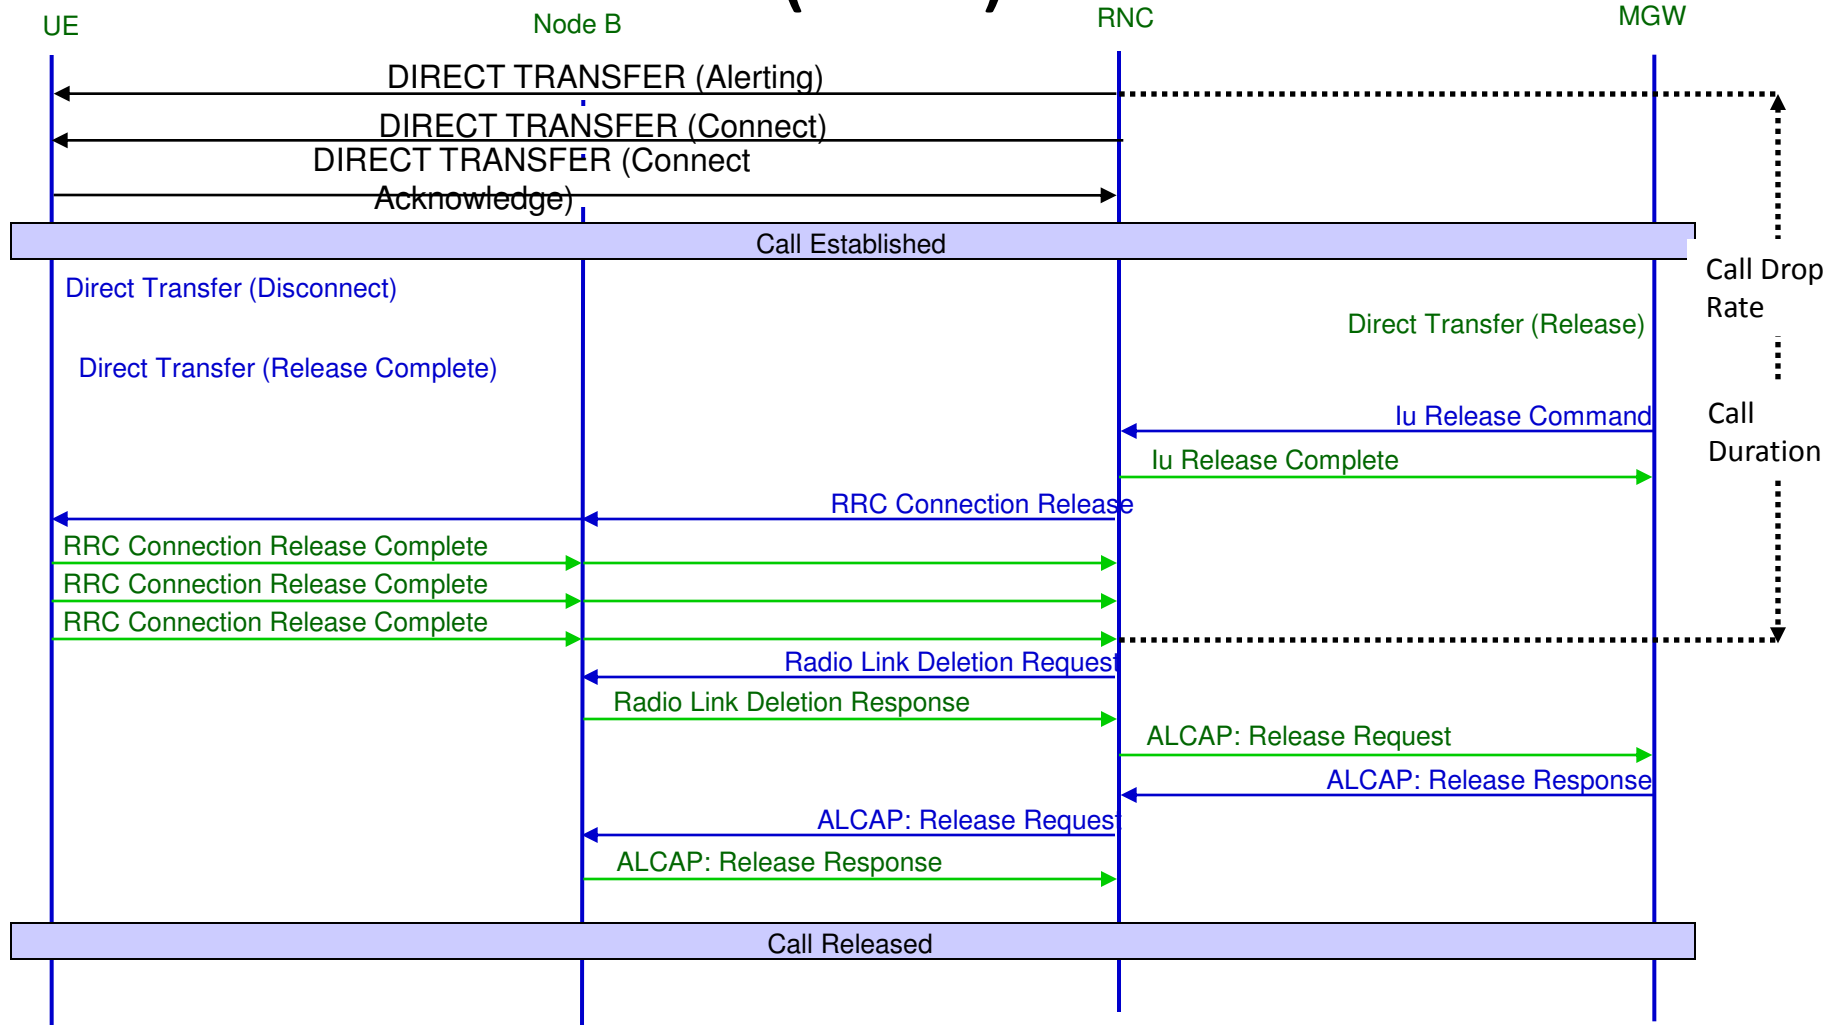
Definition of the Call Completion Rate (CCR)

- **Call Drop (voice, circuit switched)**
 - A dropped call occurs. The call will be dropped in case RRC connection release (not normal release) message has been send from RNC to UE.

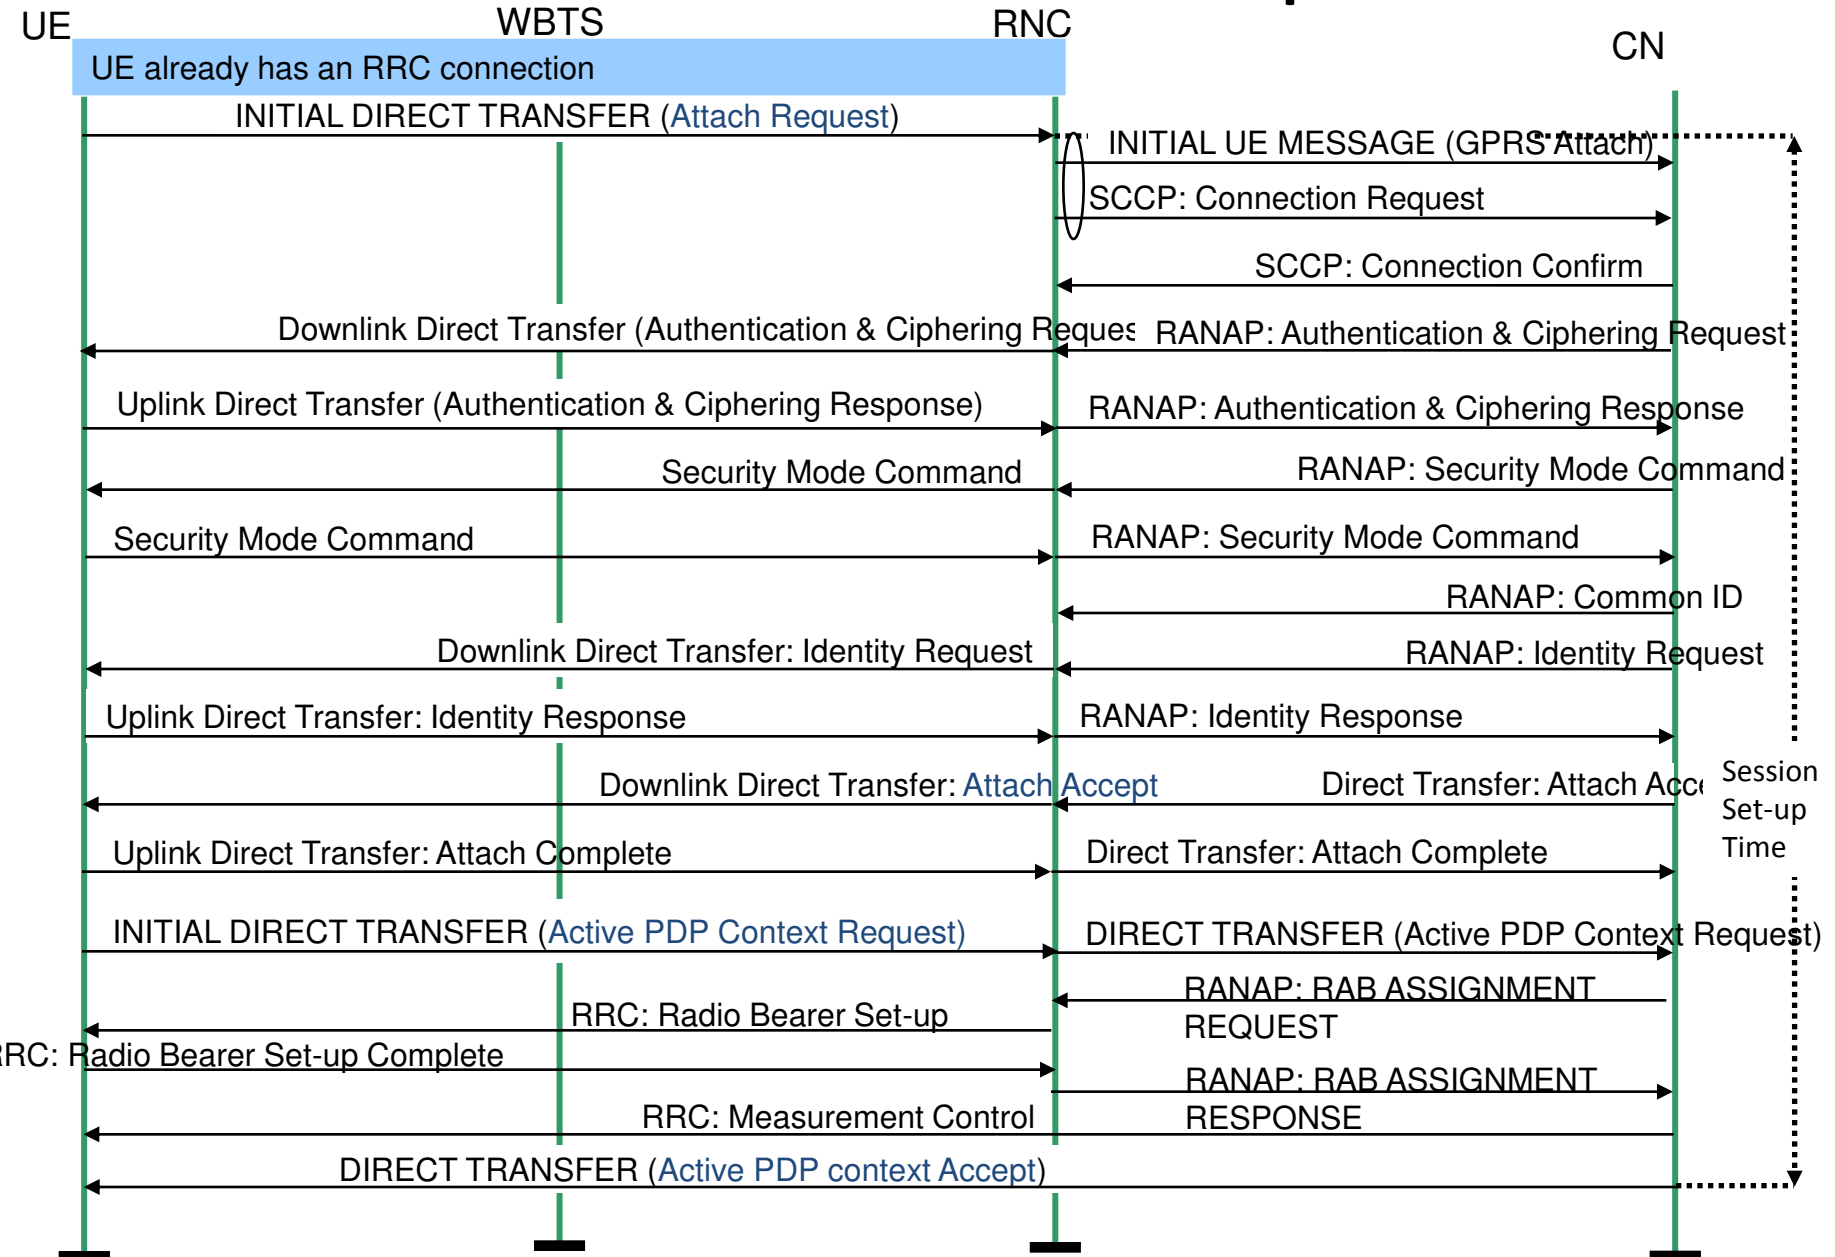
Definition of Session Setup Time - PS

- **Session Setup Time (packet switched)**
 - The “session setup time” is the delay between the time the UE sends the data session activation request until GPRS attach and PDP context activation has been successfully completed.

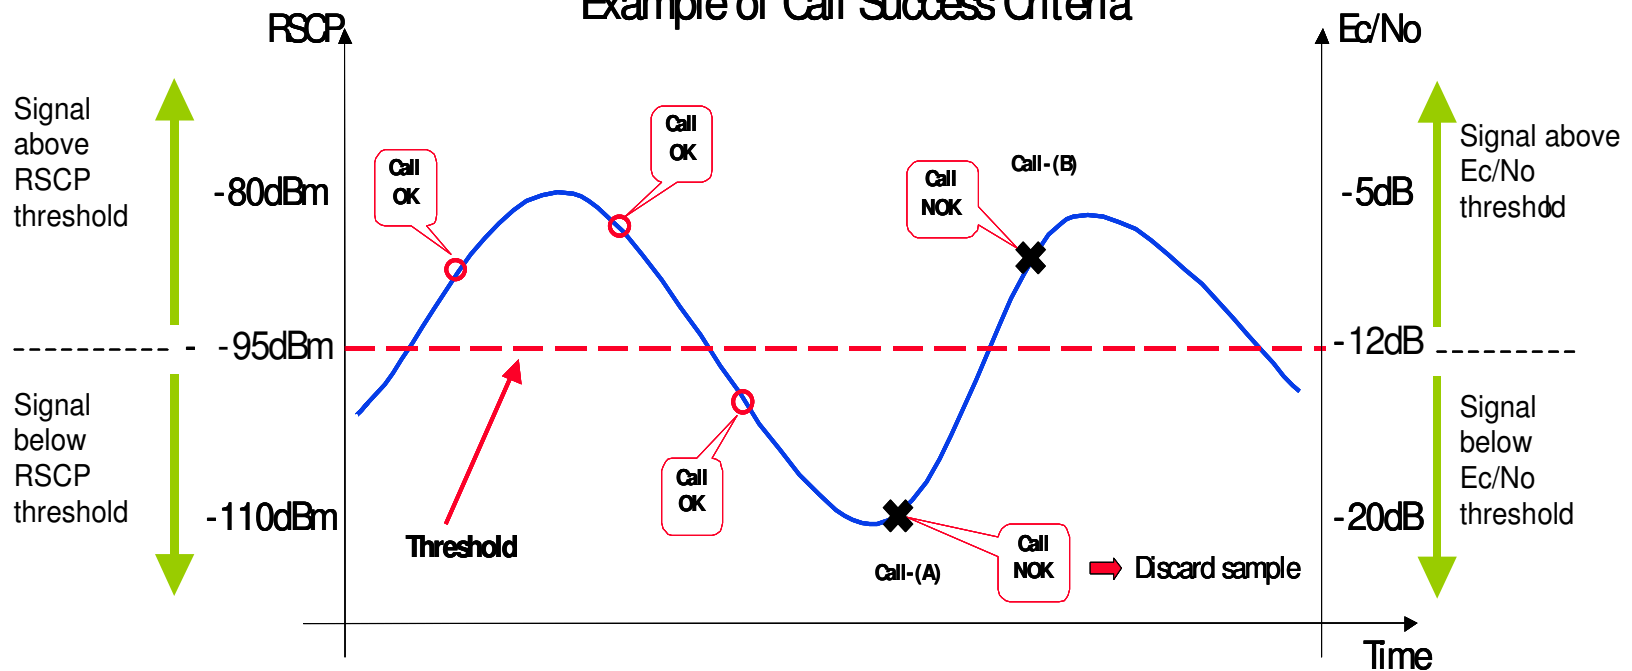
Example of Call Success Criteria

- The KPI measurement conditions should be used to define exclusion areas during drive test for acceptance of a cluster.
- All failures happening in those area, that do not respect the coverage requirements should be discarded.

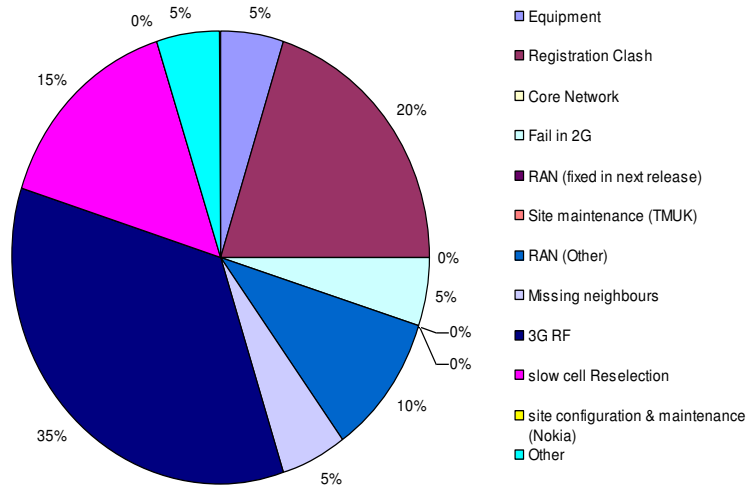
Call Set-up Failures Breakdown - Benchmark Drive

Failure Type	total	%
Equipment	1	5.0
Registration Clash	4	20.0
Core Network	0	0.0
Fail in 2G	1	5.0
RAN (fixed in next release)	0	0.0
Site maintenance (TMUK)	0	0.0
RAN (Other)	2	10.0
Missing neighbours	1	5.0
3G RF	7	35.0
slow cell Reselection	3	15.0
site configuration & maintenance (Nokia)	0	0.0
Other	1	5.0

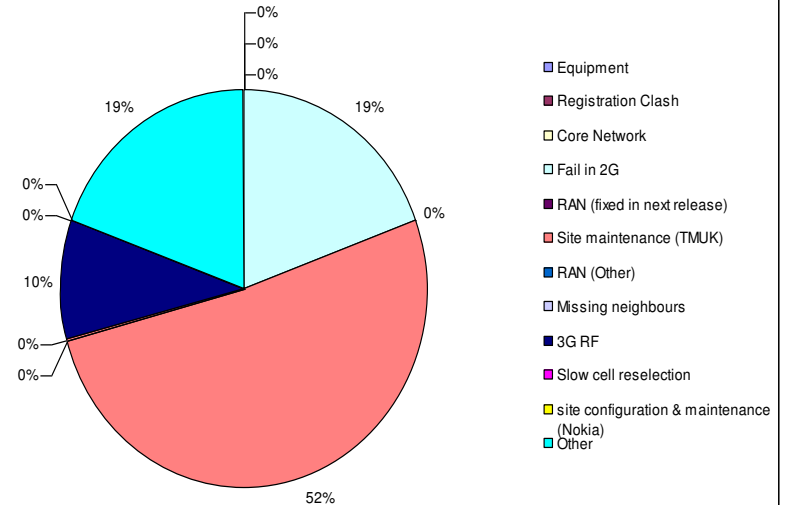
Call Setup Failure Breakdown - Final Drive

Failure Type	total	%
Equipment	0	0.0
Registration Clash	0	0.0
Core Network	0	0.0
Fail in 2G	6	19.4
RAN (fixed in next release)	0	0.0
Site maintenance (TMUK)	16	51.6
RAN (Other)	0	0.0
Missing neighbours	0	0.0
3G RF	3	9.7
Slow cell reselection	0	0.0
site configuration & maintenance (Nokia)	0	0.0
Other	6	19.4

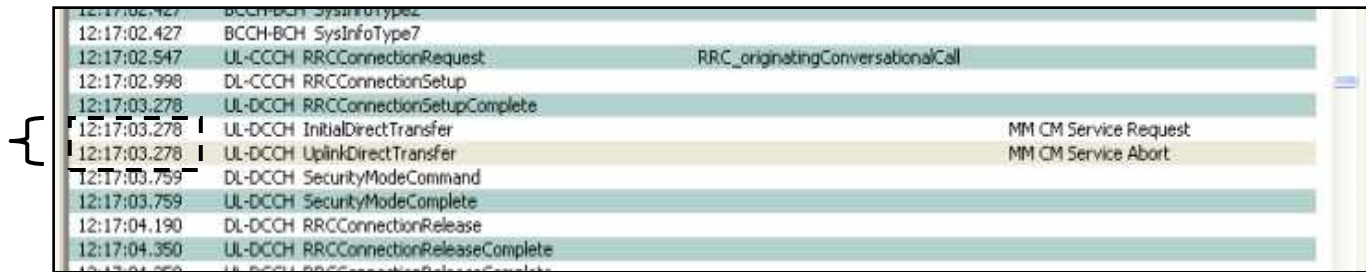
Non Genuine Call Setup Failures

- Measurement system failures by drive test tool
 - “CM Service Abort” within milliseconds from “CM Service Request”
 - No time for response from NW

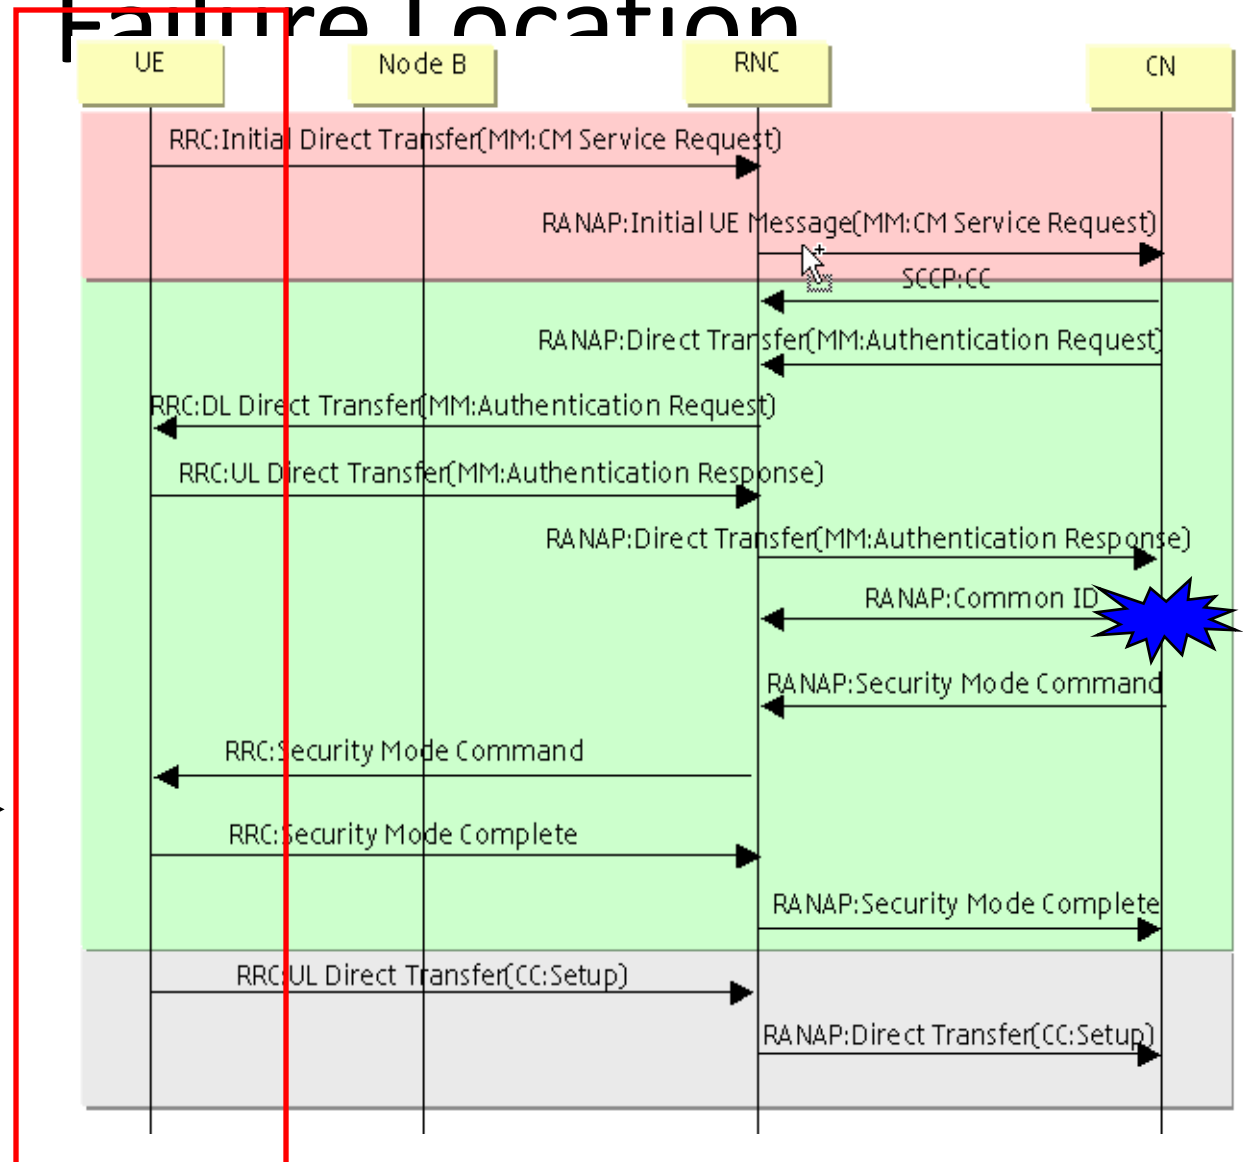
Failure Location

- Analyse the signalling flow to find the location of failure and potential cause

- UE log may only capture some of the messages →

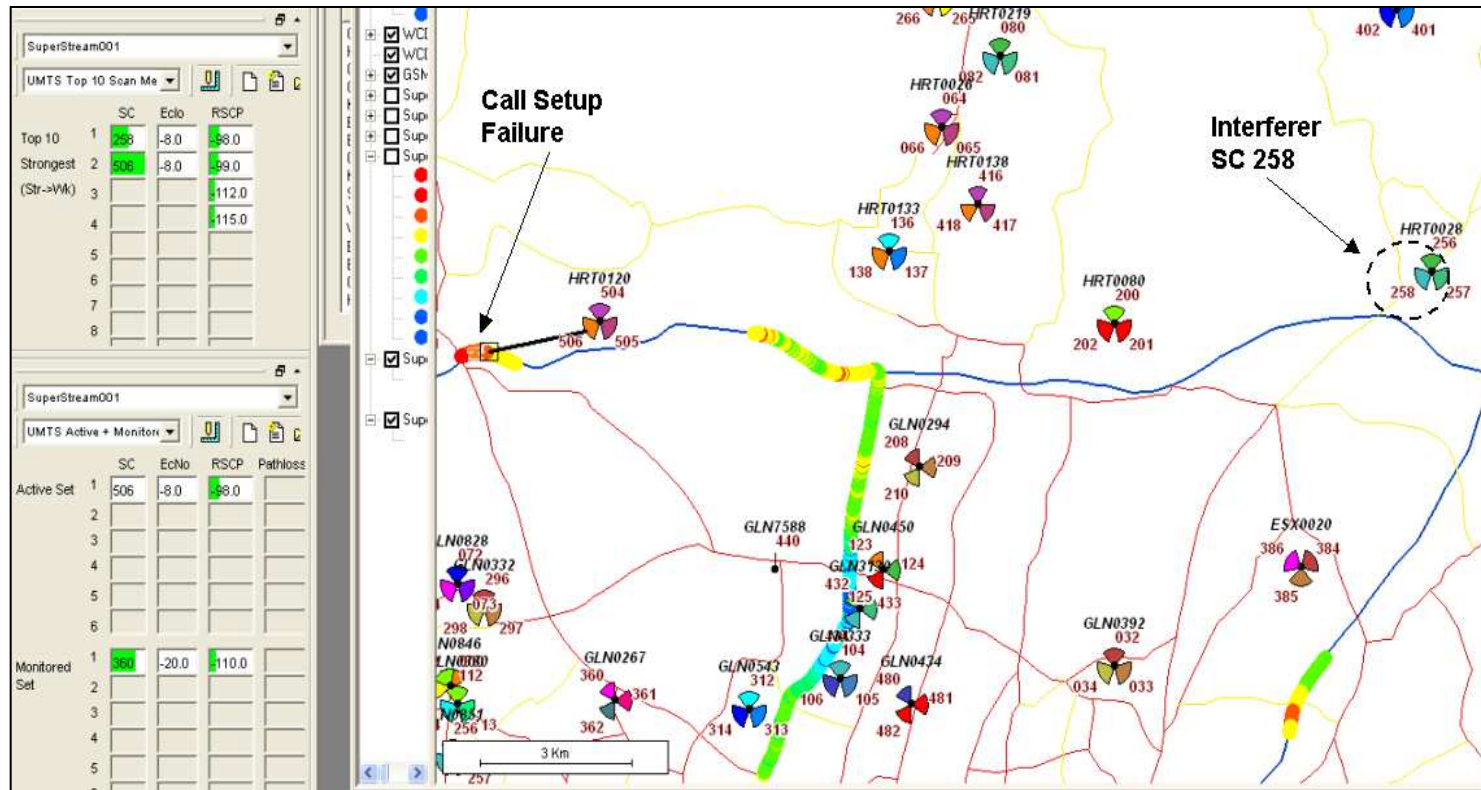
Call setup failures – RF issue

- RF issue? Coverage / Interference / Dominance

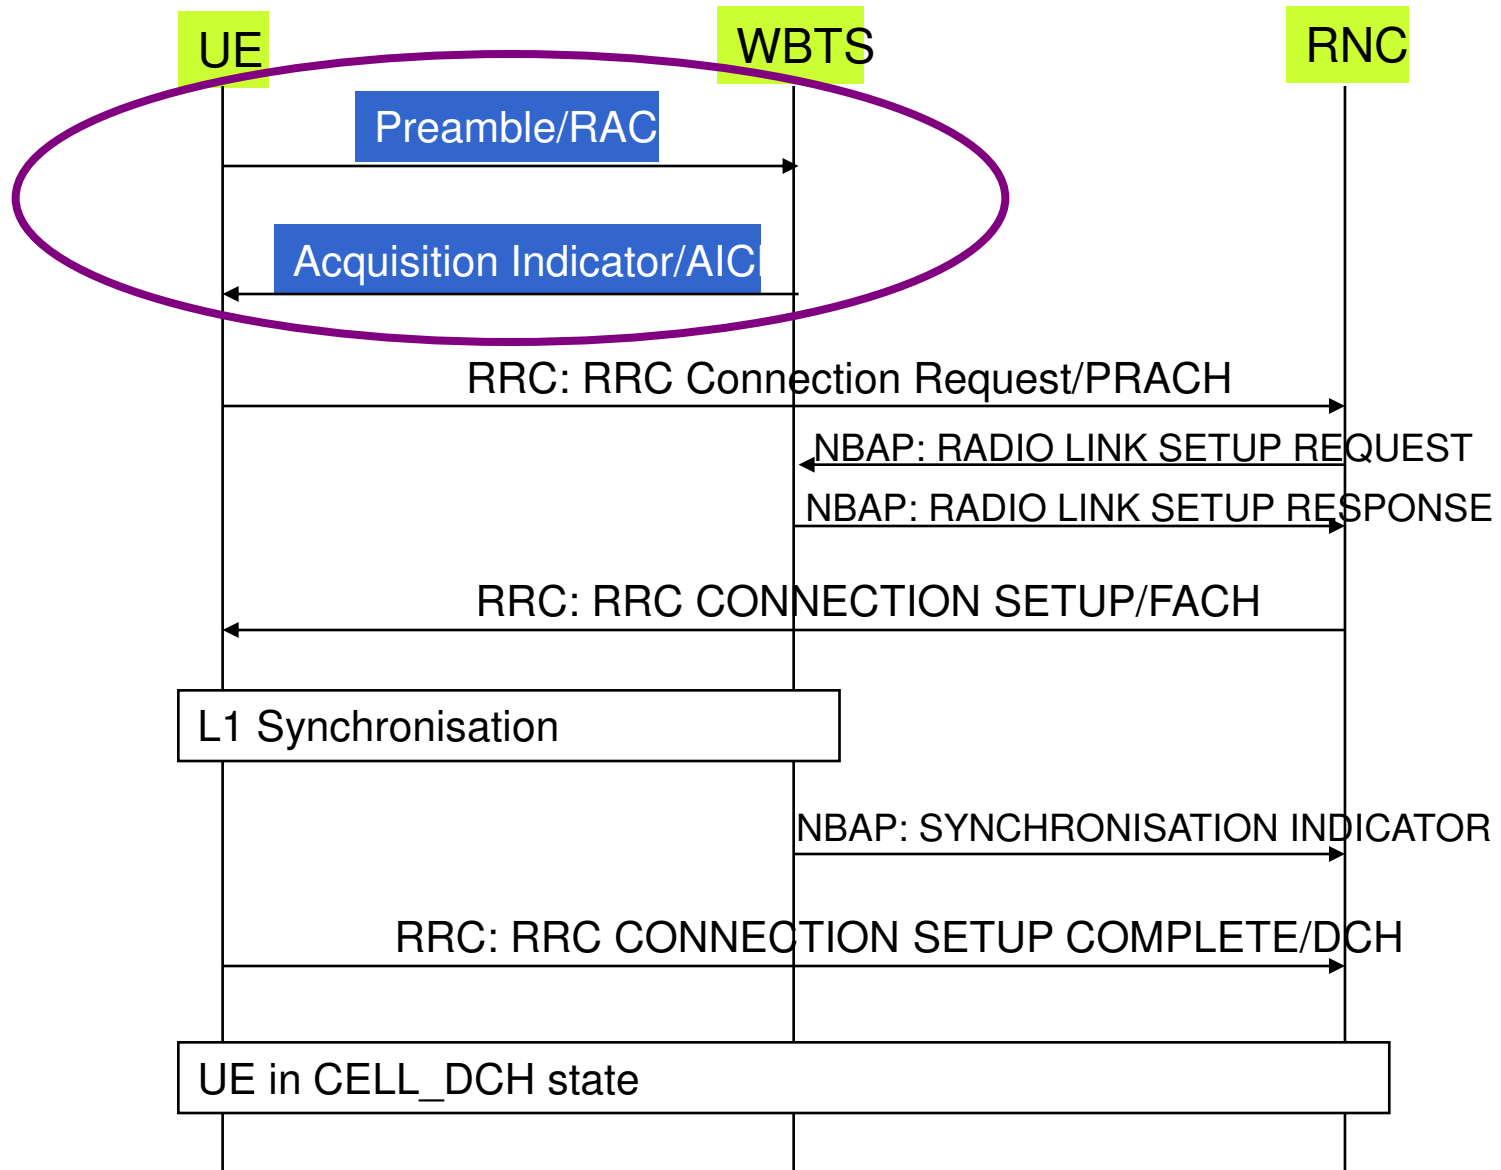
Call Setup Failure Analysis- Block B

- The purpose of this activity is to check the Random Access Process is working adequately by investigating whether AI (Acquisition Indicator) has been received through DL AI CH
- If AI CH was not received by UE, the cause of the problem can be classified into:
 - Inadequate RAN parameter related to Random Access: RAN parameter settings for pre-amble transmission or open loop power control information is not correct.
 - UL Coverage limit: UL coverage of UE is smaller compared to serving cells DL coverage so that UE's Tx power cannot reach serving cell.
- The Basic theory for RACH setup procedure

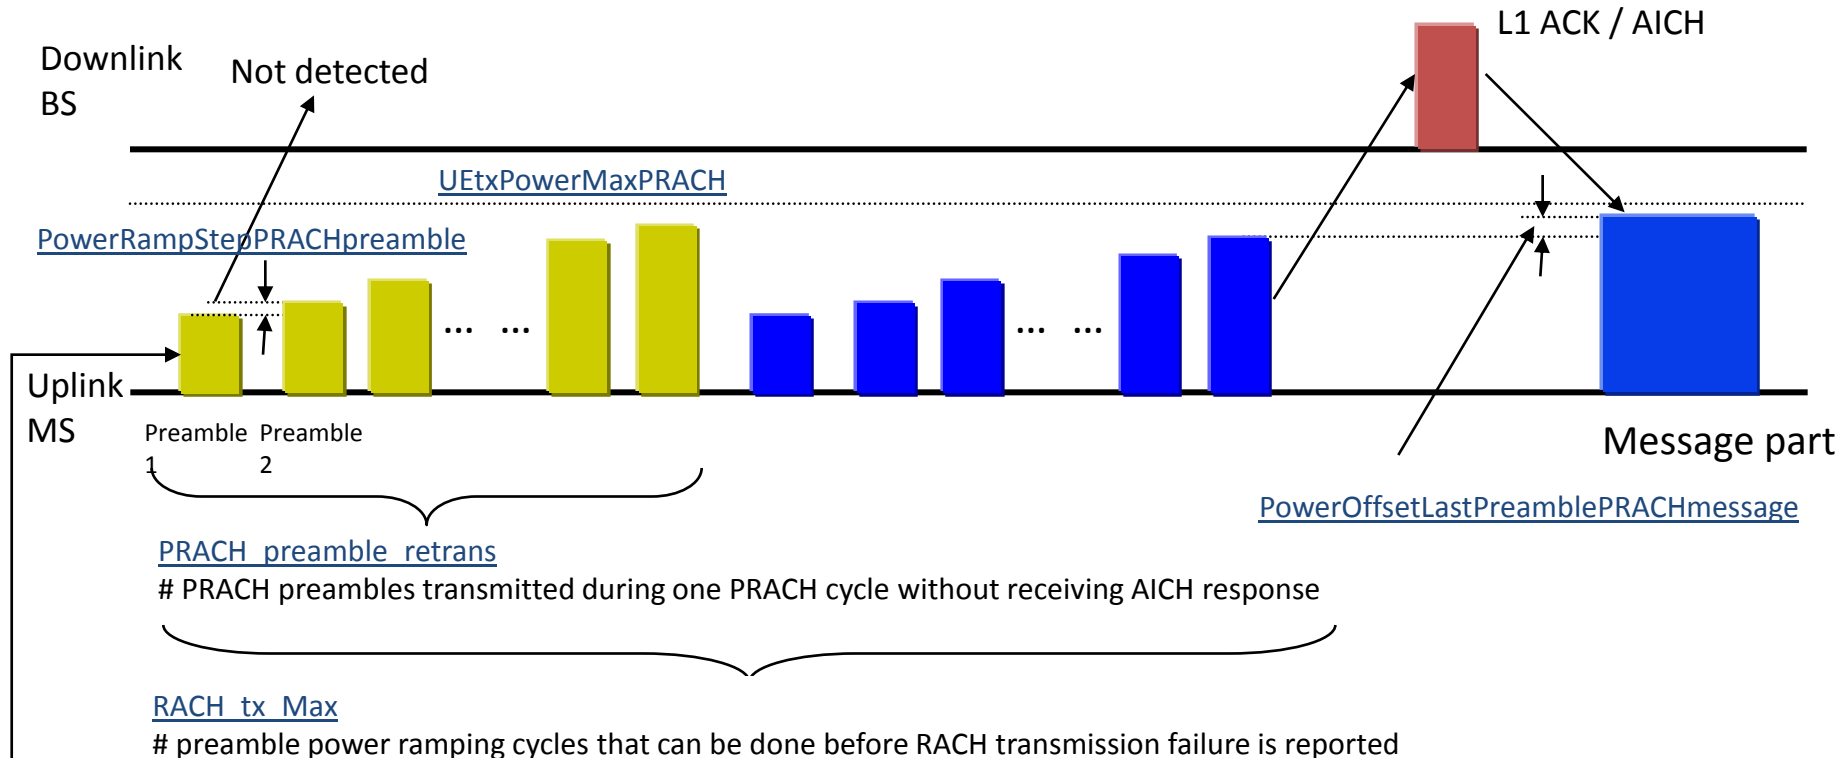
RACH Process

Initial preamble power:

- $P_{tx} = CPICH_{transmissionPower} - RSCP(CPICH) + RSSI(BS) + PRACH_{RequiredReceivedCI}$

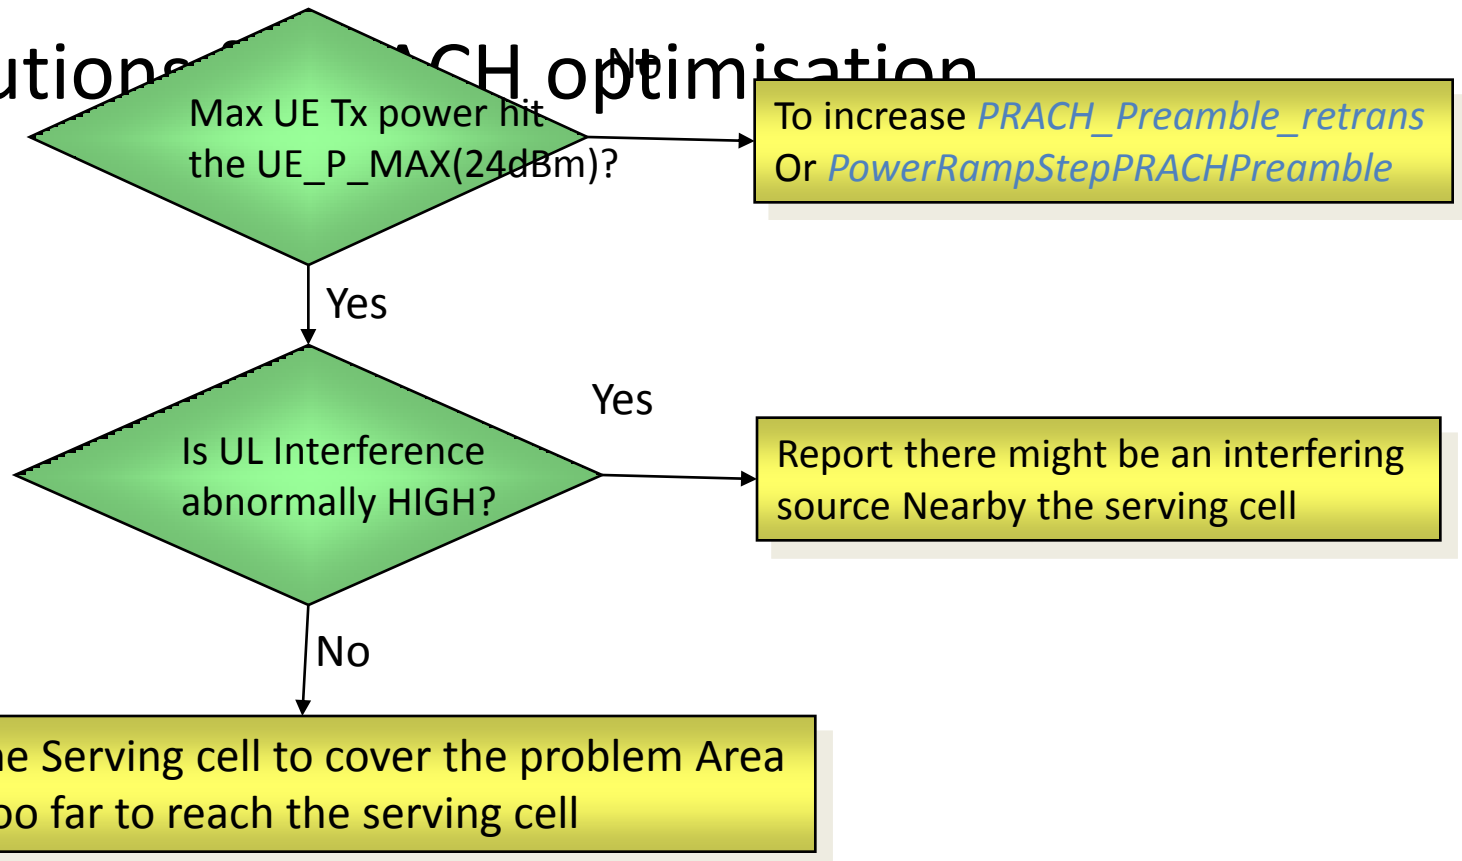
Call Setup Failure Analysis- (B)

- Solutions for PRACH optimisation

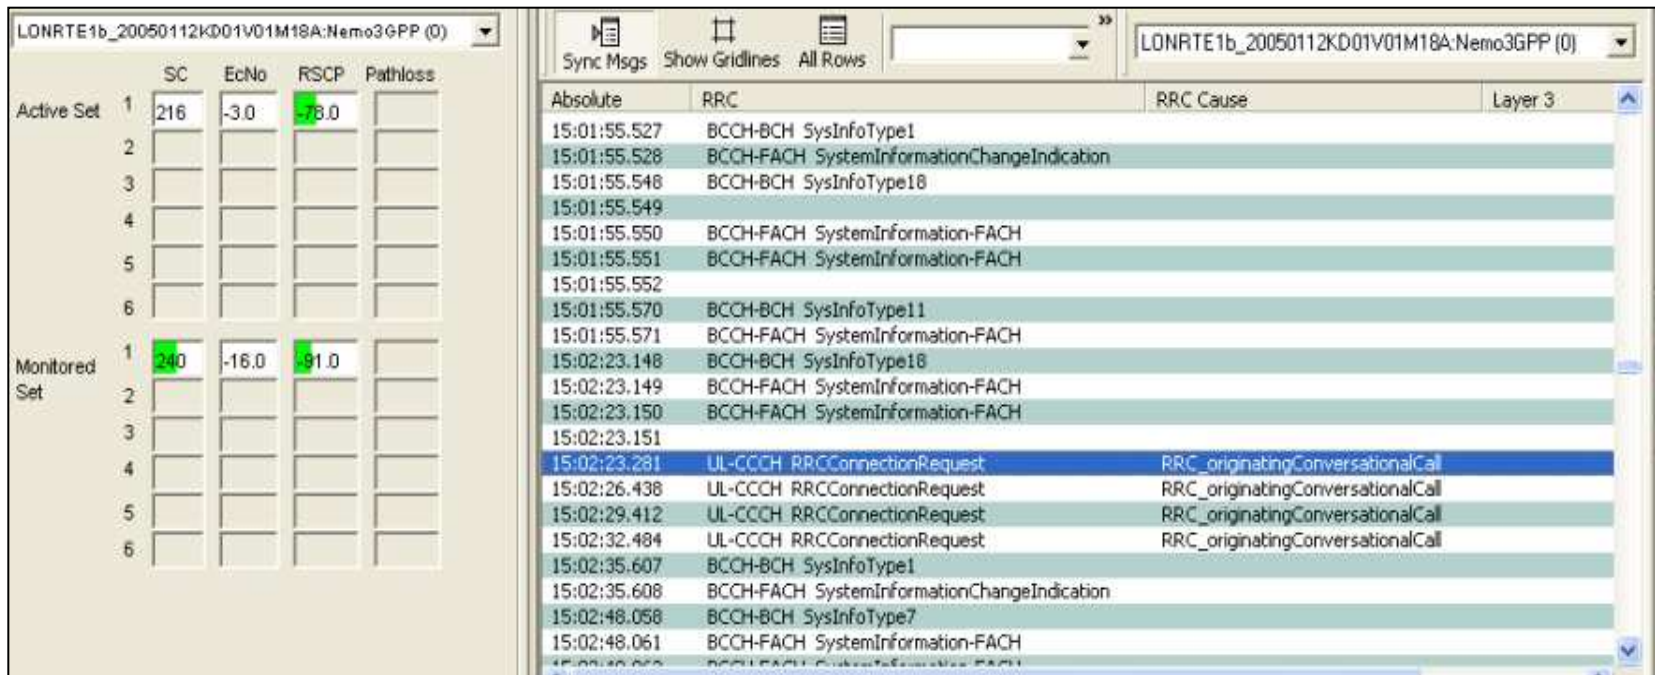
Call setup failures – System issue

- No response to “RRC Connection Request”
 - Good RF conditions
 - Wrong MHA settings or cable loss settings can cause the site not to “hear” the UE
 - PrxNoise statistics, receive link parameters and HW units to be checked (faulty MHA, wrong MHA parameters, wrong cable / feeder loss parameters, faulty units)

The screenshot displays a network monitoring interface with two main sections. The left section shows RF parameters for an 'Active Set' and a 'Monitored Set'. The right section shows a log of RRC messages.

SC	EcNo	RSCP	Pathloss
Active Set	1	216	-3.0	-78.0
	2			
	3			
	4			
	5			
	6			
Monitored Set	1	240	-16.0	-91.0
	2			
	3			
	4			
	5			
	6

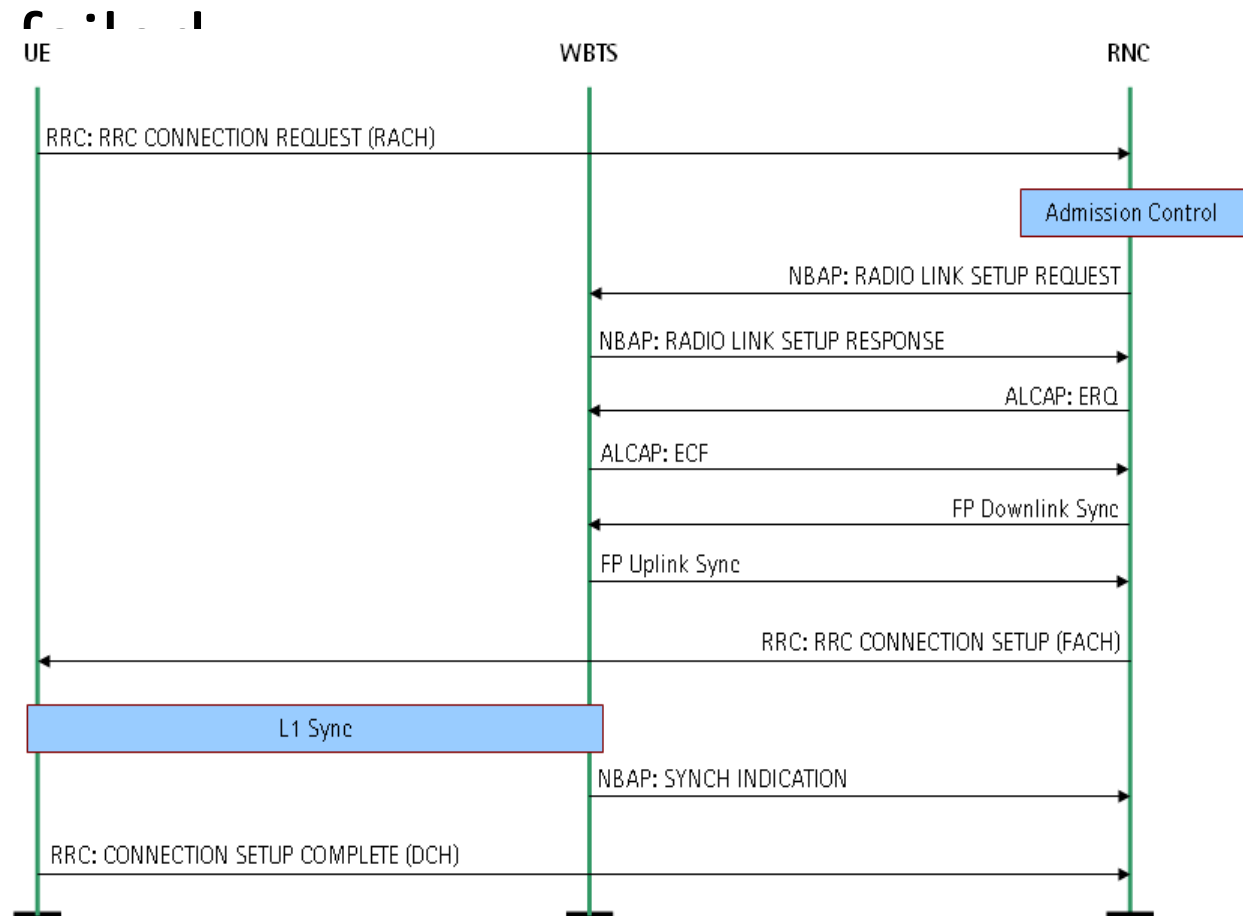
To check if Layer 1 Synchronization (slot/frame sync) has failed

- If “RRC Connection Setup Complete” message is received, the RNC has to check if

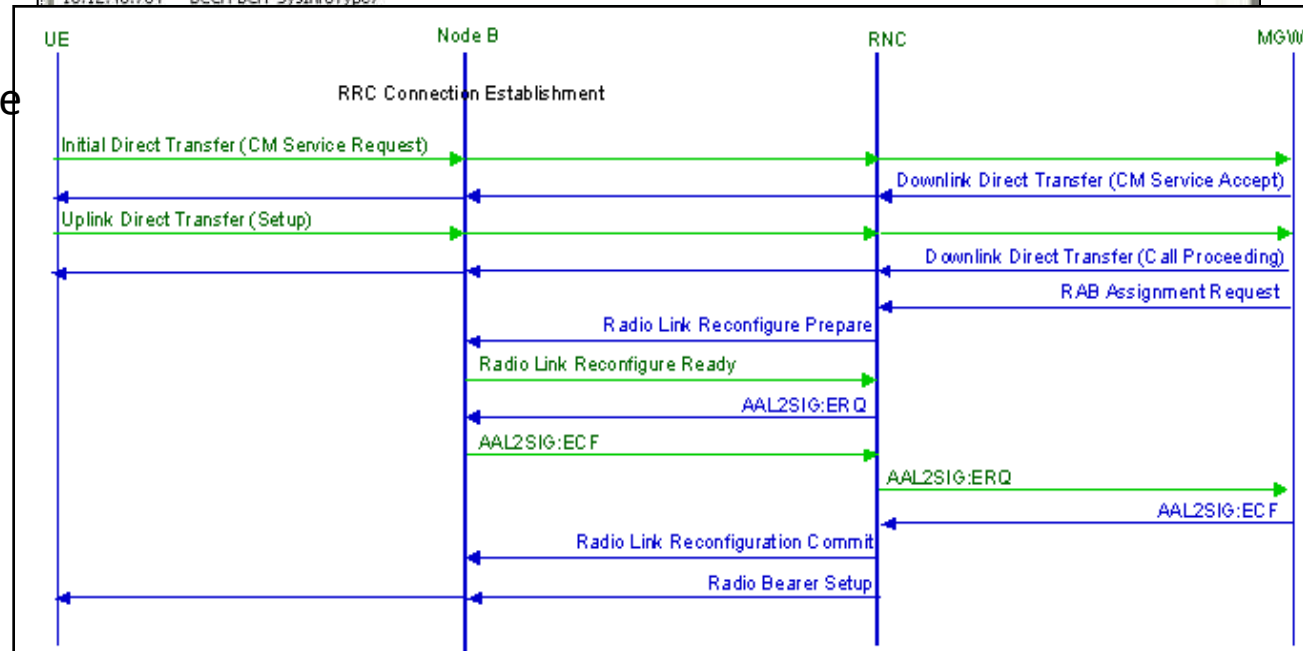
Call setup failures – System issue RNC

- “CC Disconnect” after “Call Proceeding”
- Good RF conditions
- Failures in RAB setup occur between the “RAB Assignment Request” being received from Core Network and the RAN sending out Radio Bearer Setup. Therefore the failure is between BTS and Core Network.

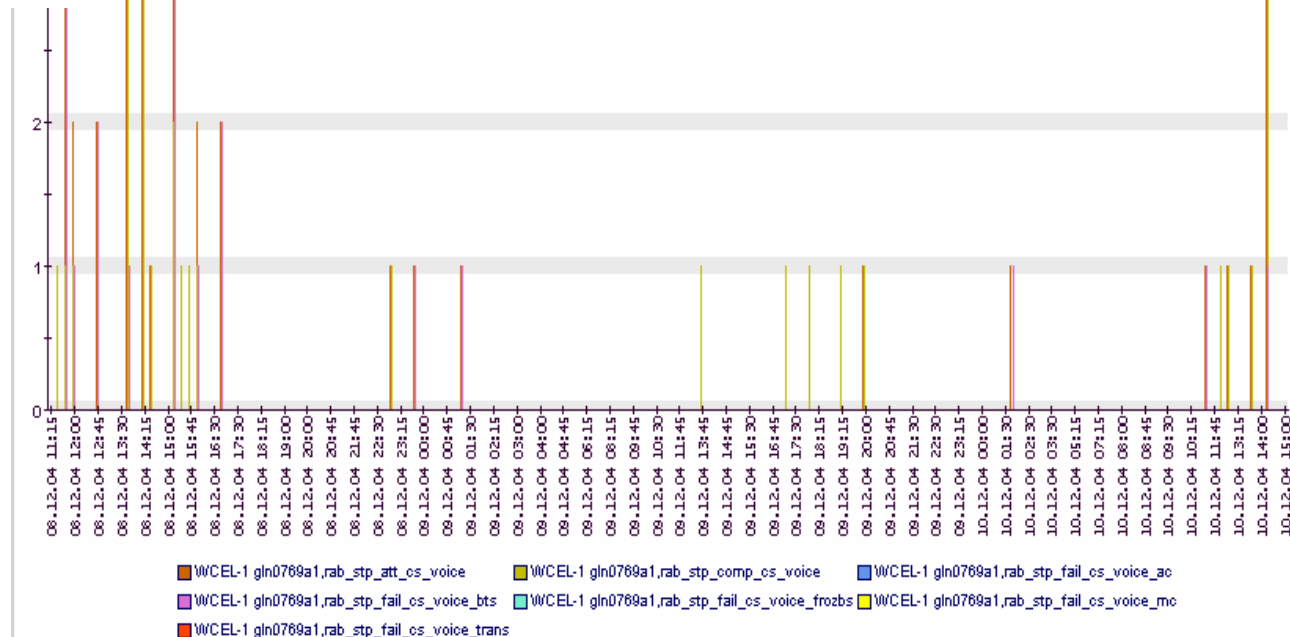
Call setup failures

- “CC Disconnect” after “Call Proceeding” (cont.)
- An example (site shows high values on counter “RAB_STP_FAIL_CS_VOICE_BT S” during the drive test
- In the recent check the counter showed no failures.
