Drive Test Analysis

Objectives

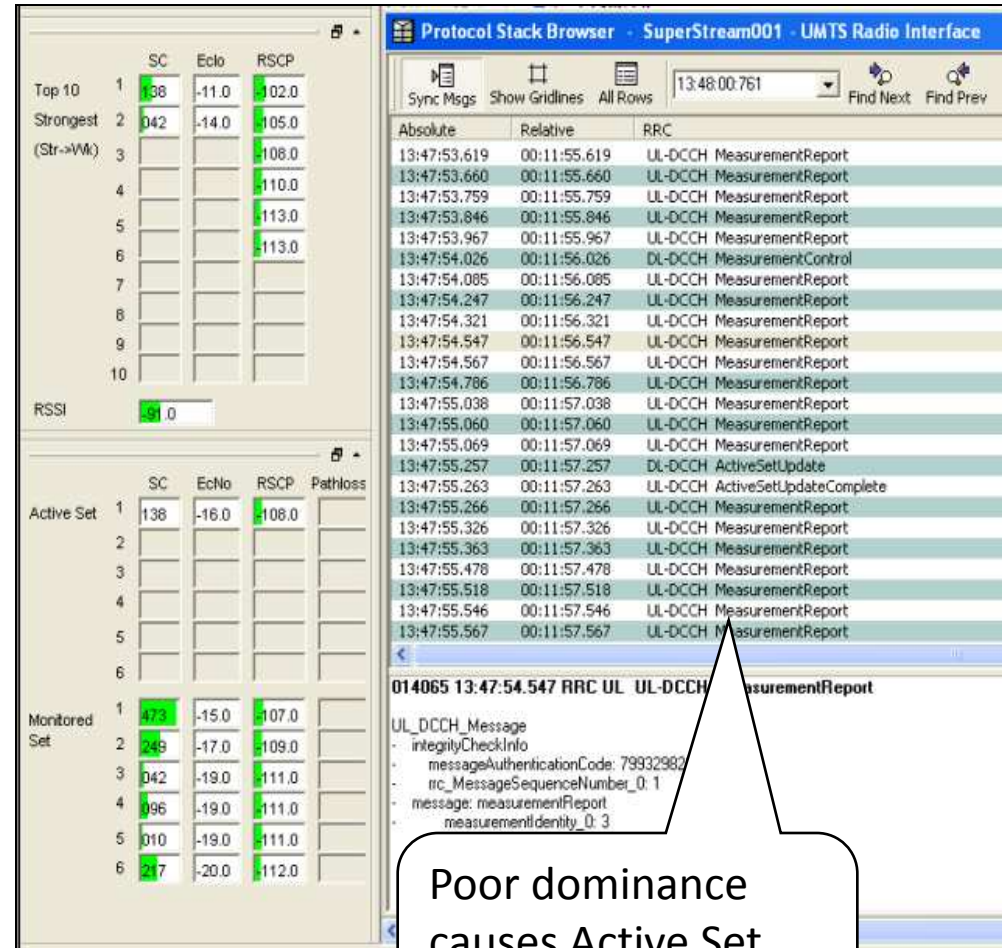
Drop call failures – RF issue

- RF drops mostly due to poor dominance or interference
- Poor coverage could lead to ISHO, although poor dominance or interference can cause ISHO to fail.
- Rapid field drop can cause drop due to coverage
- Poor dominance or interference can cause Compressed Mode (CM) to start even if RSCP is still good.
- In CM UE transmits with higher power (more interference) and spends less time on 3G (less accurate measurement reporting)
- Poor dominance or interference can lead to Active Set update failures and eventually to drop call.

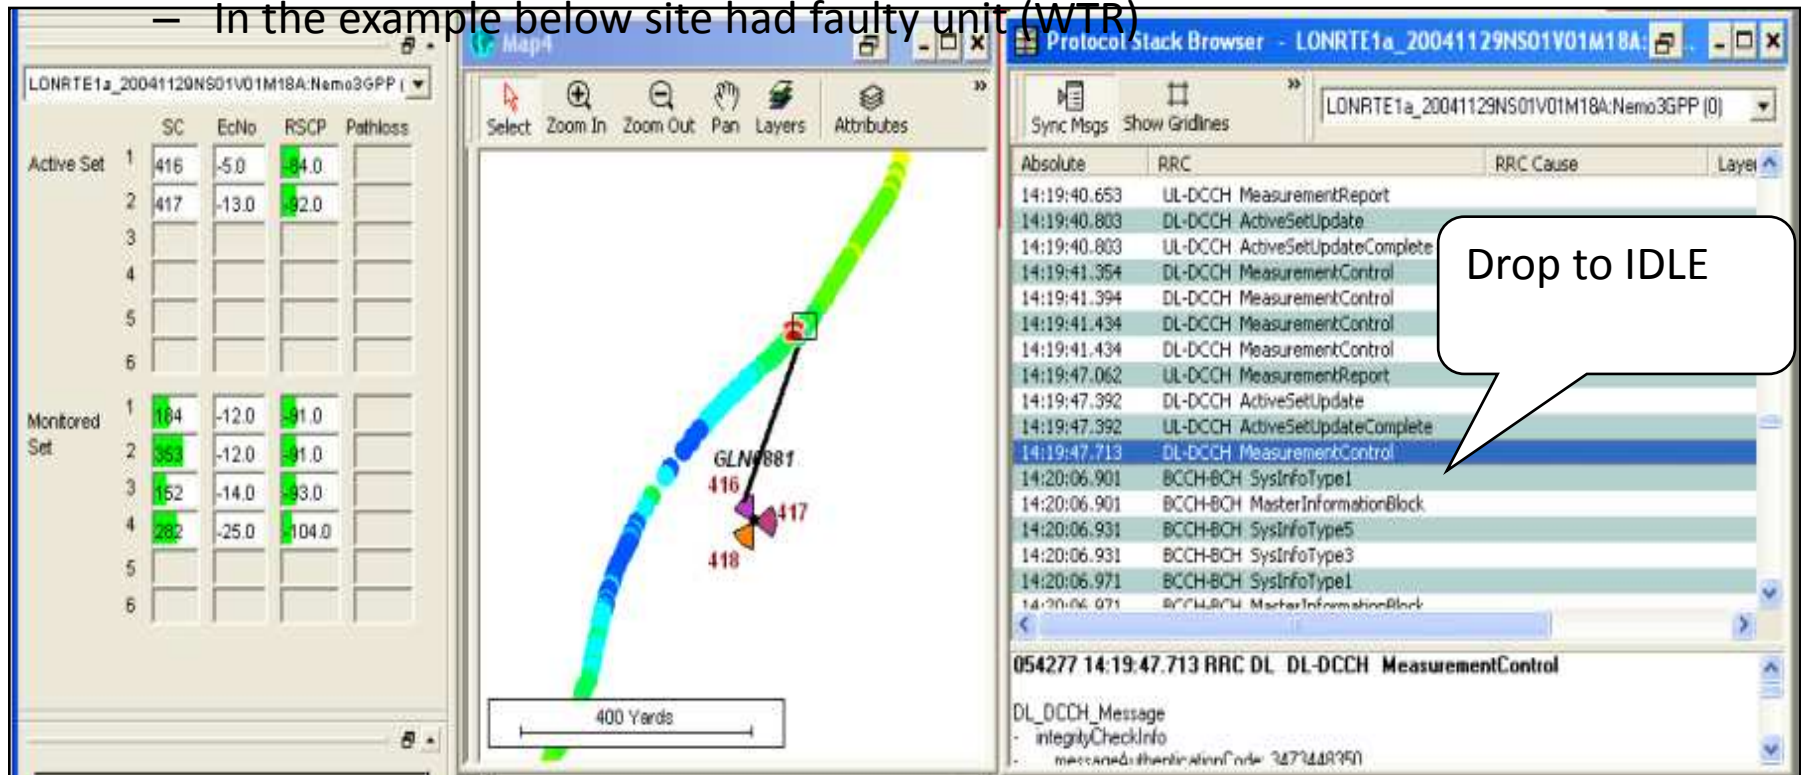
Drop call failures – System issue BTS

- Sudden drop to idle, no disconnect messaging
 - Site malfunctions to be checked
 - In the example below site had faulty unit (WTR)

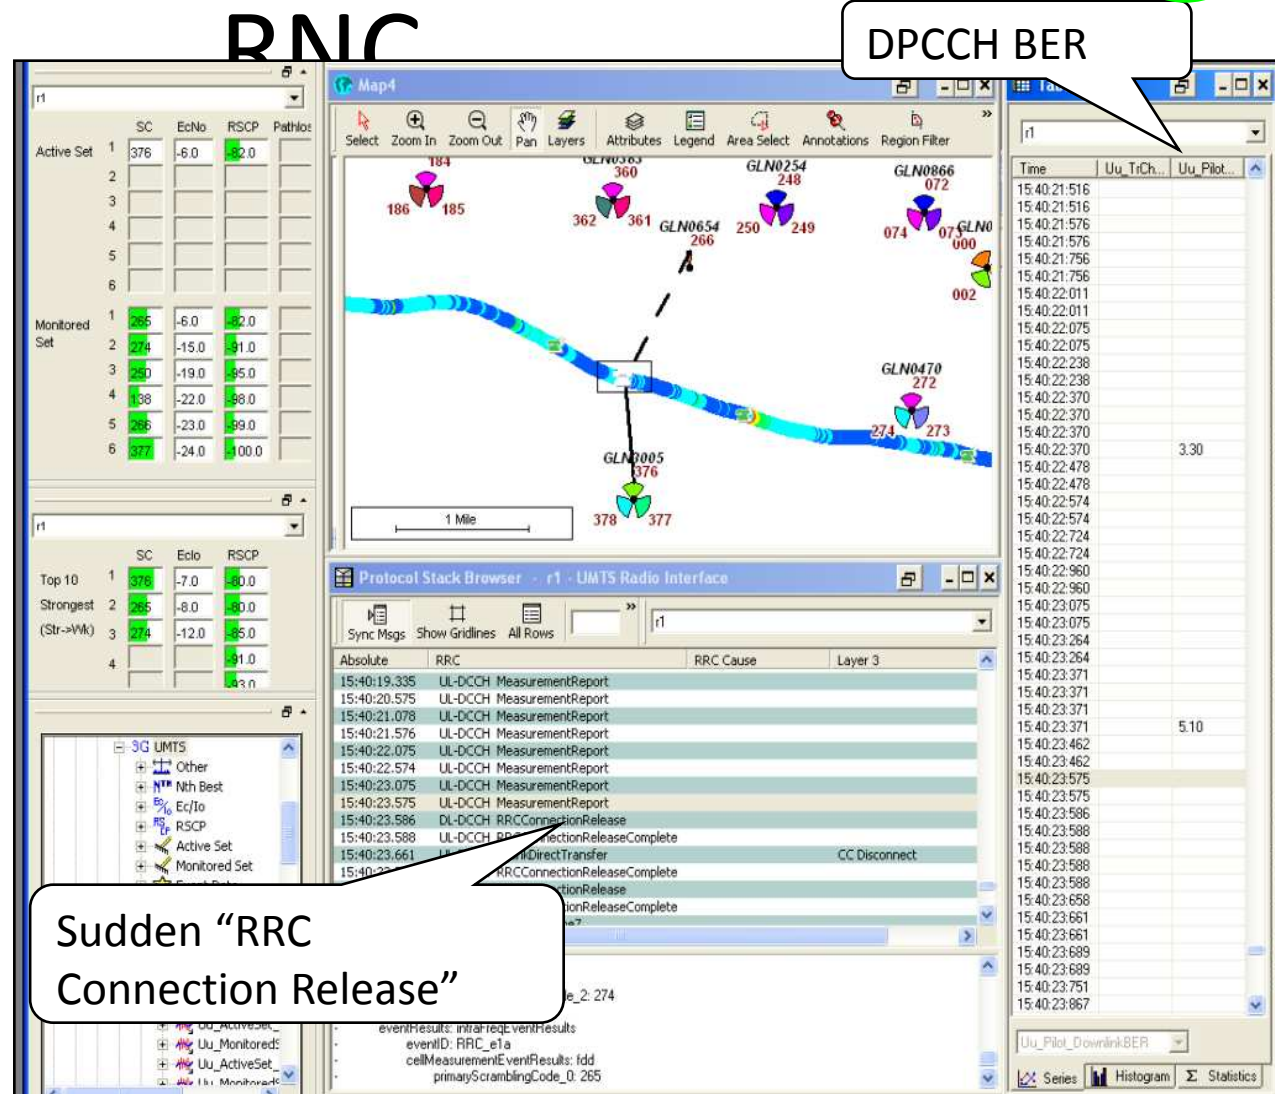
Drop call failures – System issue B

- “CC Disconnect” due to “DL RRC Connection Release”
- No response to UL Measurement Reports
- In the example site had no alarms, good RF & BER
- Not able to add SC265 to Active Set, next call on the same cell => no failure.
- Difficult to troubleshoot if the failure does not happen systematically => follow up in the next weeks drive / do a separate drive test in the area

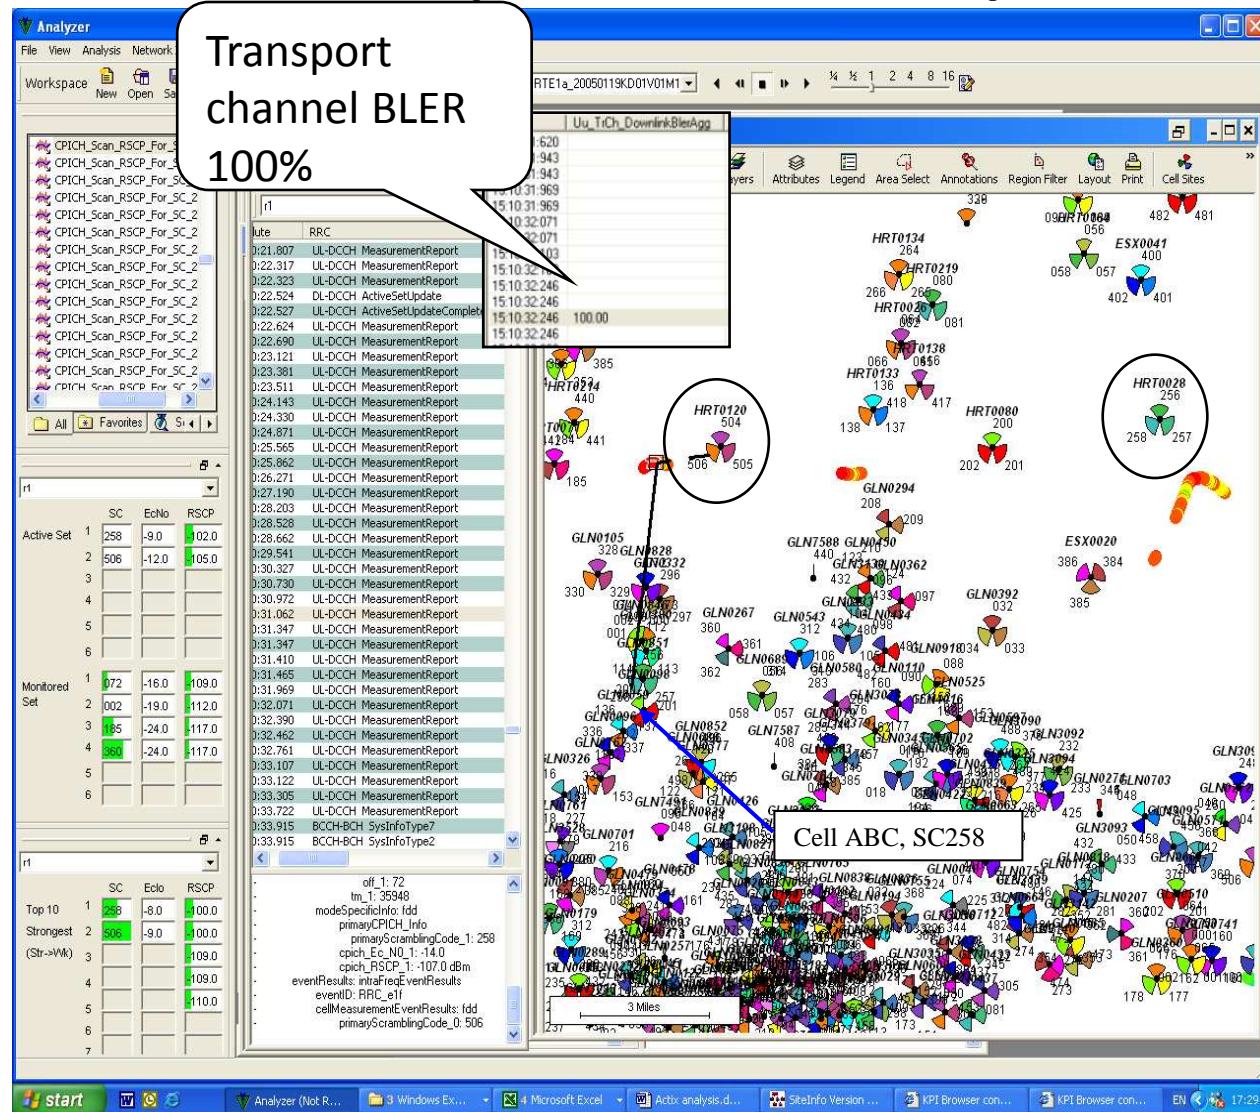
Drop call failures (SC conflict)

- Sudden drop to idle mode (no disconnect messaging)
- Cause of the failure: overshooting site and SC reuse
- Short term solution to add overshooting neighbour in ADJS definitions

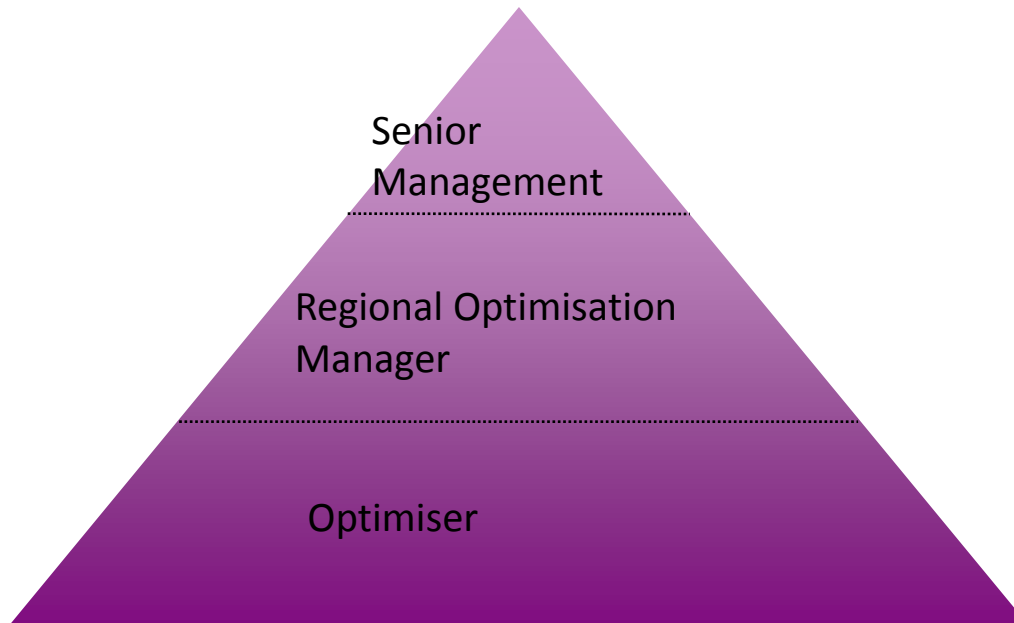
Drive Test Analysis – Reporting Levels

- Very High Level KPIs that give a users perception of the network (Network KPI)
 - KPIs that provide an Engineering view of network performance e.g CSSR, CDR, OCSR, SHO performance. (KPIs required for each optimisers area)
 - Highly detailed KPIs that give a detailed picture of network performance at an Engineering level and allow root cause analysis
-
- The different reporting levels may want to see KPIs based on different cuts of the data (e.g. raw or end user)
 - Processing Drive Data to provide the information required at the bottom level means that the higher level information can be easily extracted

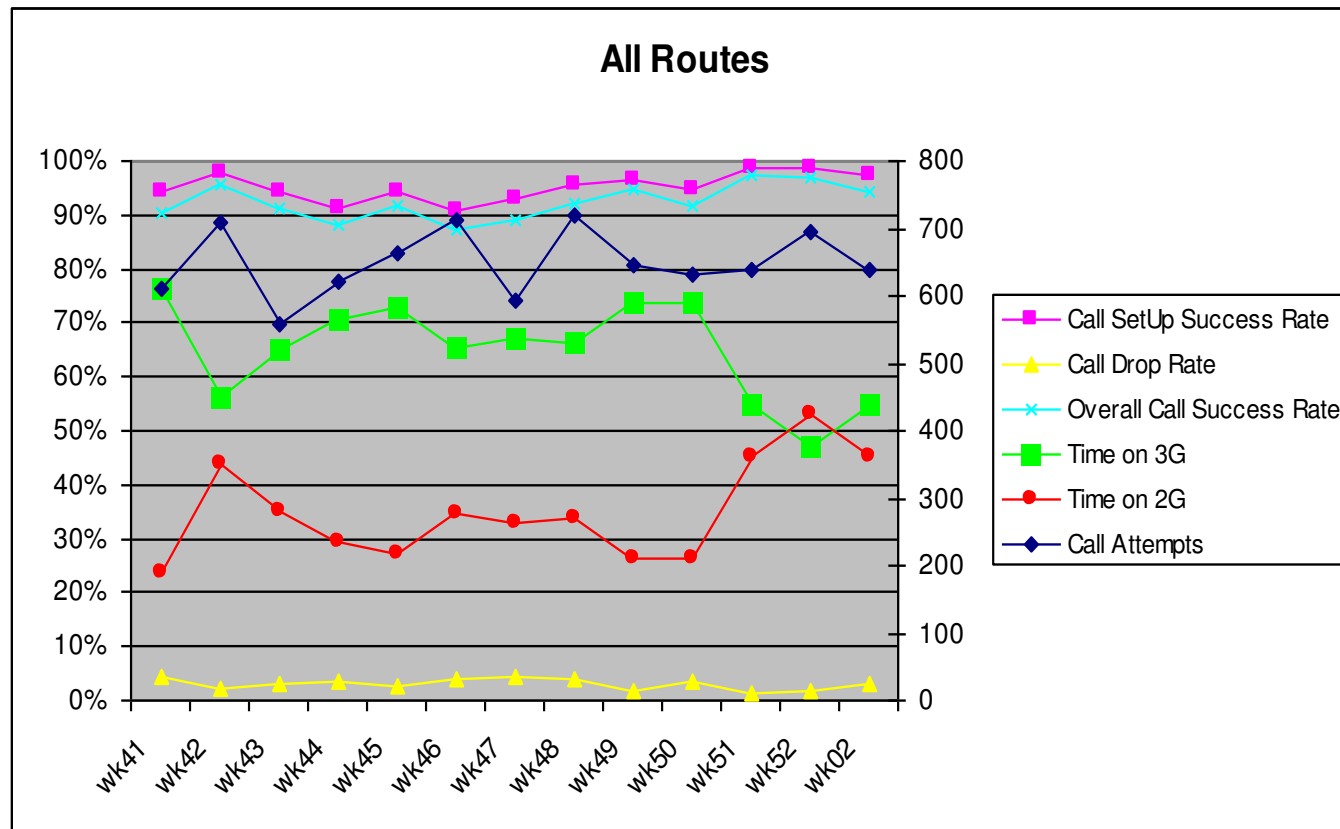
KPI reporting

- Weekly KPI trends (non-genuine failures should be excluded)

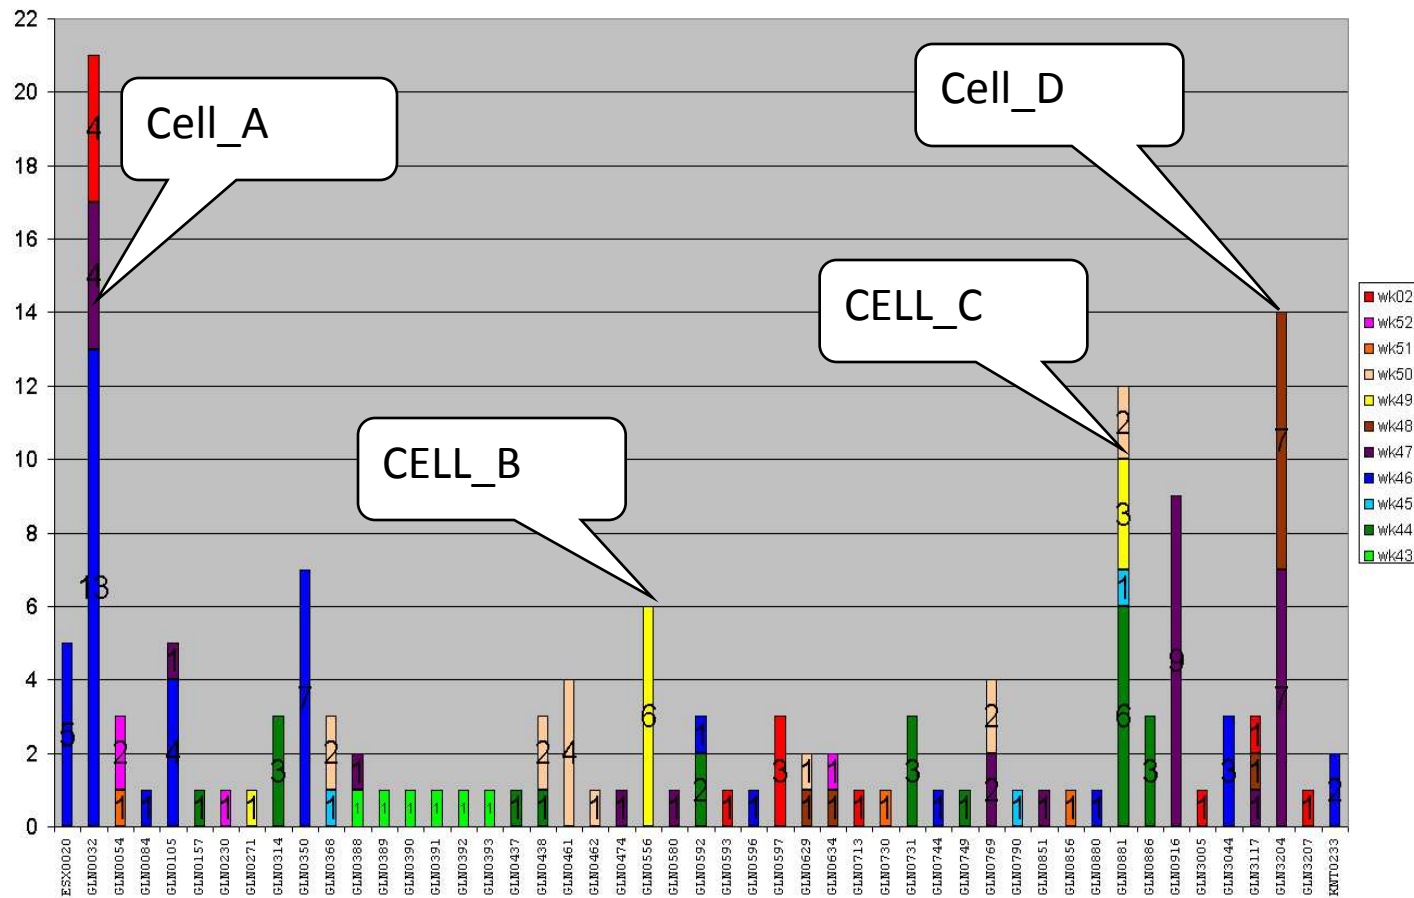
BTS failure chart (call setup failure & drops)

- Cumulative number of failures that occurred per site over time
- If the UE is spending only a small percentage of time on 3G problems may not be identified.
