FRONT CRASH SENSOR INSPECTION AND REPLACEMENT

AFFECTED VEHICLES: CERTAIN 2001 MODEL YEAR TOWN CAR AND WINDSTAR

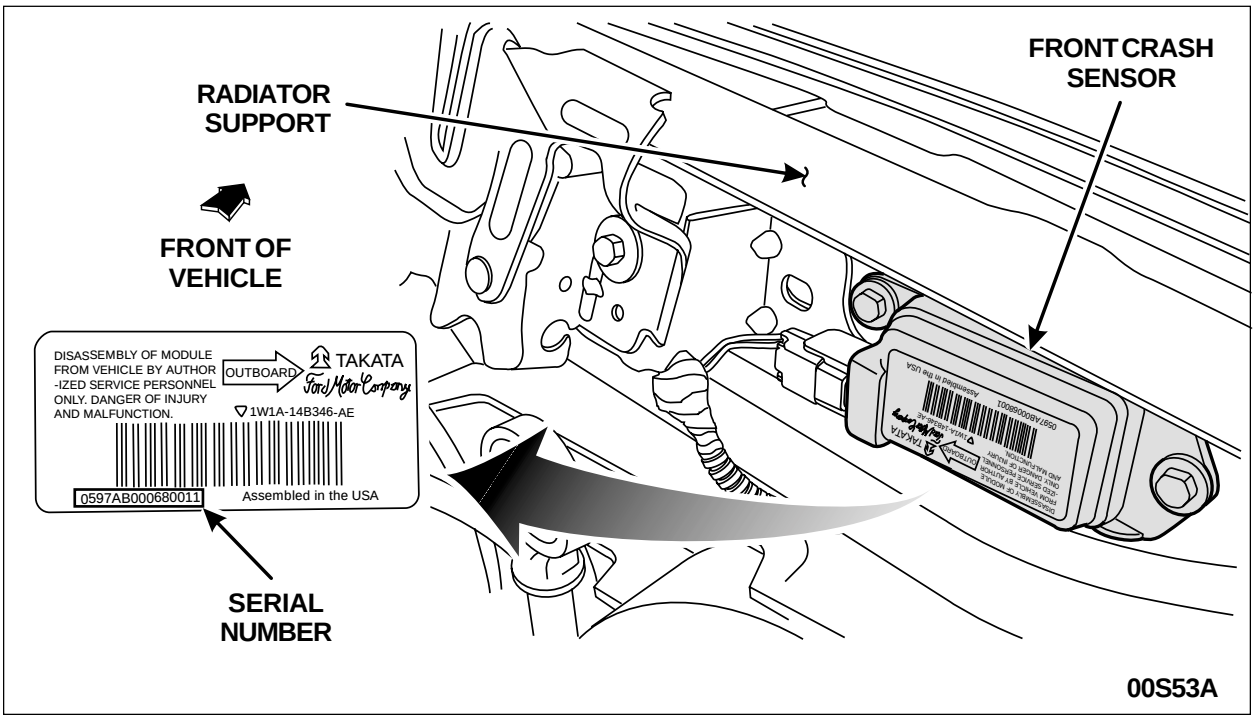
FIGURE 1

Locate the front crash sensor on the back of the radiator support and record the serial number. Refer to Figure 1.

- If the serial number is listed in the Affected Serial Number Chart on Page 4, replace the front crash sensor. Refer to the service procedure in section 501-20B in the appropriate Workshop Manual.
   - If the serial number is **NOT** listed in the Affected Serial Number Chart on Page 4, replacement of the front crash sensor is not required, the vehicle may be released.

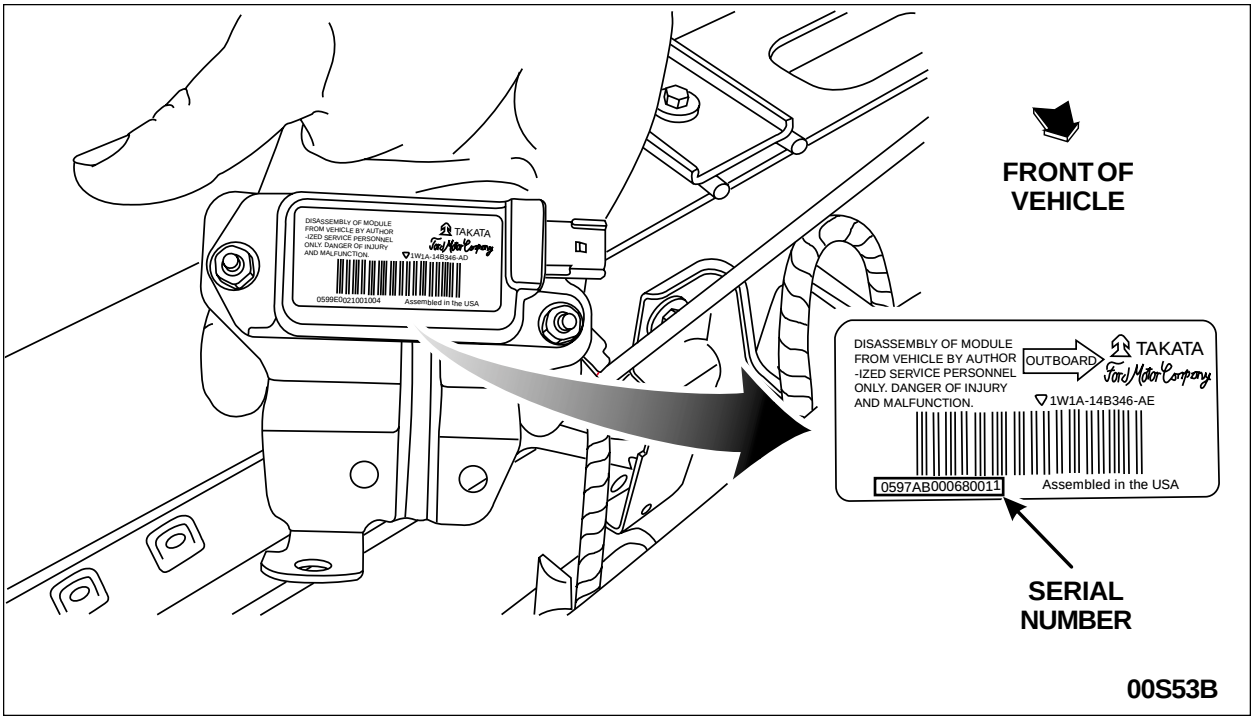
FIGURE 2

Record the serial number on the front crash sensor. See Figure 2.
   - If the serial number is listed in the Affected Serial Number Chart on page 4, replacement of the front crash sensor is required. Discard the sensor and install a ***new*** one. Refer to the service procedure in section 501-20B in the appropriate Workshop Manual.
   - If the serial number is **NOT** listed in the Affected Serial Number Chart on page 4, replacement of the front crash sensor is not required. Proceed with this procedure.

7. Install and connect the original front crash sensor. Tighten the bolts to 12 Nm (9 lb-ft).
8. Install the radiator sight shield.
9. Connect the battery ground cable.
10. Repeat the system prove out as described in step 1.
