CATALYST MONITOR SENSOR CONNECTOR INSPECTION

AFFECTED VEHICLES: CERTAIN 2002 MODEL YEAR THUNDERBIRD

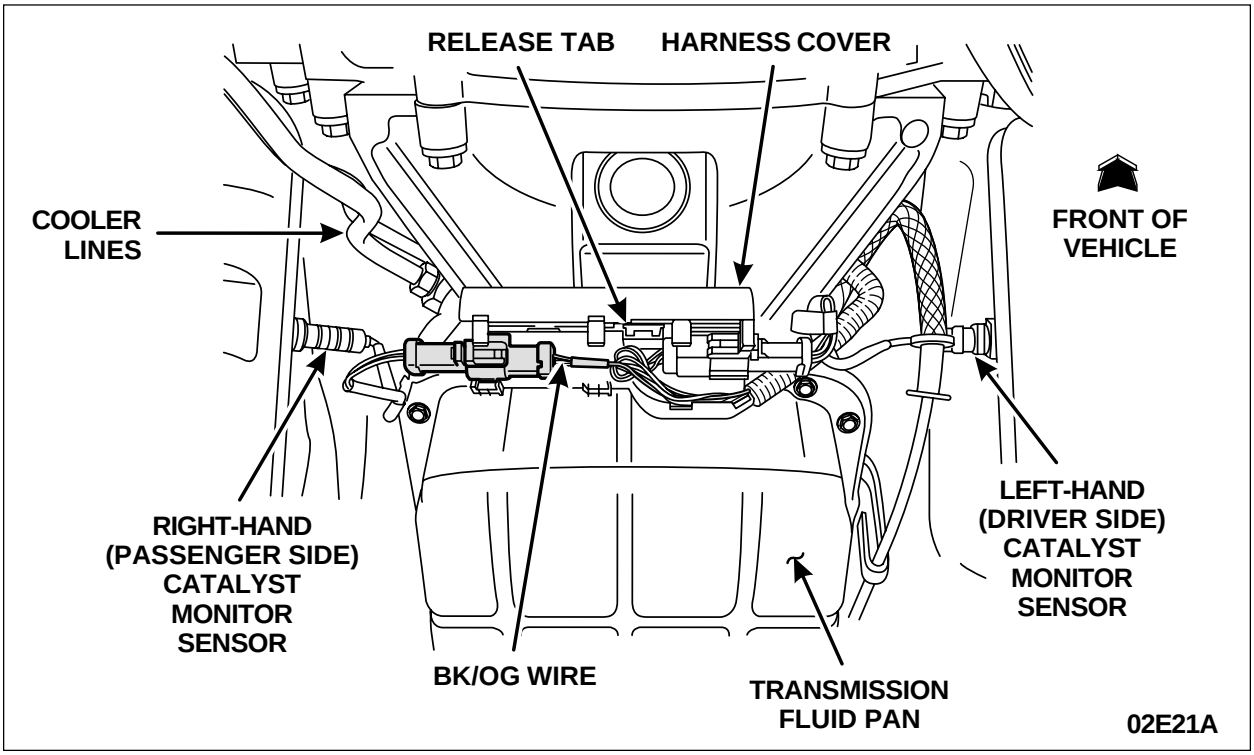
FIGURE 1

The connectors for the catalyst monitor sensors (CMS) may be reversed. The harness will be inspected to determine if the connectors are routed to the proper CMS. If required, some disassembly of the harness will be necessary to switch the position of the connectors. Self-tests will be performed to verify the repair and to clear any diagnostic trouble codes (DTCs) related to this repair. The only DTCs related to this program are P1129 (engine running) and P0136/P0156 (continuous DTCs). If any other DTCs are found, they are not related to this program and should be diagnosed and repaired under the applicable warranty.

1. Raise the vehicle on a hoist.
2. Open the harness cover located in front of the transmission fluid pan. See Figure 1.
3. Locate the black with orange striped (BK/OG) wire in the harness and determine if it is correctly routed and connected to the right-hand CMS (toward transmission cooler lines). See Figure 1.
   - If the BK/OG wire is connected to the right-hand CMS, close the harness cover and lower the vehicle. Proceed to step 10.
   - If the BK/OG wire is connected to the left-hand CMS, continue to the next step.
4. Disconnect the right- and left-hand CMS connectors. See Figure 1.
5. Depress the release tab and slide the harness cover off the mounting bracket. See Figure 1.
