NOISE—WINDNOISE FROM THE “A” PILLAR AREA	Article No. 02-17-8

FORD: 2001-2003 MUSTANG

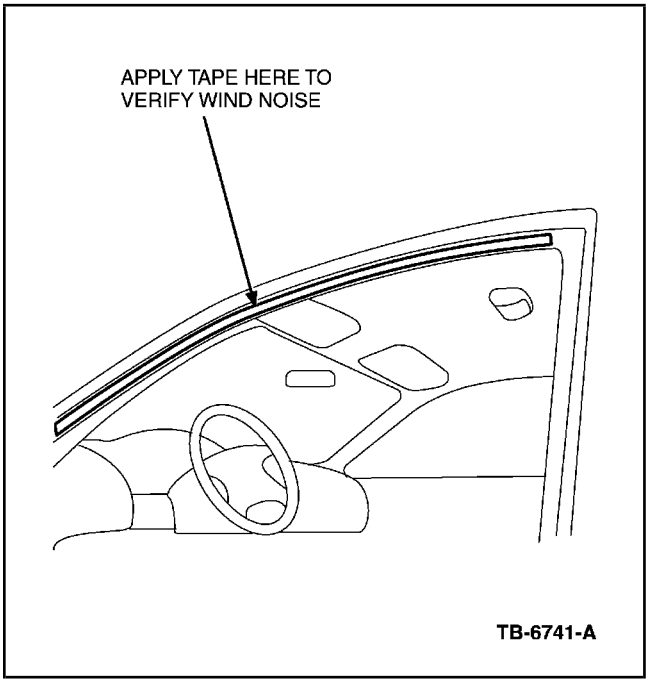
Figure 1 - Article 02-17-8

Some 2001-2003 model year Mustangs may exhibit a whistle type windnoise from the “A” pillar area. This may be caused by wind moving over the fastener holes of the “A” pillar applique.

1. Verify windnoise by placing tape the length of the “A” pillar applique (roof moulding) on the door glass side (Figure 1).
2. Drive vehicle and verify that the wind noise is gone.
3. If the noise remains, do not continue with this article. Refer to Workshop Manual Section 100-04 for further diagnosis.
4. If the tape eliminates the noise, remove the tape and remove the A-pillar applique per the Workshop Manual (Section 501-08). Do not continue with the removal of the C-pillar trim.
5. Place foam block 2R3Z-63518C46-AA over third retaining hole in applique (Figures 2 and 3).
6. Re-install applique.
