# **Revision Guide for AMD Family 19h Models 00h-0Fh Processors**

Publication # <b>56683</b>	Revision: <b>1.04</b>
Issue Date: <b>July 2021</b>

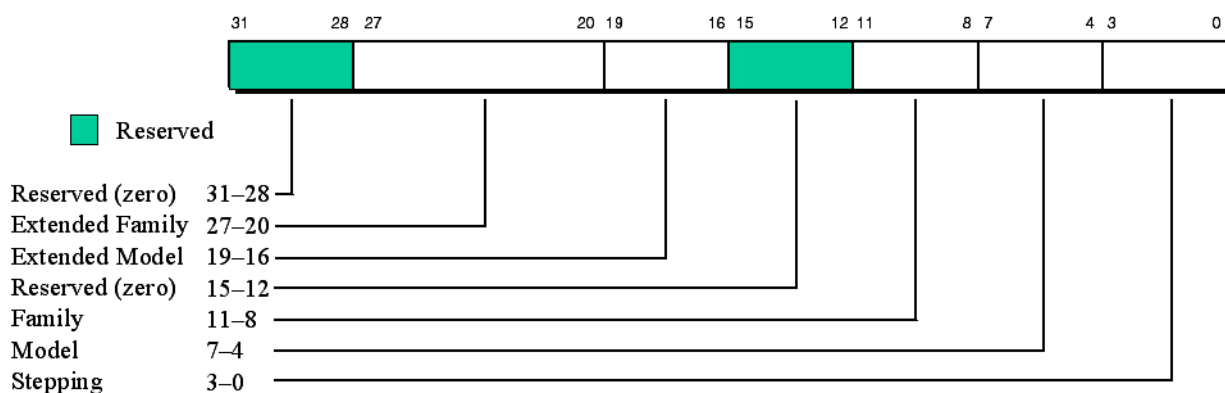
**Figure 1. Format of CPUID Fn0000\_0001\_EAX**

A processor revision is identified using a unique value that is returned in the EAX register after executing the CPUID instruction function 0000\_0001h (CPUID Fn0000\_0001\_EAX). Figure 1 shows the format of the value from CPUID Fn0000\_0001\_EAX.
