8th and 9th Generation Intel® Core™ Processor Family

Specification Update

***Supporting 8th Generation Intel® Core™ Processor Families for
S/H/U Platforms, formerly known as Coffee Lake***

***Supporting 9th Generation Intel® Core™ Processor Families
Processors for S/H Platforms, formerly known as Coffee Lake
Refresh***

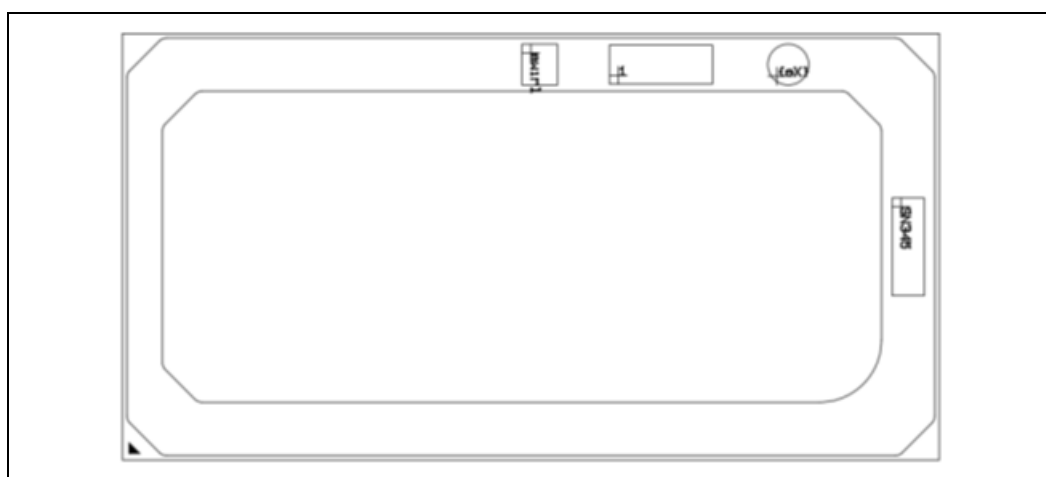
Figure 2-3. U-Processor Line Multi-Chip Package BGA Top-Side Markings

Pin Count: 1528

Package Size: 46 mm x 24 mm
