SUSPENSION—HARSH RIDE—SUSPENSION SITS LOW IN FRONT	Article No. 02-21-16

FORD: 2003 CROWN VICTORIA

MERCURY: 2003 GRAND MARQUIS

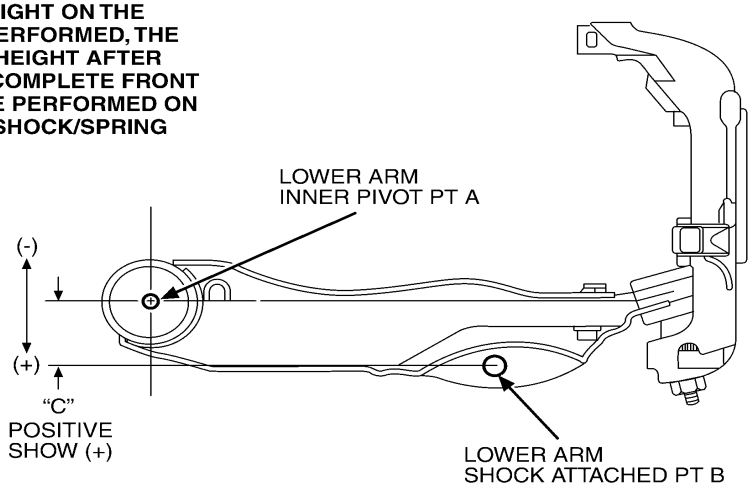
Figure 1 - Article 02-21-16

a. Measure the distance from the Lower Control Arm (LCA) inner pivot point A (bolt center) to the ground.
    b. Measure the distance from the shock attachment B (bolt center) to the ground.

c. Subtract b. from a. and the front ride height should be at a minimum of 60 mm. (Figure 1).
3. If the vehicle is below 63 mm but above 57 mm, remove existing springs and replace with 3W1Z-5310-EA. Refer to Section 204-01 of the Workshop Manual for replacement procedures.

FRONT SUSPENSION "C" DIMENSION PROCEDURE AT CURB WEIGHT

4. If the vehicle is below 57 mm, remove existing springs and replace with 3W1Z-5310-HA. Refer to Section 204-01 of the Workshop Manual for replacement procedures.

NOTE: FINAL SPRING BUSHING TORQUE MUST BE PERFORMED AT CURB WEIGHT ON THE VEHICLE. IF THIS IS NOT PERFORMED, THE VEHICLE MAY LOSE RIDE HEIGHT AFTER LOADING/UNLOADING. A COMPLETE FRONT END ALIGNMENT MUST BE PERFORMED ON THE VEHICLE AFTER THE SHOCK/SPRING INSTALLATION.
