7th and 8th Generation Intel® Core™ Processor Family

Specification Update

Revision 013

March 2021

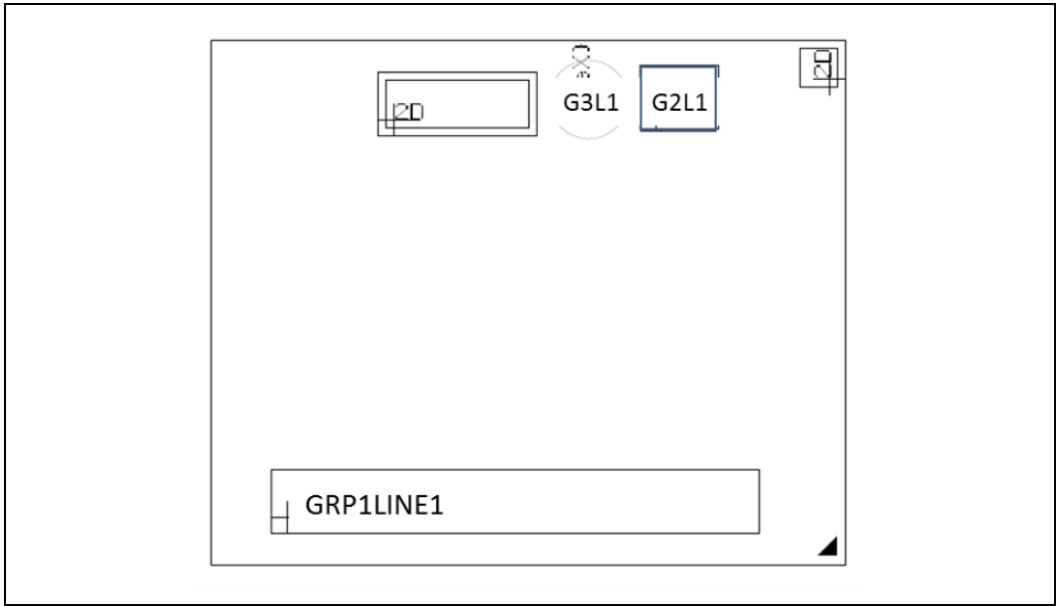
Figure 1. Y-Processor Line BGA Top-Side Markings

Pin Count: 1515

Package Size: 20 mm x 16.5 mm

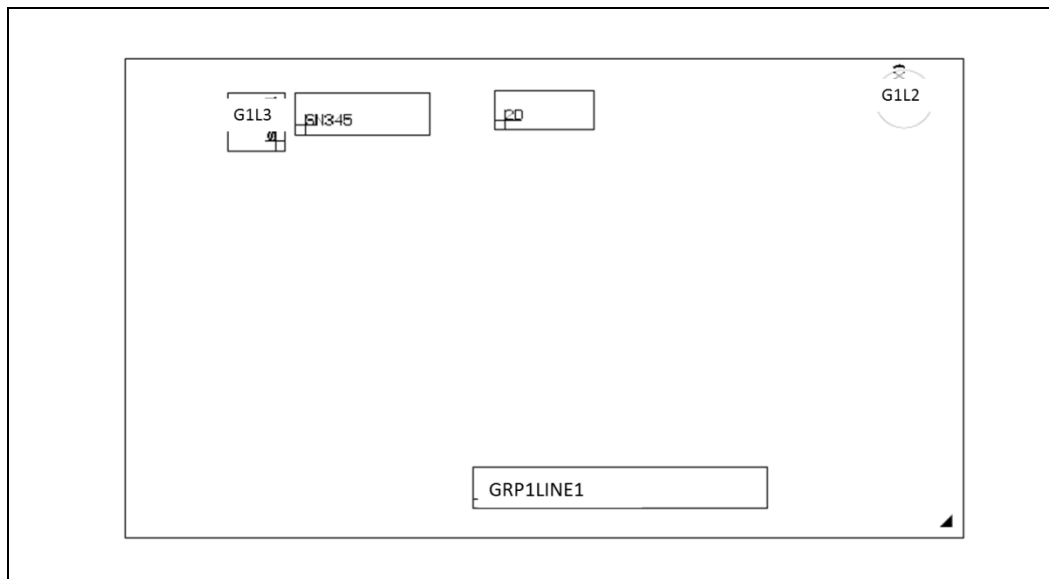
Figure 2. U/U-Quad Core Processor Line BGA Top-Side Markings

Pin Count: 1356

Package Size: 42 mm x 24 mm

GRP1LINE1:	FPOxxxxxSSPEC
GRP2LINE1 (G2L1):	{eX}
GRP3LINE1 (G3L1):	Intel logo

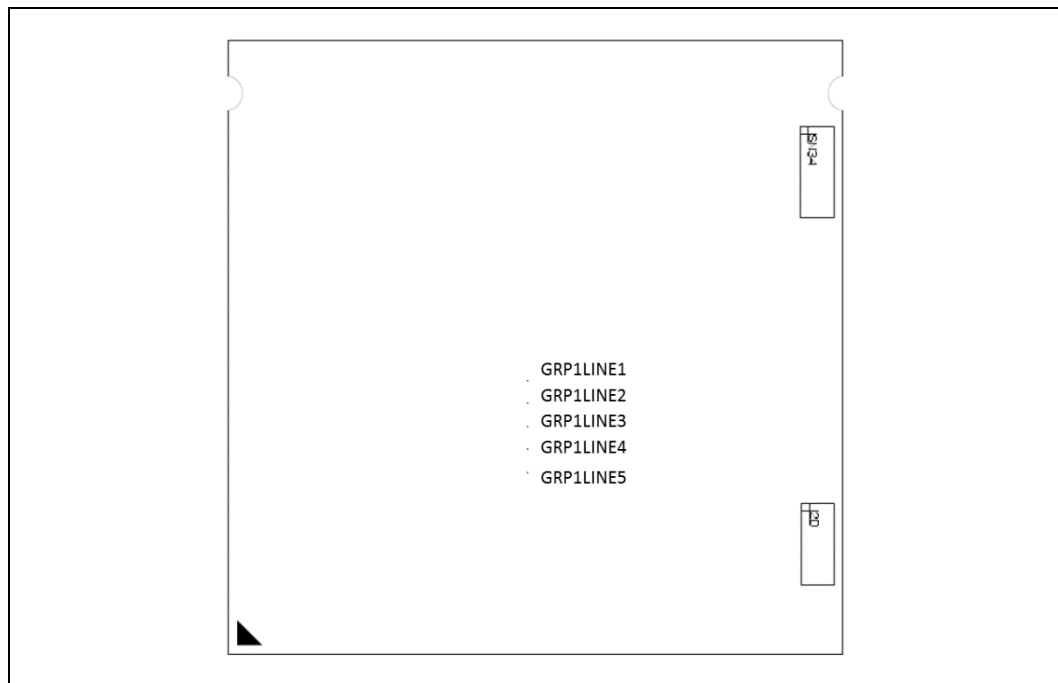
Figure 3. S-Processor Line LGA Top-Side Markings

Pin Count: 1151

Package Size: 37.5 mm x 37.5 mm

GRP1LINE1:	Intel logo
GRP1LINE2:	BRAND
GRP1LINE3:	PROC#
GRP1LINE4:	SSPEC SPEED
GRP1LINE5:	{FPO} {eX}

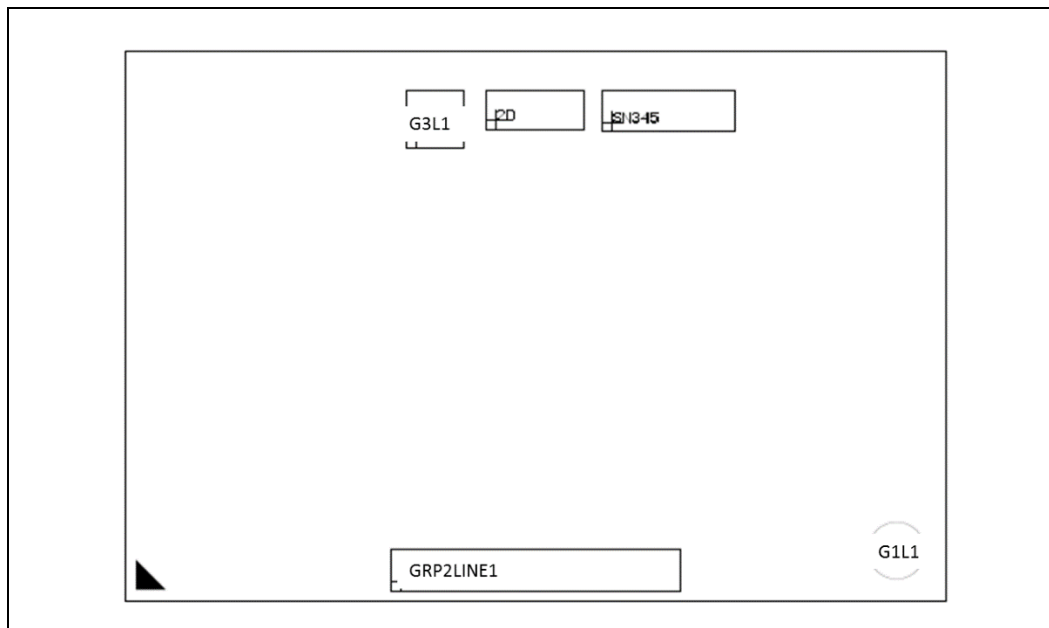
Figure 4. H-Processor Line BGA Top-Side Markings

Pin Count: 1440

Package Size: 42 mm x 28 mm

GRP1LINE1 (G1L1): {eX}
 GRP2LINE1: FPOxxxxxSSPEC
 GRP3LINE1 (G3L1): Intel logo

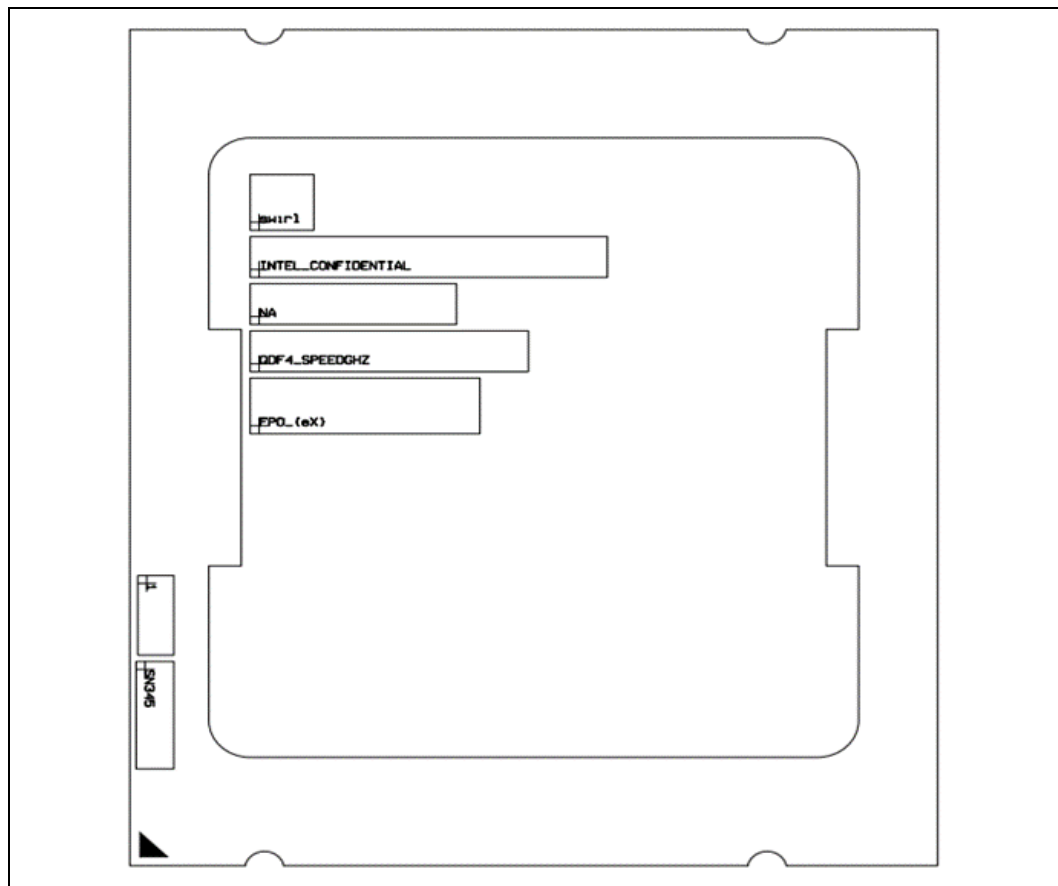
Figure 5. X-Processor Line LGA Top-Side Markings

Pin Count: 2066

Package Size: 45 mm x 52.5 mm

GRP1LINE1 (G1L1): {eX}
 GRP2LINE1: FPOxxxxxSSPEC
 GRP3LINE1 (G3L1): Intel logo

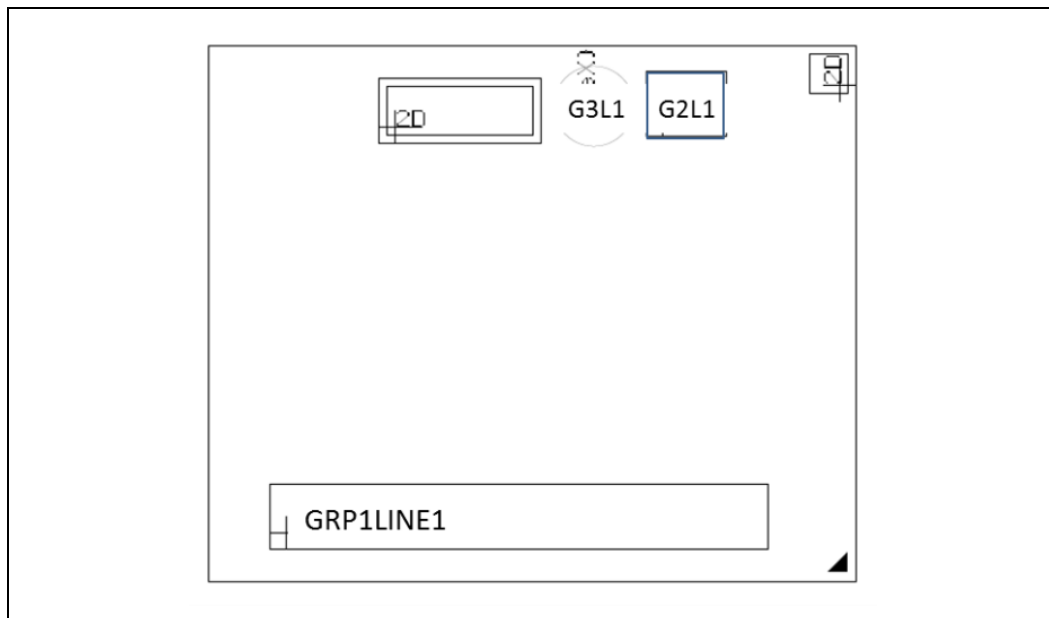
Figure 6. Y22-Processor Line Multi-Chip Package BGA Top-Side Markings

Pin Count: 1515

Package Size: 20.5 mm x 16.5 mm
