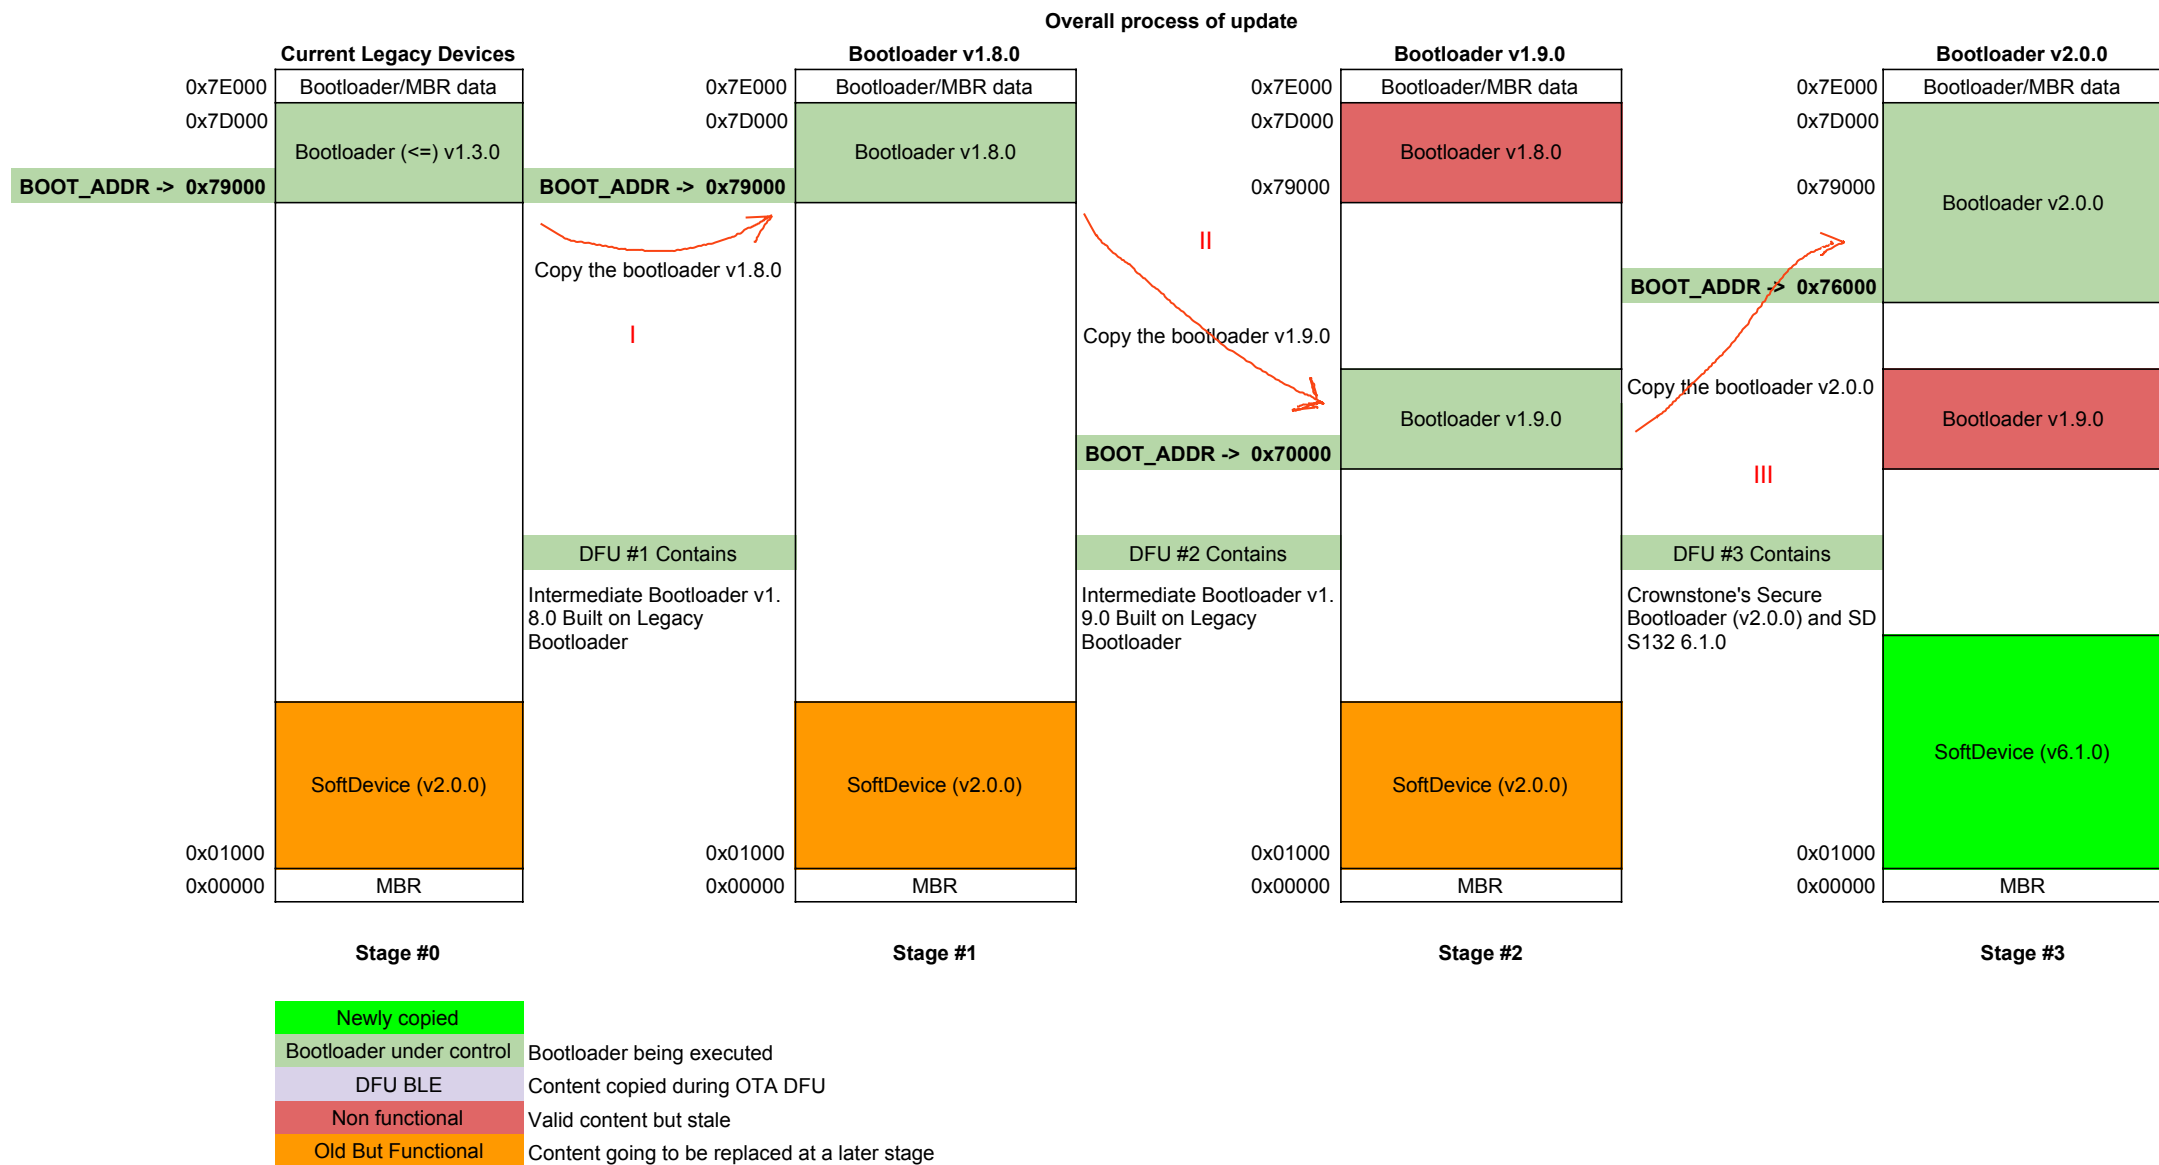
#	Process	Vulnerable	Time Taken	Failure Consequence	DFU Content	Current Boot addr
I	The bootloader (v1.8.0) is copied to the same old address (0x79000)	No	~10 secs	Will fail to write the new bootloader	Bootloader v1.8.0	0x79000
II	The bootloader v1.9.0 is sent through the DFU to be copied at 0x70000.	No	~10 secs	Will fail to copy and set control to the new control, while the control is still at 0x79000.	Bootloader v1.9.0	0x70000
III	The secure bootloader v2.0.0 along with the softdevice v6.1.0 is copied to 0x76000 and 0x1000 respectively.	No	~25 secs	* evaluated in a separate table	Bootloader v2.0.0 + Softdevice v6.1.0	0x76000
