BRAKE PEDAL POSITION SWITCH WIRE ROUTING INSPECTION AND REPAIR

AFFECTED VEHICLES: CERTAIN 2000 F-53 MOTORHOME CHASSIS

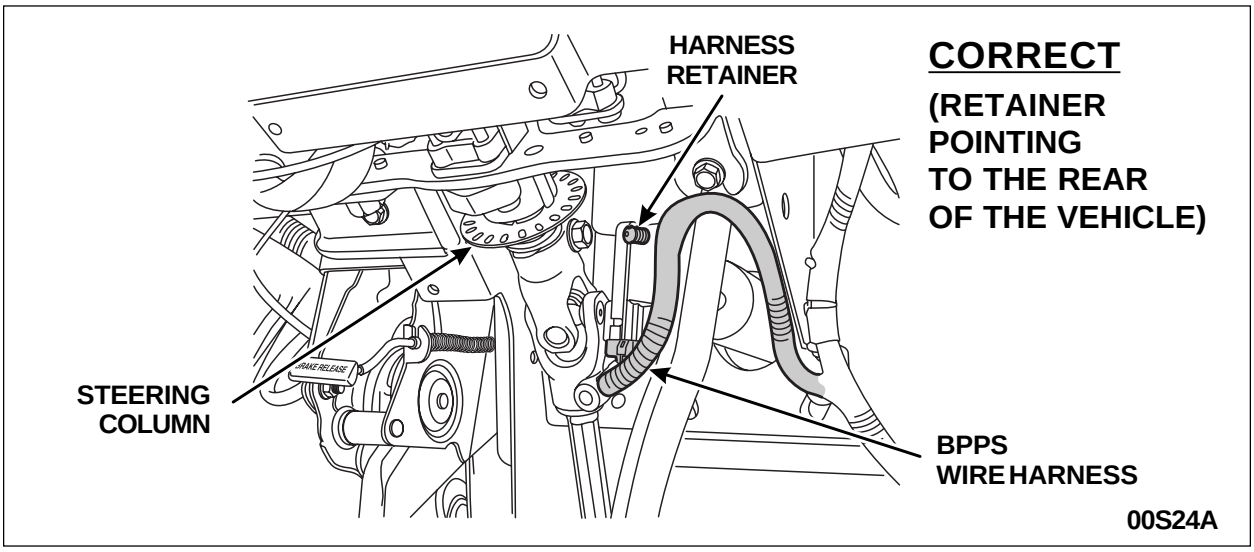
FIGURE 1

1. Remove the steering column shrouds necessary to gain access to the Brake Pedal Position Switch (BPPS).
2. Inspect the wiring harness to see if it is routed properly. See Figures 1 and 2.
   a) **CORRECTLY ROUTED HARNESS**: The harness retainer (which secures it to the switch) will be installed from the front toward the back and the harness will be routed away from all steering column rotating parts. See Figure 1.
   b) **INCORRECTLY ROUTED HARNESS**: The harness retainer will be installed from the back to the front and the harness will be located very close to (if not touching) the steering column rotating parts. See Figure 2.

3. If the harness is routed properly, reinstall the steering column shrouds and return the vehicle to the owner.
4. If the harness is routed incorrectly but there is no damage to the harness, detach the retainer from the switch, reposition the wiring away from the steering column and reattach the retainer from the front toward the back. See Figure 1 for proper routing. Reinstall the shrouds and return the vehicle to the owner.
