UNIT TRIPPING REPORT

UNIT No: 2

STATION: NTPL, TUTICORIN.

REPORT NO: 89

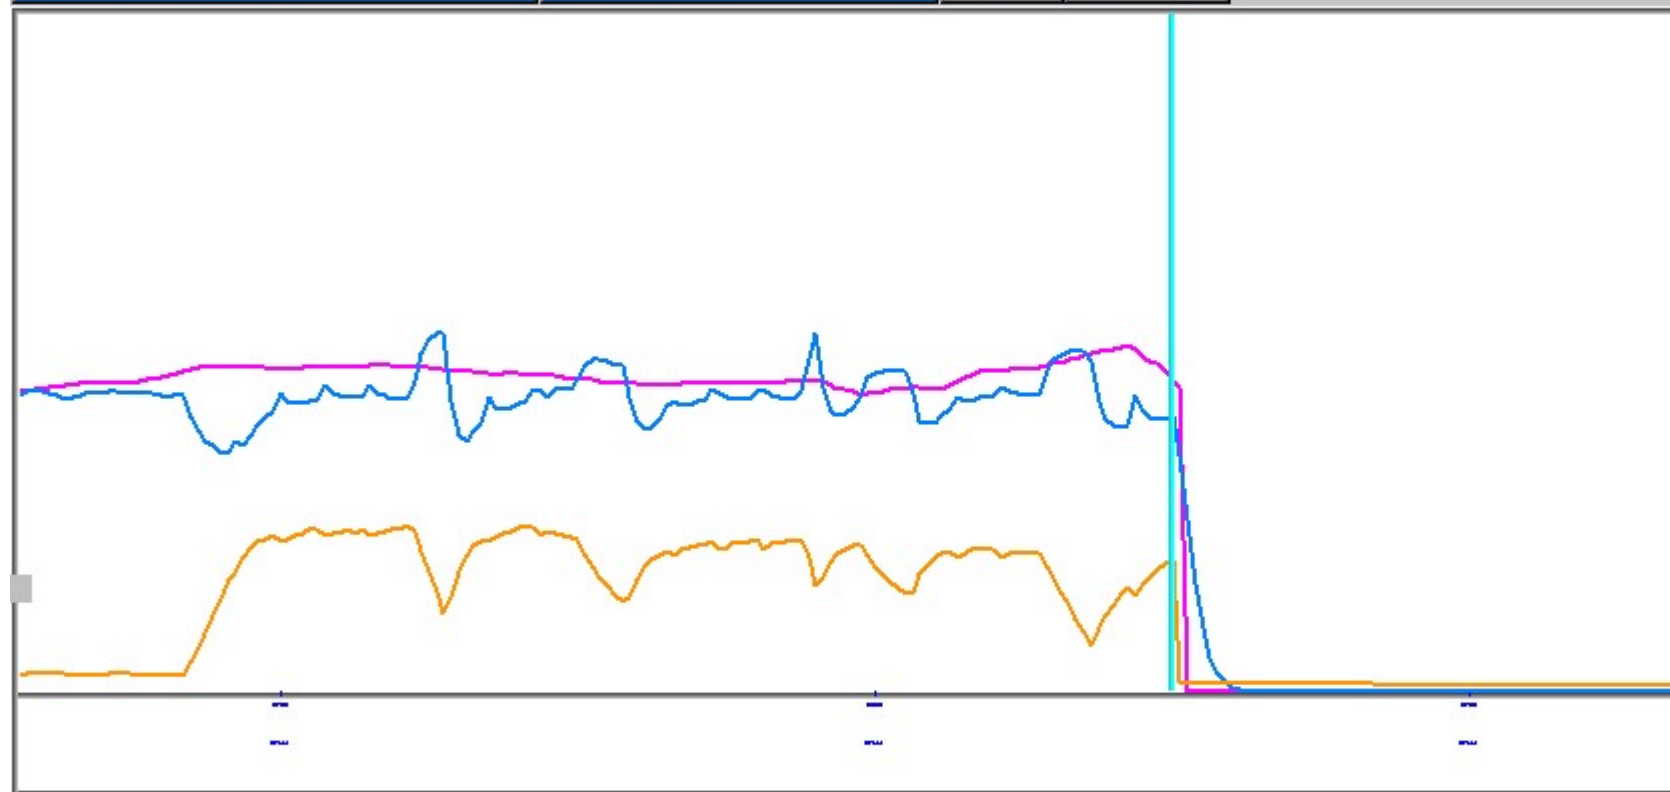
SB PRESS TX SEL

22.3815 KSC

| 6. Supporting documents attached | : S.O.E & Trends |
