• NOISE—GEAR “WHINE” HEARD IN PASSENGER COMPARTMENT • TRANSAXLE—GEAR “WHINE” NOISE HEARD IN PASSENGER COMPARTMENT	Article No. 01-5-7

MERCURY: 1999-2001 VILLAGER

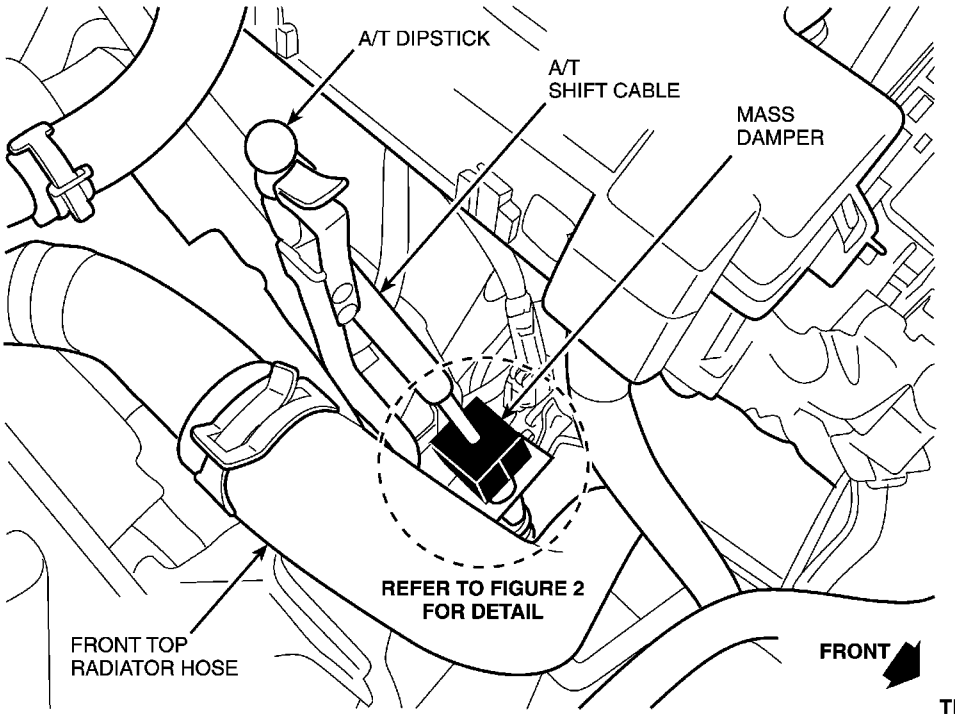
Figure 1 - Article 01-5-7

Some vehicles may exhibit a gear “whine” noise from the front under light acceleration while driving between 40 km/h (25 mph) and 113 km/h (70 mph). This condition may be due to the Automatic Transaxle (A/T) shift cable transmitting normal operational noise from the transaxle into the passenger compartment.

1. Road test the vehicle to confirm a gear whine noise is heard.
2. Install Mass Damper (XF5Z-7L256-AA) on the A/T shift cable so that it is positioned 10mm above the A/T shift cable rubber boot (refer to Figures 1 and 2).
3. Road test the vehicle to confirm the gear whine noise is resolved.
