Intel[®] Atom[™] Processor Z5xx Series

Specification Update

Intel[®] Atom[™] processor Z550, Z540, Z530, Z520, Z515, Z510, and Z500 on 45-nm process technology

Revision 013

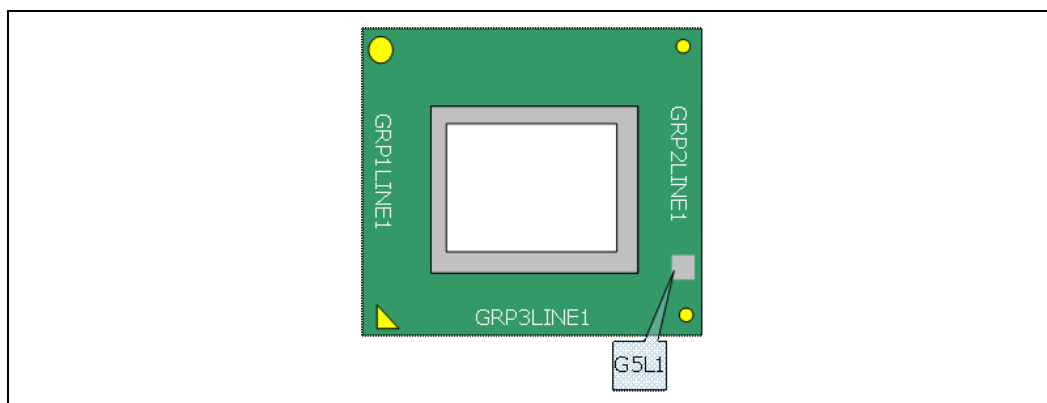
Figure 1. Intel® Atom™ Processor Z5xx Series (Micro-FCBGA) Markings

Intel® Atom™ processor Z5xx series may be identified by the following component markings.

GRP1LINE1: INTEL {M}©'07 {e1}
GRP2LINE1: <Level-4 Name><FSB>
GRP3LINE1: {FPO} S-SPEC
G5L1: 2D Matrix
