SEAT BELT BUCKLE INSPECTION AND/OR REPLACEMENT PROCEDURE

AFFECTED VEHICLES: **CERTAIN 2001 MODEL YEAR CROWN VICTORIA, EXCURSION, EXPEDITION, F-150, F-250 THROUGH 550, GRAND MARQUIS, NAVIGATOR, RANGER, TOWN CAR AND WINDSTAR**

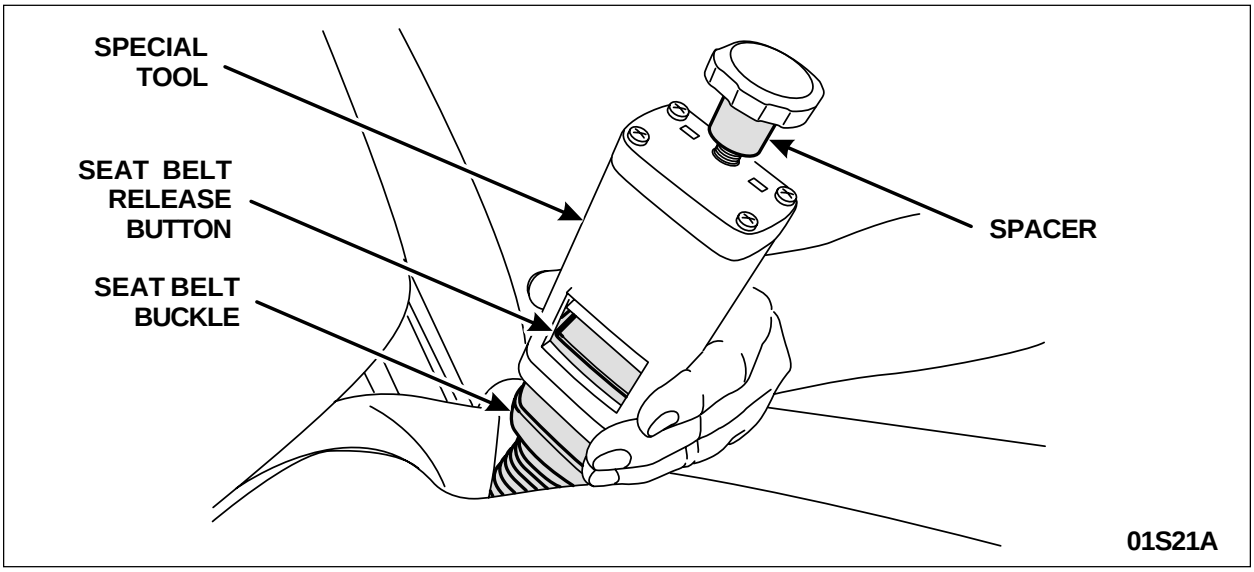
FIGURE 1

Slowly press and release the red seat belt release button located on the driver side seat belt buckle. Then, install the special tool onto the driver side seat belt buckle and hold it in place. See Figure 1.

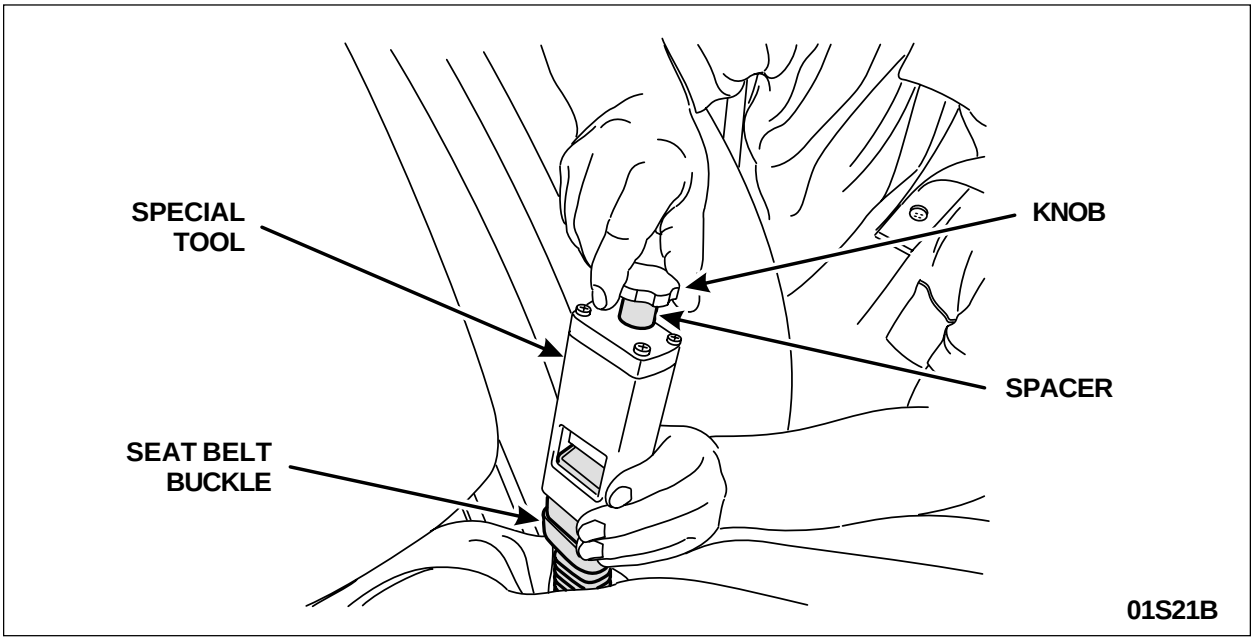
FIGURE 2

While holding the special tool in place, turn the knob on the special tool until it bottoms out. If resistance is felt while turning the knob on the special tool, it may require lubrication. Lubricate the threads on the knob shaft with Lubriplate® (130-AA) white grease or similar white lithium grease. See Figure 2.
