Intel[®] Atom[™] Processor N400 Series

Specification Update

May 2013

Revision 009

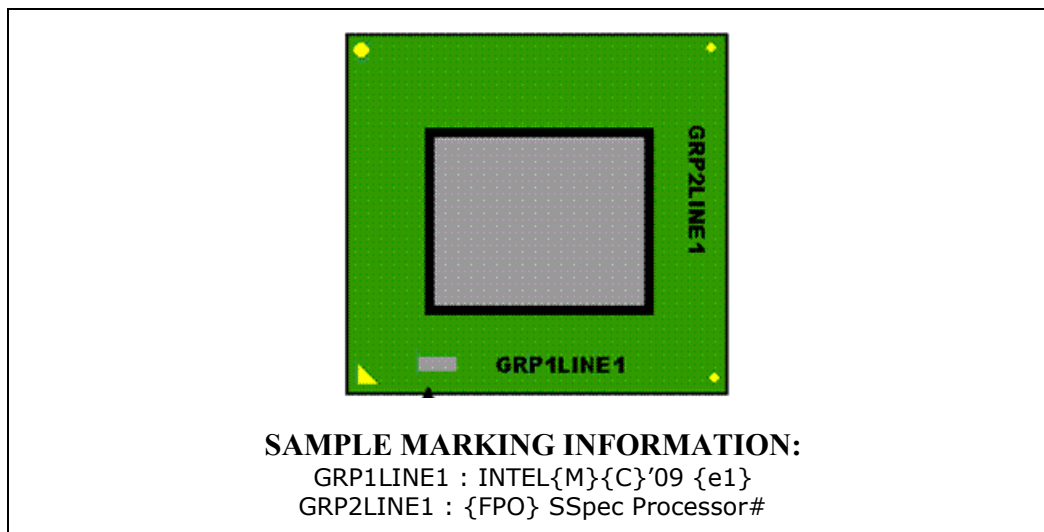
Figure 1. Intel® Atom™ Processor N400 Series (Micro-FCBGA8) Markings

The Intel® Atom™ Processor N400 series is identified by the following component markings.
