• BRAKES—STOPLAMPS INOPERATIVE—SERVICE REPAIR KIT FOR BRAKE PEDAL POSITION SWITCH WIRING CONNECTOR • ELECTRICAL—TRANSMISSION SHIFT INTERLOCK INOPERATIVE—SERVICE REPAIR KIT FOR BRAKE PEDAL POSITION SWITCH WIRING CONNECTOR	**Article No. 02-13-6**

FORD: 1998-2002 CROWN VICTORIA

LINCOLN: 1998-2002 TOWN CAR

MERCURY: 1998-2002 GRAND MARQUIS

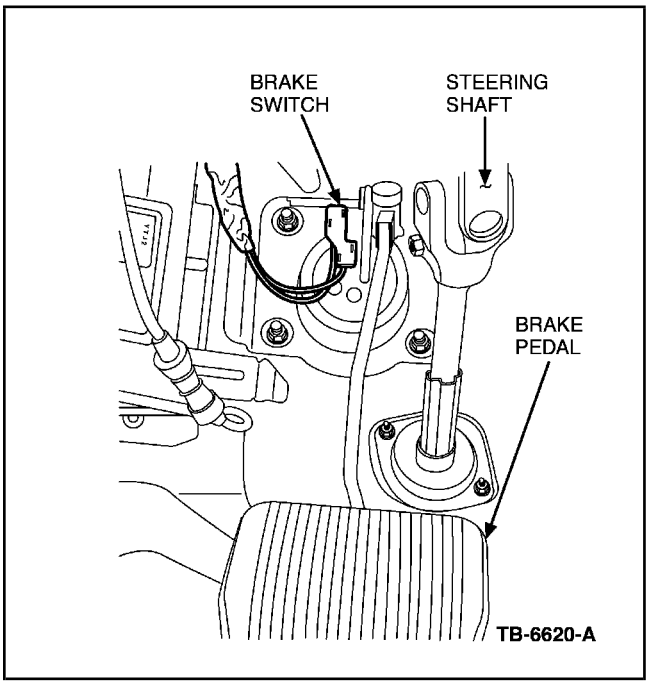
Figure 1 - Article 02-13-6

The Brake Shift Interlock may be inoperative on some vehicles, not allowing the operator to move the shift lever from the Park position. Stop Lamp operation may also be affected. This may be caused by a deformed Brake Pedal Position Switch electrical connector.

Restore Brake Pedal Position Switch operation by installing an updated electrical connector and pigtail. Refer to the following Service procedure for details.
