Intel® Atom™ Processor N500 Series

Specification Update

Revision 005

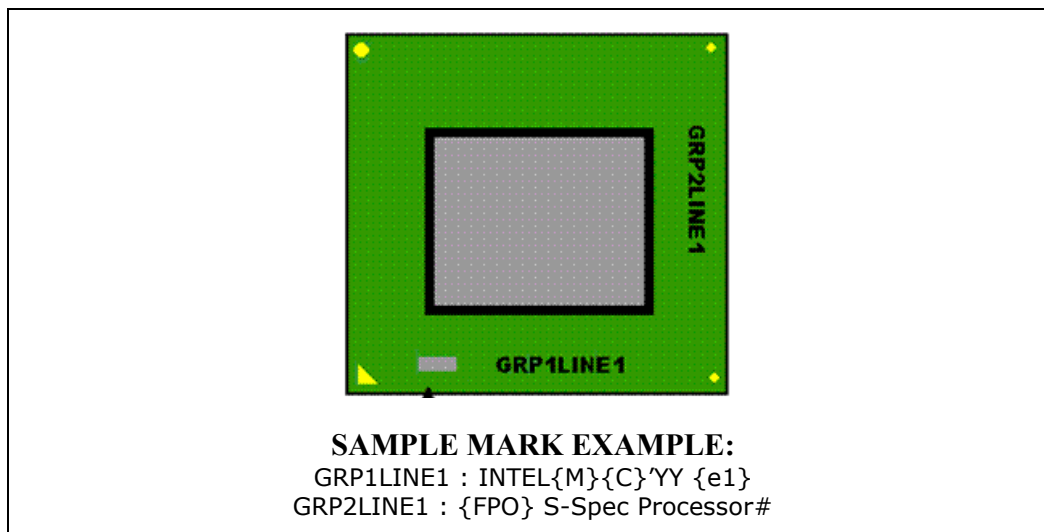
Figure 1. Intel® Atom™ Processor N500 Series (Micro-FCBGA8) Markings

The Intel® Atom™ Processor N500 series is identified by the following component markings.
