FOCUS SONY SUBWOOFER SPEAKER REPLACEMENT

AFFECTED VEHICLES: CERTAIN 2001 FOCUS SONY EDITION MODELS

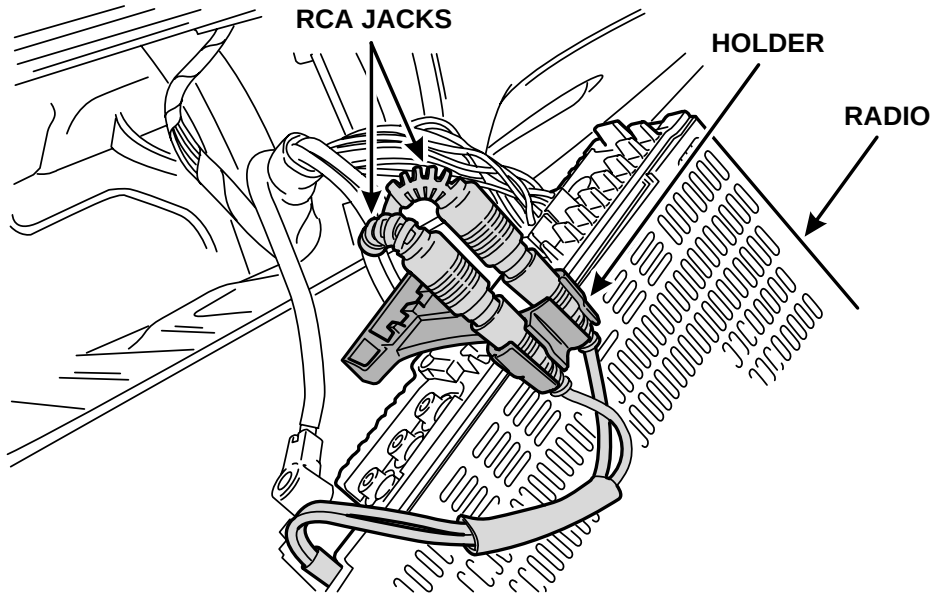
FIGURE 1

This procedure will instruct you to check and restore the subwoofer connections at the back of the radio. Both RCA jacks may have been disconnected intentionally per an earlier OASIS/SSM message. After these connections are restored, the subwoofer speaker will be replaced with one of a higher wattage rating.

1. Using two (2) pick tools or other suitable radio removal tools, remove the radio.
2. Check and if necessary, reconnect both RCA jacks at the back of the radio, then secure the jacks in the holder and reinstall the radio. See Figure 1.
