TRIM—WEAR OR HOLE IN SEAT BACK COVER AT LOWER LEFT AREA OF SEAT BACK	Article No. 02-9-10

FORD: 1999-2000 WINDSTAR

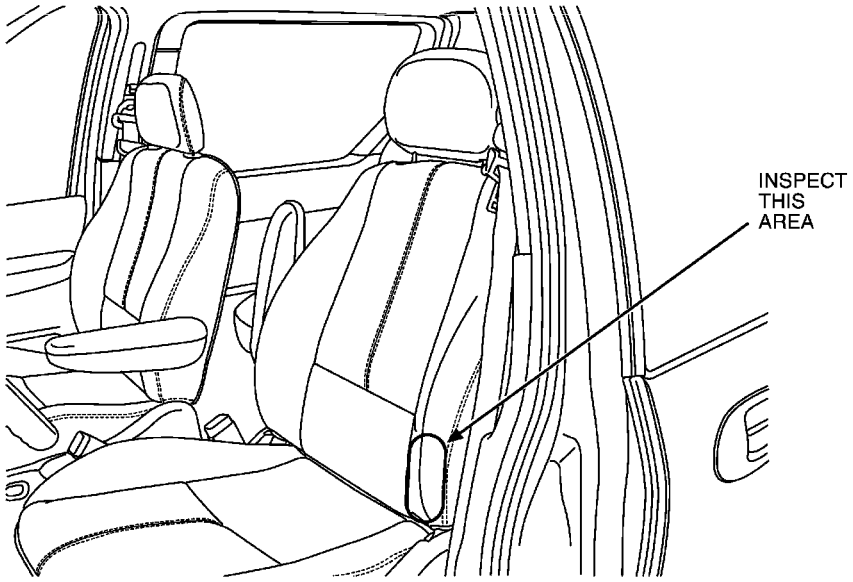
Figure 1 - Article 02-9-10

Some Vehicles built between August 1998 and January 2000 may exhibit a small hole or wear mark in the driver's side seat back cover, near the lower left area of the seat, on the seat back. This may be caused by a protruding area of the seat frame.

1. Inspect the side of the lower seat backrest closest to the drivers door (Figure 1). If there are signs of wear in the lower left corner of the seat back cover, or a hole in the seat back cover, proceed to install the protective strip covering and replace the seat back cover.
2. Remove the seat. Refer to Workshop Manual Section (501-10).
3. Remove the armrest. Refer to Workshop Manual Section (501-10).
4. Remove the two armrest studs.
5. Remove the covers for the front seat back assist handle - two covers.
6. Remove the two seat back assist handle screws.
7. Remove the headrest.
8. Disconnect the J-retainer.
9. Partially remove the seat back cover. (Necessary to gain access to headrest guides).
10. Remove the headrest guides.
11. Remove the seat back cover.
12. Install the protective strip.
