Intel® Atom™ Processor 300^Δ Series

Specification Update

April 2010

Revision 004

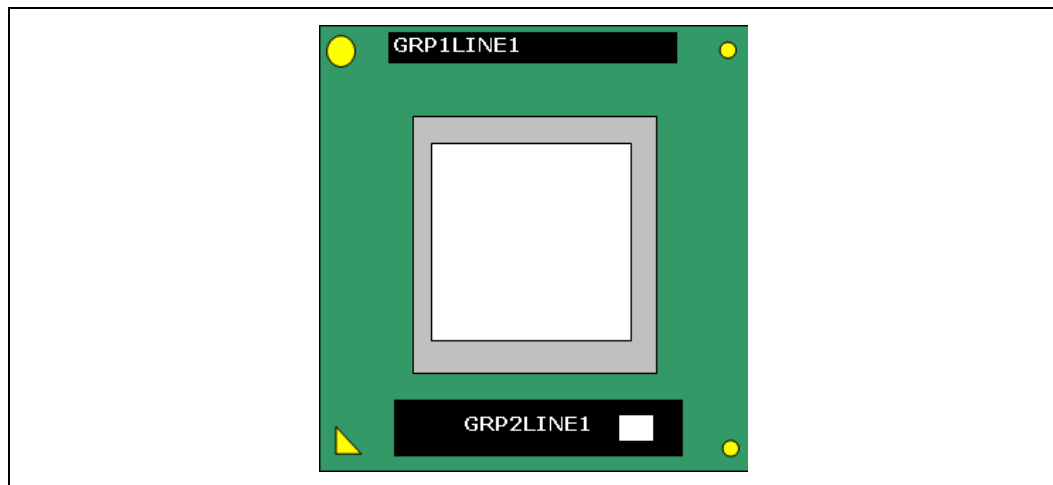
Figure 1. Intel® Atom™ Processor 300 Series (Micro-FCPGA/FCBGA) Markings

The Intel® Atom™ Processor 300 Series processor may be identified by the following component markings.
