CROWN VICTORIA POLICE INTERCEPTOR (CVPI) PACKAGE OPTIONAL UPGRADE KIT

AFFECTED VEHICLES: **CERTAIN 1992 THROUGH 2003 MODEL YEAR CROWN VICTORIA POLICE INTERCEPTOR (CVPI) VEHICLES CURRENTLY IN POLICE DUTY**

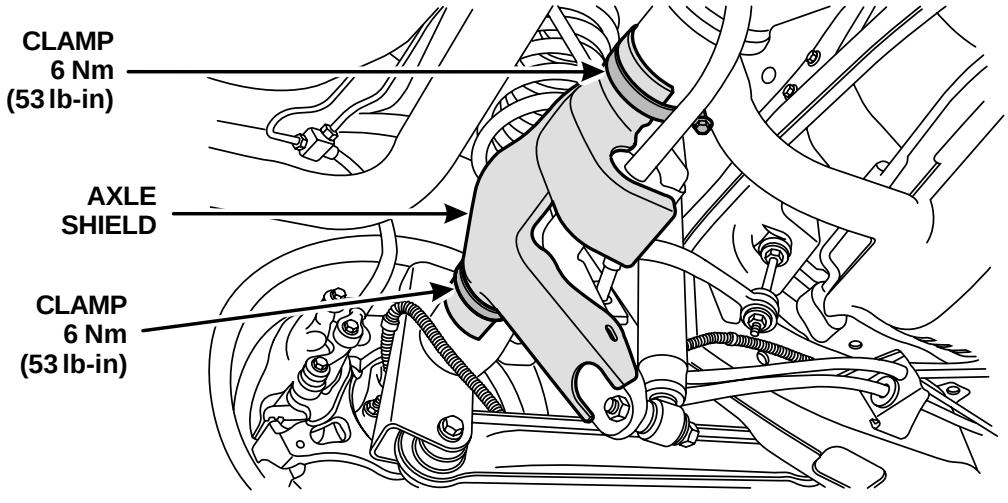
FIGURE 1

1998-2002 MODEL YEAR VEHICLES

Install the left and right axle shields being sure to position them so there is clearance between the shield and the stabilizer bar as illustrated. On 1992 to 1997 model year vehicles, be sure the ABS circuit wiring harness is not pinched under the shield and the right side parking brake cable is positioned in the notch molded into the shield. Tighten the clamps to 6 Nm (53 lb-in). See Figures 1 and 2.

In some cases, excess weld material on the coil spring seat or stabilizer bar bracket can interfere with clamp installation. If necessary, grind away only enough excess weld material to allow for correct seating of the shield and clamp onto the axle. **DO NOT grind the parent metal.**
