HOOD LATCH STRIKER REPLACEMENT

AFFECTED VEHICLES: **CERTAIN 2001 MODEL YEAR RANGER, EXPLORER SPORT AND SPORT TRAC VEHICLES**

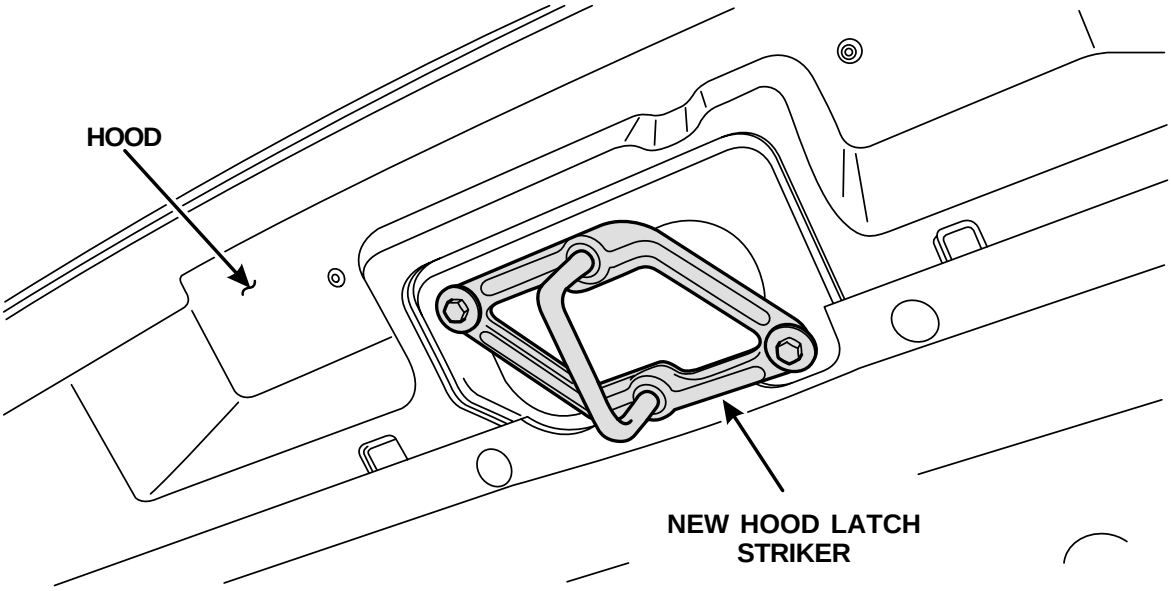
FIGURE 1

RANGER SHOWN, EXPLORER SPORT/SPORT TRAC SIMILAR **00S45A**

1. Remove the hood latch striker.
2. Install the ***new*** hood latch striker. Tighten the bolts to 12 Nm (9 lb-ft). See Figure 1.

3. Close the hood and check hood alignment. Adjust hood latch striker as necessary.
