LEXUS GS300/GS430 SUP (RM786E)

# INSPECTION PROCEDURE

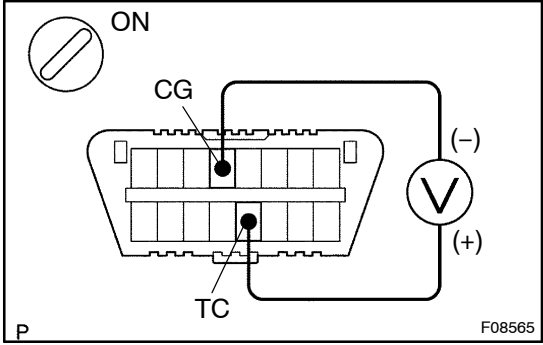
### 1 Check voltage between terminals TC and CG of DLC3.

Measure the voltage between terminals TC and CG of the DLC3.

Voltage: 9 – 14 V
