ELECTRICAL—AFTERMARKET ACCESSORIES INOPERATIVE OR NOT OPERATING AS DESIGNED—POLICE INTERCEPTOR MODELS BUILT BEFORE 5/23/2002 ONLY	Article No. 02-15-1

FORD: 2003 CROWN VICTORIA

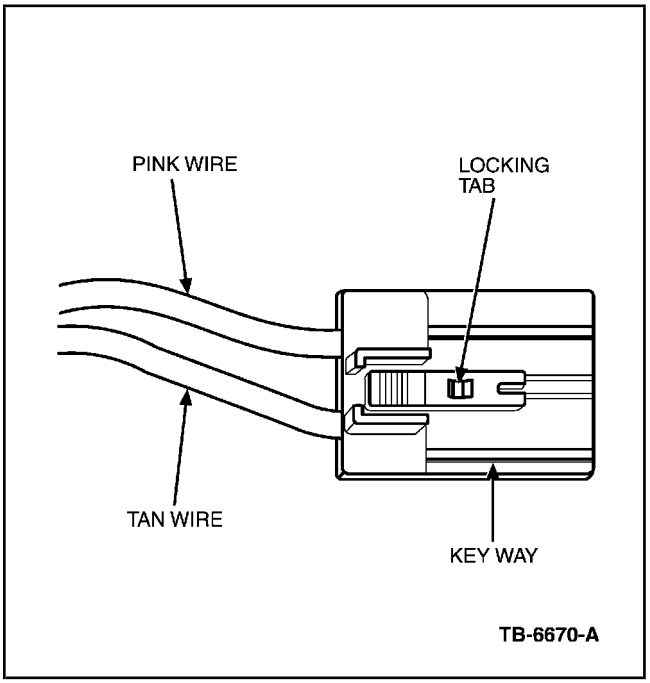
Figure 1 - Article 02-15-1

Some 2003 Crown Victoria Police Interceptors built before 5/23/2002 may have the tan and pink wires into electrical connector C2232d in the incorrect pin locations. These wires supply power to the optional police front power distribution box. The tan wire is hot at all times; whereas, the pink wire is hot with ignition in run. This may cause aftermarket police accessories intended to have power only with key on, to be powered at all times. Accessories intended to have power at all times, would have power only with key on.

Locate connector C2232d under the passenger side instrument panel. This connector supplies power to the optional police front power distribution box. Compare the wire locations to those shown in Figure 1. If the wires are in the incorrect pin locations, refer to the following Service Procedure for details.

5. Grasp the connector with one hand and use the screwdriver to depress the locking pin inside the connector to release the terminals.
6. Switch locations of the terminals to match Figure 1.
