Revision Guide for AMD Family 17h Models 00h-0Fh Processors

Publication # 55449	Revision: 1.16
Issue Date: May 2019

Advanced Micro Devices

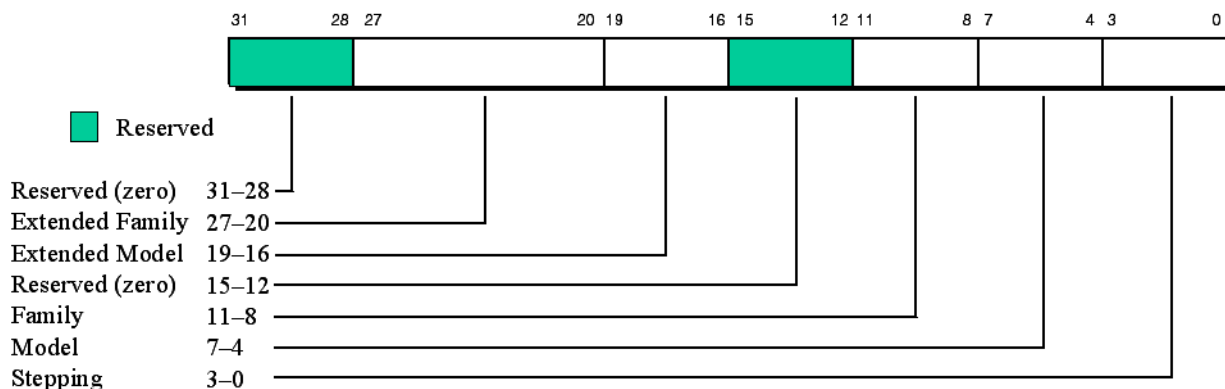
A processor revision is identified using a unique value that is returned in the EAX register after executing the CPUID instruction function 0000_0001h (CPUID Fn0000_0001_EAX).

Figure 1. Format of CPUID Fn0000_0001_EAX

The following tables show the identification numbers from CPUID Fn0000_0001_EAX for each revision of the processor to each processor segment. "X" signifies that the revision has been used in the processor segment. "N/A" signifies that the revision has not been used in the processor segment.
