VILLAGER SEAT BELT BUCKLE INSPECTION AND REPLACEMENT

AFFECTED VEHICLES: CERTAIN 2001 MODEL YEAR VILLAGER

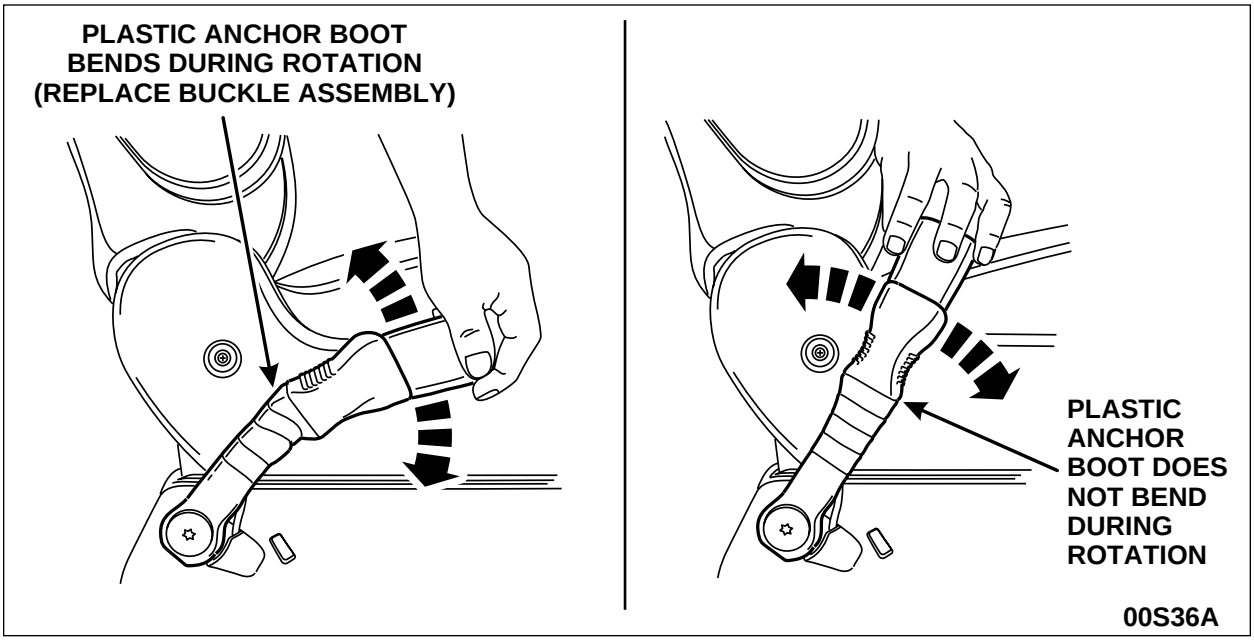
FIGURE 1

1. Grasp the end of the seat belt buckle and rotate the buckle assembly forward and backward as shown in the illustration. The buckle assembly should rotate freely and the plastic anchor boot should remain straight. See Figure 1.
   - If the effort necessary to rotate the buckle assembly bends the plastic anchor boot, replace the buckle assembly. Any bending of the plastic anchor boot is **NOT** acceptable. Refer to the service procedures in Section 501-20A of the appropriate Workshop Manual.
   - If the buckle assembly rotates freely and the plastic anchor boot does not bend, continue with the inspection procedure.

- If the effort necessary to rotate the buckle assembly bends the plastic anchor boot, replace the buckle assembly. Any bending of the plastic anchor boot is **NOT** acceptable. Refer to the service procedures in Section 501-20A of the appropriate Workshop Manual.
