PX4 / PX4-GPSDrivers

u-blox: reduce update rate for M9N to 5Hz (instead of 10Hz) #57

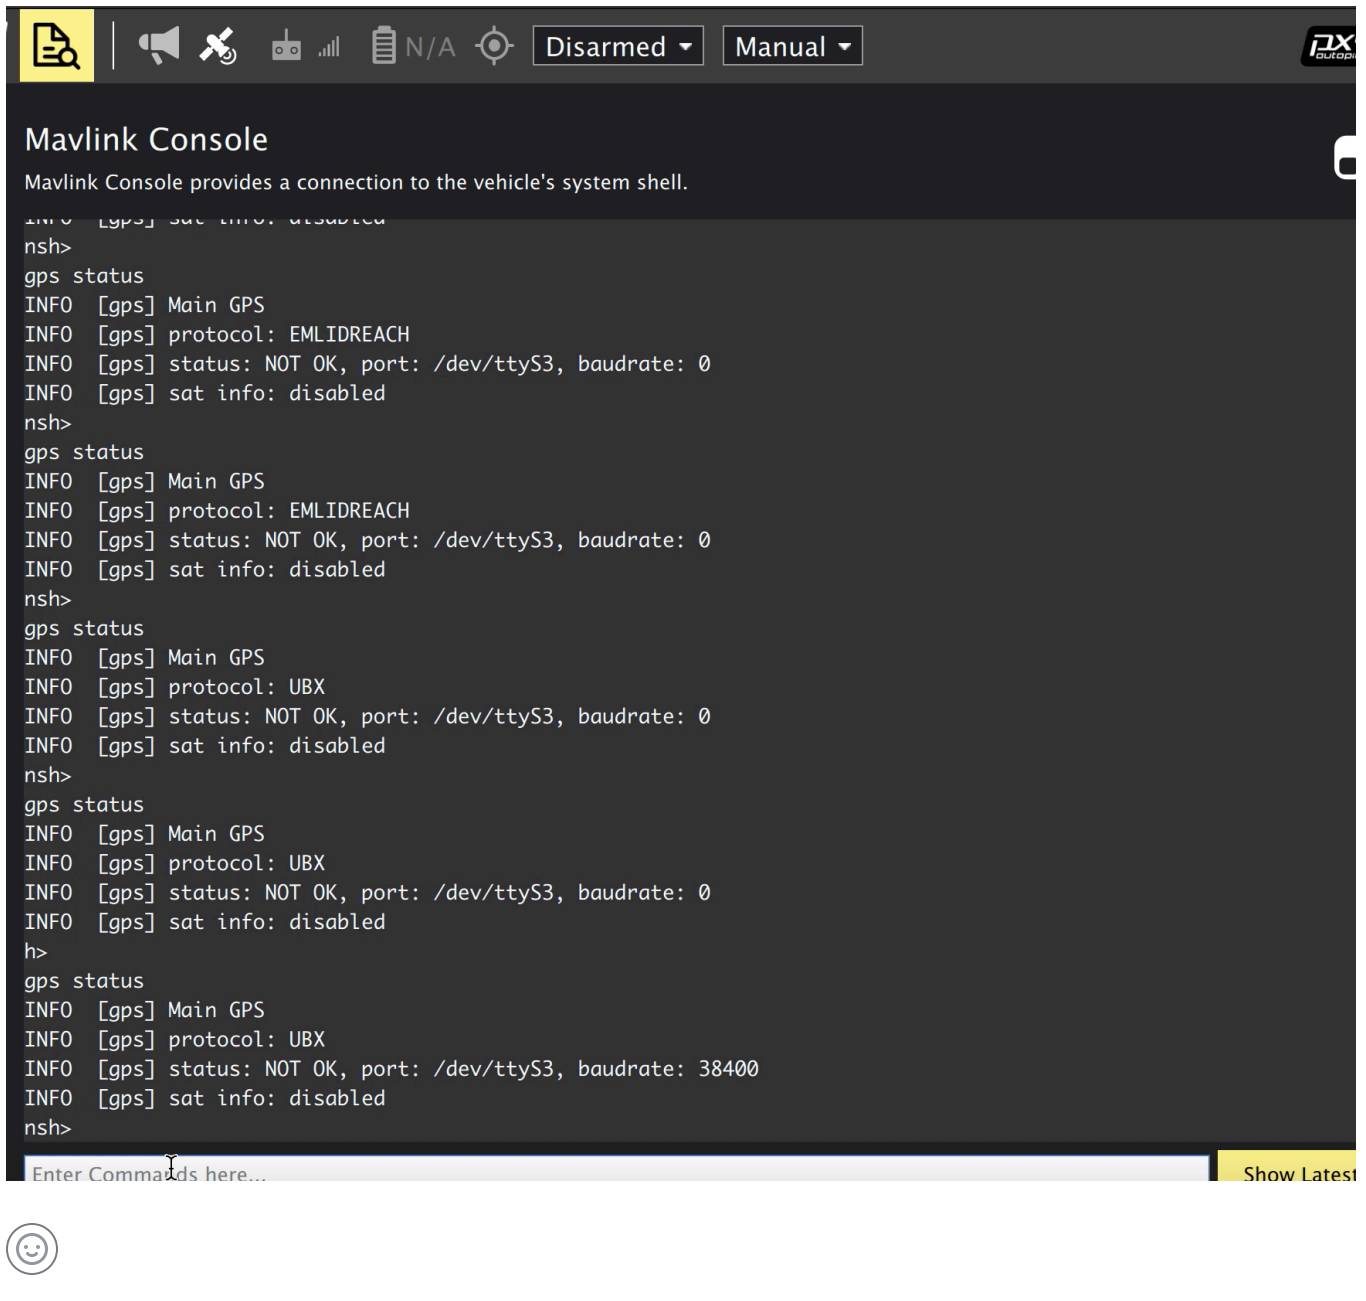
The image shows a screenshot of the Mavlink Console interface. At the top, there is a status bar with various icons (a magnifying glass, a speaker, a crossed-out speaker, a radio tower, a signal strength indicator, a battery level indicator, and a gear icon) and two buttons: "Disarmed" and "Manual". Below the status bar, the title "Mavlink Console" is displayed. Underneath the title, a message states: "Mavlink Console provides a connection to the vehicle's system shell." The main area of the console is a dark gray terminal window showing the following text:

```
nsh>
gps status
INFO [gps] Main GPS
INFO [gps] protocol: EMLIDREACH
INFO [gps] status: NOT OK, port: /dev/ttyS3, baudrate: 0
INFO [gps] sat info: disabled
nsh>
gps status
INFO [gps] Main GPS
INFO [gps] protocol: EMLIDREACH
INFO [gps] status: NOT OK, port: /dev/ttyS3, baudrate: 0
INFO [gps] sat info: disabled
nsh>
gps status
INFO [gps] Main GPS
INFO [gps] protocol: UBX
INFO [gps] status: NOT OK, port: /dev/ttyS3, baudrate: 0
INFO [gps] sat info: disabled
nsh>
gps status
INFO [gps] Main GPS
INFO [gps] protocol: UBX
INFO [gps] status: NOT OK, port: /dev/ttyS3, baudrate: 0
INFO [gps] sat info: disabled
h>
gps status
INFO [gps] Main GPS
INFO [gps] protocol: UBX
INFO [gps] status: NOT OK, port: /dev/ttyS3, baudrate: 38400
INFO [gps] sat info: disabled
nsh>
```
