AXLE PIVOT BRACKET FOR LEFT AXLE

AFFECTED VEHICLES: CERTAIN 2000 MODEL YEAR ECONOLINE

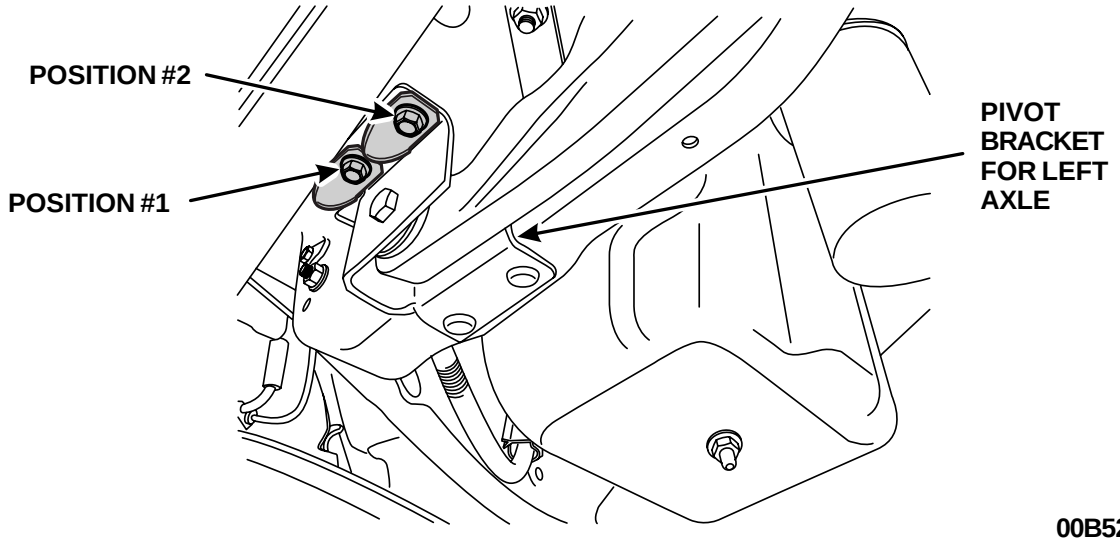
FIGURE 1

1. Raise and support the vehicle.
2. On gasoline engine vehicles, remove the lower air deflector.
3. Visually inspect the bolts in positions 1 and 2 as shown in the illustration. See Figure 1.

4. If either bolt is installed from the bottom (pointing upward toward the oil pan), the bolt(s) must be removed and replaced.
5. Position an adjustable vehicle stand and a block of wood under the oil pan.

6. Remove the right and left engine insulator-to-frame retaining nuts.
7. Remove the transmission mount-to-crossmember nuts.
8. **CAUTION: The engine should be lifted no more than 50 mm (2 in) to prevent damaging other engine components.**

Raise the engine approximately 50 mm (2 in).
9. Remove and discard the incorrectly installed bolt(s) from the axle pivot bracket.
10. Install a ***new*** bolt(s) (N811530-S100) from the top and nut(s) (N802074-S2) from the bottom. Tighten to 90 Nm (66 lb-ft).
11. Lower the engine.
12. Install the engine insulator nuts. Tighten the nuts to 90 Nm (66 lb-ft).
13. Install the transmission mount-to-crossmember nuts. Tighten the nuts to 90 Nm (66 lb-ft).
14. Install the lower air deflector (gasoline engines only).
15. Lower the vehicle.

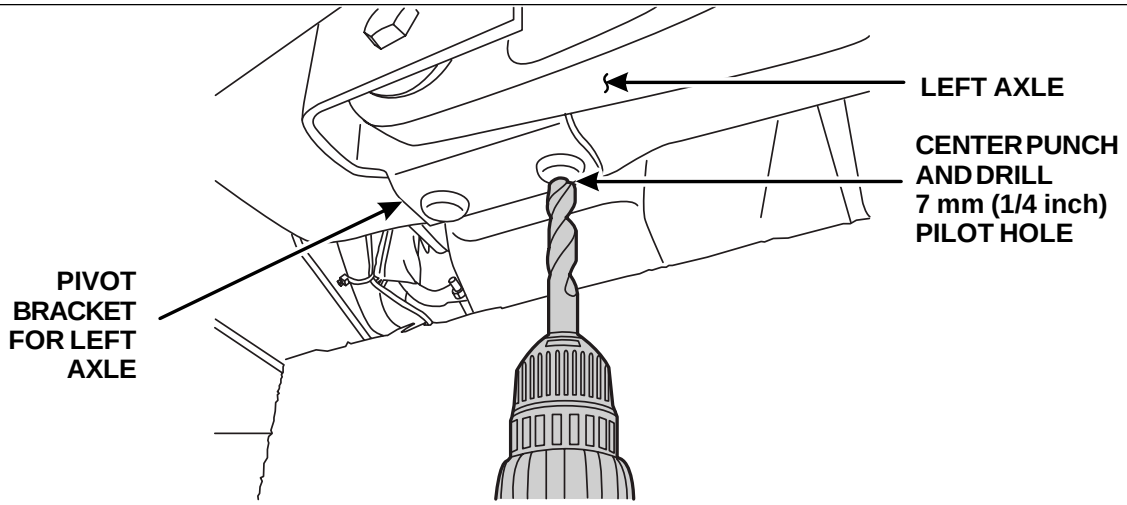
FIGURE 2

These vehicles have rivets retaining the pivot bracket. The rivets are incorrectly installed, and must be replaced with bolts. The rivets will be drilled out two at a time, then bolts will be installed from the top. The engine will need to be raised off of the crossmember to provide clearance for installation of the bolts.

7. Center punch two (2) rivets, then drill a 7 mm (1/4 inch) pilot hole in each rivet. See Figure 2.

WARNING: REMOVE NO MORE THAN TWO (2) RIVETS AT ONE TIME TO MAINTAIN SUPPORT FOR THE PIVOT ARM

8. Drill off the heads of the rivets with a 12 mm (15/32 inch) drill bit. Use of a chisel may be necessary.
9. Ream the holes with a 13 mm (1/2 inch) drill bit.
10. Install ***new*** bolts (58675-S2) with ***new*** washers (44879-S2) from the top, then install ***new*** washers (44879-S2) and ***new*** nuts (34989-S2) from the bottom. Tighten to 120 Nm (89 lb-ft).
11. Perform steps 6 through 9 on the remaining two (2) rivets.
12. Lower the engine.
13. Install the engine insulator nuts. Tighten the nuts to 90 Nm (66 lb-ft).
14. Install the transmission mount-to-crossmember nuts. Tighten the nuts to 90 Nm (66 lb-ft).
15. Install the lower air deflector (gasoline engines only).
16. Lower the vehicle.
