NOISE—SQUEAK/CREAK NOISE COMING FROM DOOR HINGE AREA	Article No. 02-7-4

FORD: 2000-2002 CROWN VICTORIA

MERCURY: 2000-2002 GRAND MARQUIS

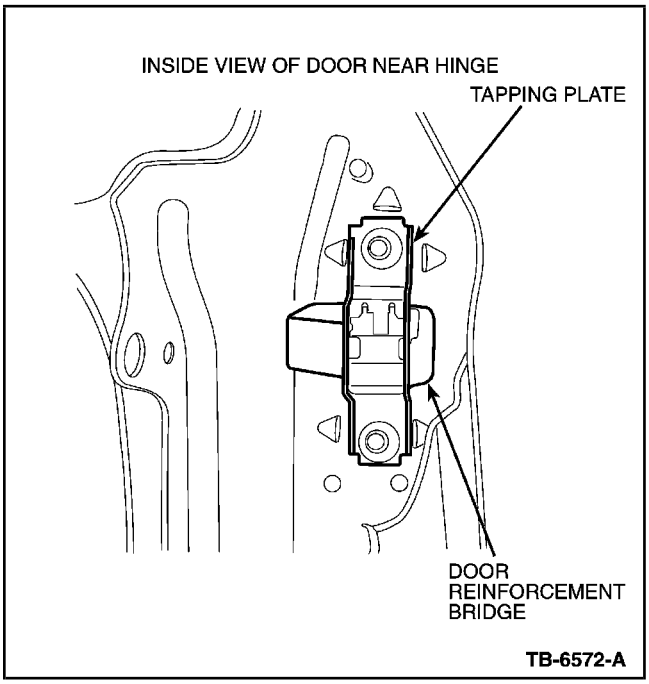
Figure 1 - Article 02-7-4

Some vehicles may exhibit a squeak/creak noise coming from the left front or right front door hinge area. This may be caused by the door reinforcement tapping plate edges rubbing against the door reinforcement (Figure 1). This tapping plate may contact the door reinforcement bridge, located on the inside door, across from the hinge.

Verify condition. Apply Ford Long Life Lubricating Grease, part number F5AZ-19G209-AA, on the hinges in the area specified. Refer to the following Service Procedure for details.

1. Open the door.
2. Apply Ford Long Life Lubricating Grease (F5AZ-19G209-AA) on the hinges to the outside surface while the door is open.
3. Open and close the door several times. If the squeak/creak is still present:
4. Remove the door inner panel. Refer to Section 501-05 of the Crown Victoria/Grand Marquis Work Shop Manual.
5. Remove the speaker.
6. Reach inside and apply Ford Long Life Lubricating Grease (F5AZ-19G209-AA) on the top and bottom inside hinge reinforcements (sheet metal and tapping plate).
7. Re-install the door panel and speaker. Refer to Section 501-05 of the Crown Victoria/Grand Marquis Work Shop Manual.
8. Verify the repair.
