# **PRECONSTRUCTION CONDITION DOCUMENTATION REPORT OF THE 1567 BROADWAY (W HOTEL)**

**224 WEST 47TH STREET**

**Re: Preconstruction Condition Documentation  
of the 1567 Broadway Building**

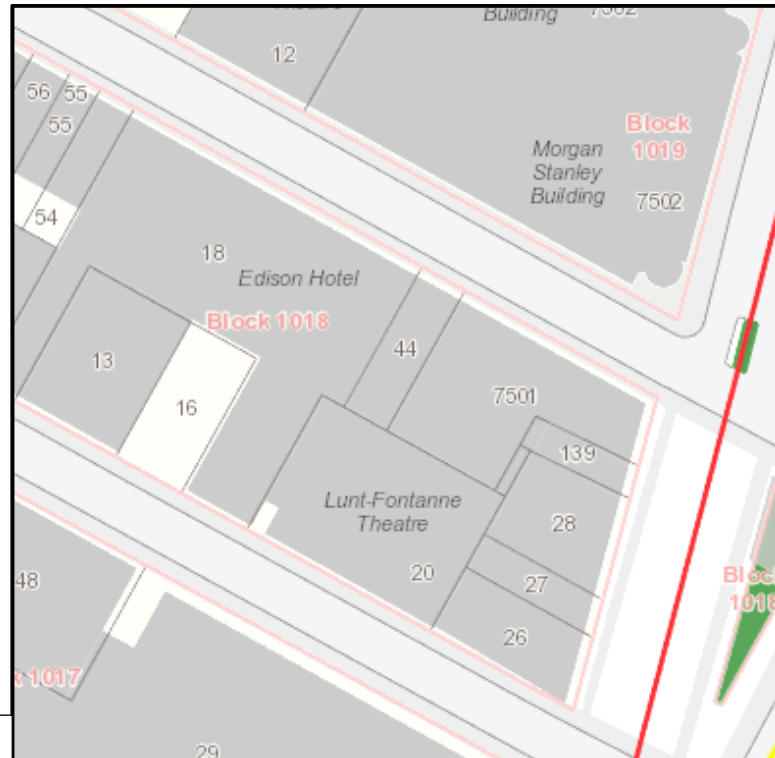
FIGURE 1 – SITE PLAN

The project site was located on the south side of West 47th Street, see Figure 1 – Site Plan. The project site was a parcel belonging to Block 1018 and Lot 44, and measured approximately 33' x 100'. Currently, the site supported an existing 10-story building. We understand the plans call for constructing additional floors atop the existing 224 West 47<sup>th</sup> Street building.

Portion of the 203 West 46 Street abutted the site on the south. A 54- story building (1567 Broadway) abutted the site on the east, and 22- story hotel building (219 West 46th Street) abutted the site on the west.

Note: Site Plan is an excerpt from [www.oasisnyc.net](http://www.oasisnyc.net) acquired on 12/21/2021
